SCL-DR-65-5

REPORT OF MINUTEMAN ACCIDENT  
INVOLVING A MK 11 RE-ENTRY VEHICLE  
AT SITE LIMA II, DECEMBER 5, 1964 ~~(CFRD)~~

R. K. Petersen, 8141-2  
Sandia Corporation, Livermore Laboratory

January 1965

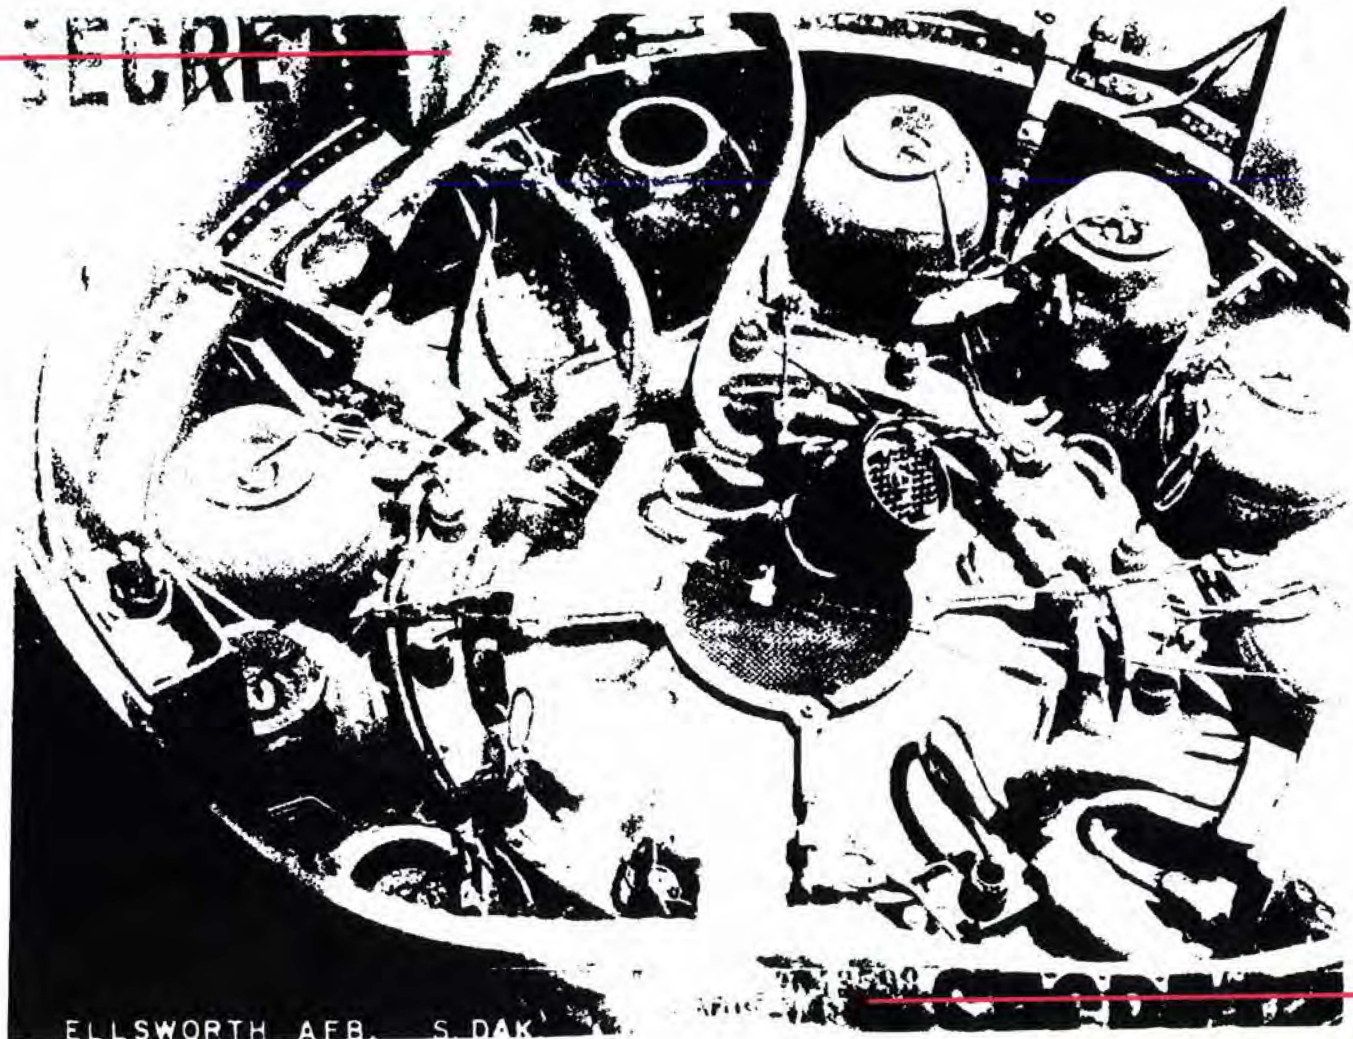
Figure 7. Evidence of Fired Retrorocket

Capt. Tschirhart reported that one retrorocket had fired (Figure 7) and stated that this had caused the RV to separate and fall to the bottom of the silo. He reported that the "firing set" had broken loose and that the tritium bottle was exposed to view but seemed intact. Further, Capt. Tschirhart was certain that the warhead high explosive (HE) had broken up.
