ANALYSIS OF THE SAFETY ASPECTS OF THE MK 39 MOD 2 BOMBS INVOLVED IN B-52G CRASH NEAR GREENSBORO, NORTH CAROLINA

SCDR 81-61

February 1961

This report presents the results of the investigation and analysis of the safety aspects of the Mk 39 Mod 2 bombs involved in the B-52G crash near Greensboro, North Carolina. This investigation was conducted by Sandia Corporation subsequent to a preliminary investigation at the scene of the crash.

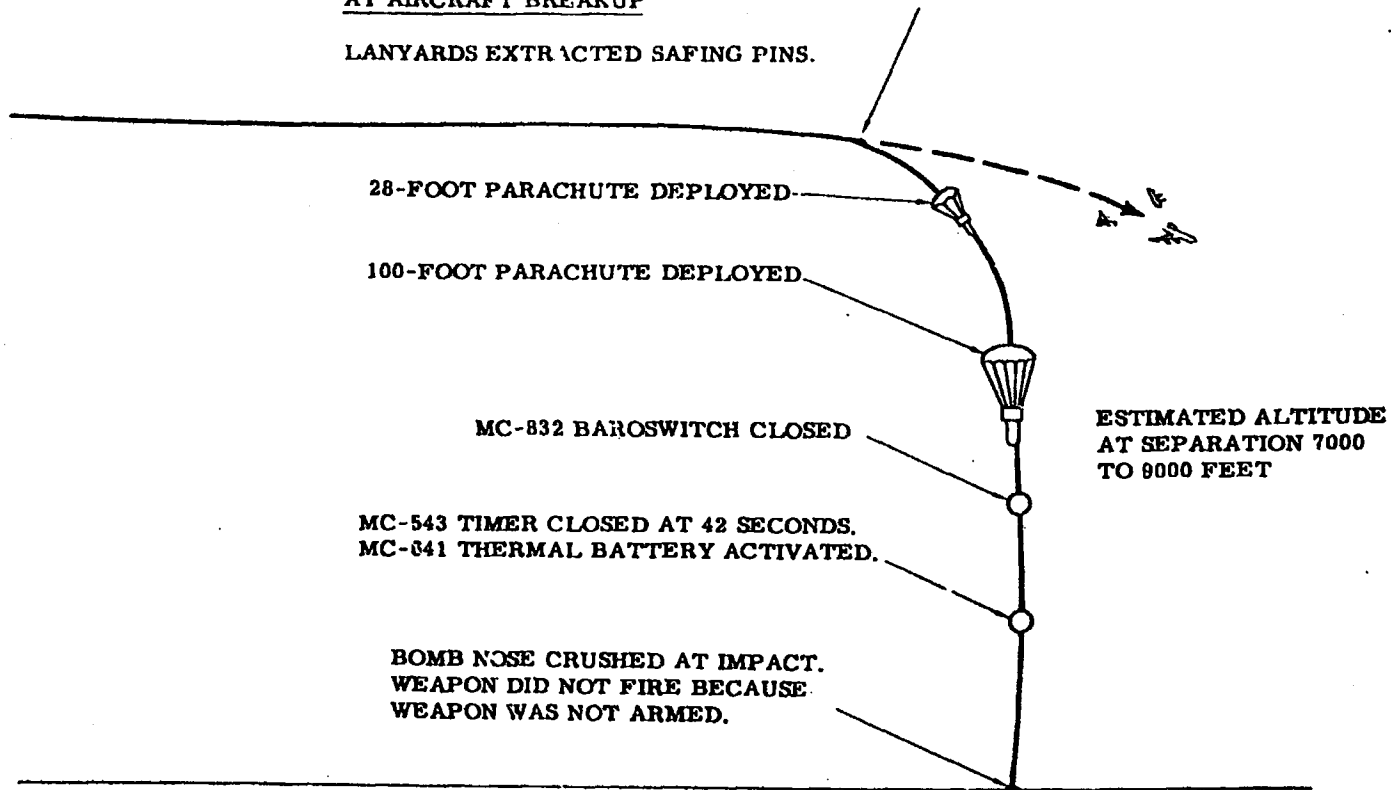
Figure 4. Probable Trajectory Sequence, Weapon No. 1

Observers reported that this weapon separated from the aircraft 7000-9000 feet above terrain. Fully retarded, it impacted in the near-vertical position, penetrated the earth approximately 18 inches, and remained in an upright position with the parachute hanging in adjacent trees. The weapon was intact with only minor damage, and it was possible to analyze the components at the scene. It was found that the safing pins in the Bisch generator rods had been extracted and the pullout valves had operated. The low-voltage thermal battery pack had been initiated and the timer had run down. The differential pressure switch contacts were closed and the high-voltage thermal battery pack had been initiated. The MC-772 Arm/Safe Switch and the MC-788 Safing Switch were in the SAFE positions. The gas reservoir valve had not been actuated and the gas remained in the reservoir. The crush nose assembly was deformed, and it can be assumed that it supplied a fire signal at impact. The probable trajectory sequence is shown in Figure 4.

From examination of the MC-845 Bisch generator assembly, it appears that the pullout rods were extracted in the normal fashion. There was no scoring or other physical damage to the assembly which would indicate that any unusual forces had been applied. Also, since the holes for the safing pins were not in any way damaged, it must be assumed that the safing pins were extracted prior to separation of the weapon from the rack. It is known that the aircraft broke up in mid-air and impacted the earth in several pieces, over a wide area. One intact safing pin and a portion of the lanyard were recovered, indicating that the pin must have been removed at the time the Bisch rods were pulled. It is believed that the lanyards attached to the safing pin in this weapon caused the safing pins to be extracted during the breakup of the aircraft.

This weapon appeared to have a completely normal retarded trajectory; therefore, it is assumed that the parachute solenoid locking device had been operated, securing the parachute static line to the aircraft structure.

From the information available on this weapon, it is apparent that all components behaved in the normal manner that would be expected if the bomb were released from the aircraft with the T-249 in the safe condition. Under these conditions, arming of the weapon is prevented by the MC-772 and the MC-788.

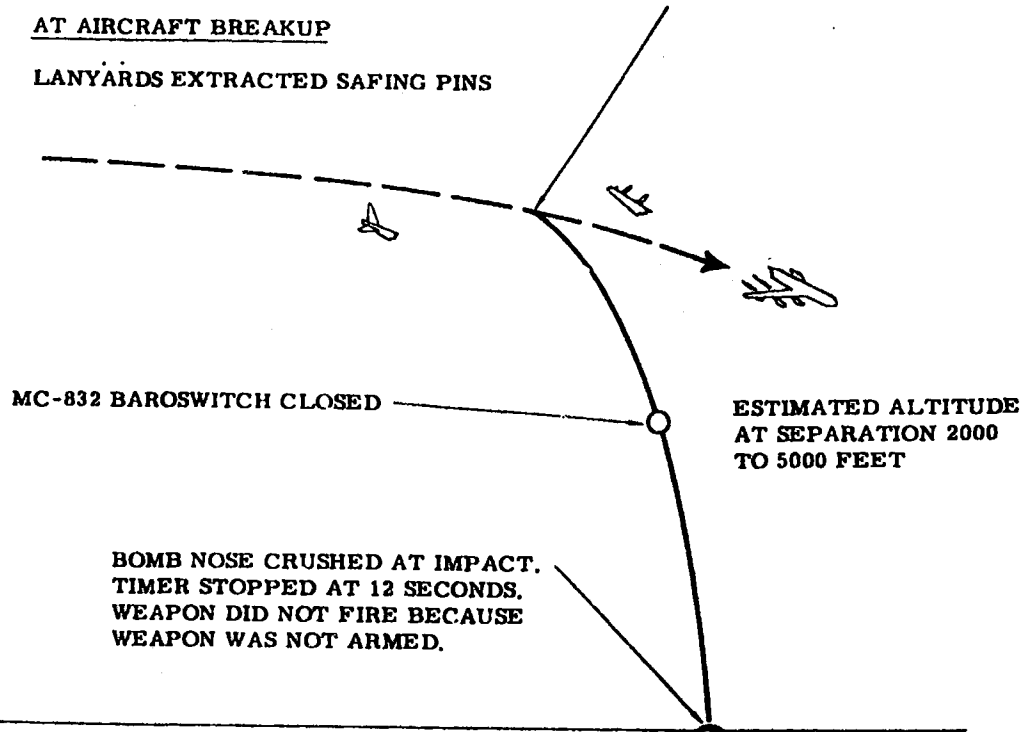
Figure 6. Probable Trajectory Sequence, Weapon No. 2

The probable trajectory sequence of this weapon is shown in Figure 6.

From the evidence available, it must be concluded that the MC-772 was in the SAFE position until time of impact. It is quite probable that the contacts of this switch never operated to the ARM position. The circumstances of this weapon up until the time of impact are very much the same as those of weapon No. 1, except that there was insufficient time between separation of the weapon from the aircraft structure until impact for the timer to operate; consequently, the high-voltage battery was not initiated.

As in the case of weapon No. 1, the fuzing sequence on this weapon appeared to have been initiated when the weapon separated from the aircraft structure.

1. The lanyard-controlled safing pins cannot be relied upon to prevent initiation of the fuzing sequence when the aircraft is involved in this type of accident.
2. The Arm/Safe switch prevented a nuclear detonation in these weapons as it was designed to do.
3. Since it is undesirable to have the fuze power supply activated except when a live release is intended, ALT 197 should be incorporated as rapidly as possible in all Mods of the Mk 15/39 family which are used in the airborne alert.
