ACCIDENT REPORT OF B52G
NEAR SEYMOUR JOHNSON AIR FORCE BASE
NORTH CAROLINA
~~(Title SRD when Associated with Sigma 1)~~

February 1961

ACCIDENT REPORT OF B52G AIRCRAFT CRASH NEAR
SEYMOUR JOHNSON AIR FORCE BASE, NORTH CAROLINA

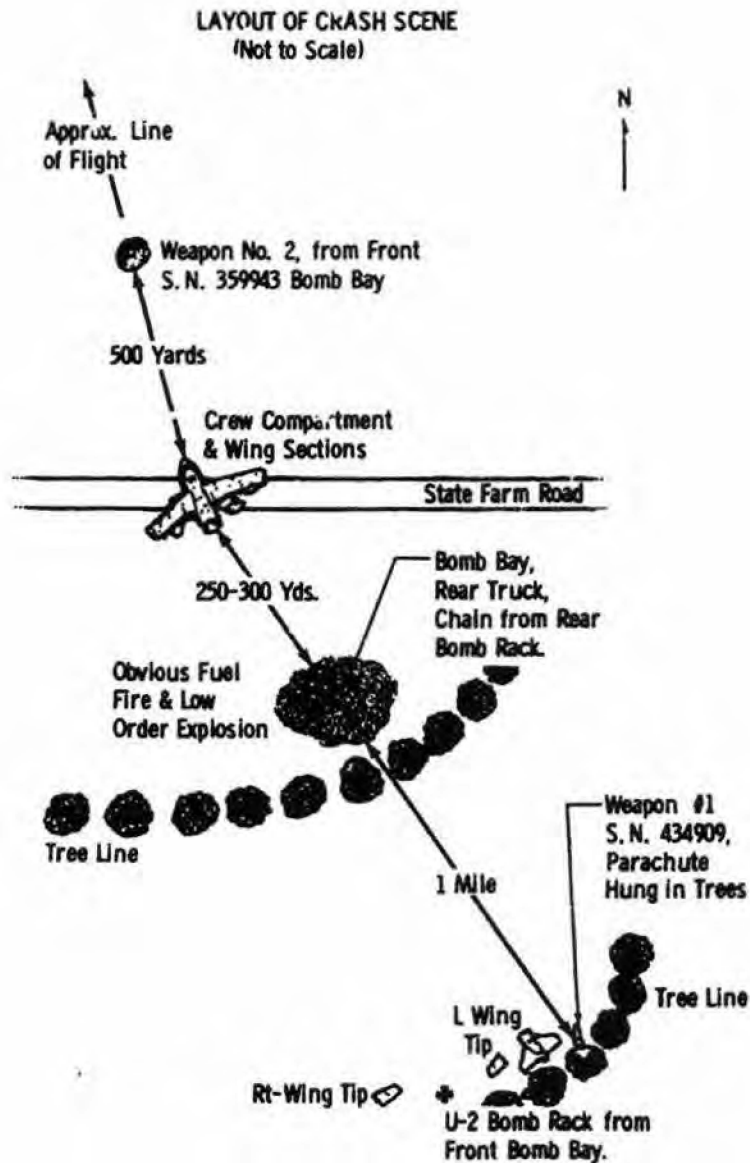
Figure 1

A sketch of the area of the aircraft accident, Figure 1, shows that the aircraft had broken into several pieces in the air. The major wing area and the crew compartments were found in an inverted position, severely burned, and completely demolished. Whether this inverted position was the result of one wing-over or a continuous gyrating action, no one is sure. As indicated in the sketch, one portion of the aircraft, the tail section, was found one mile from the location of the wing and crew compartment of the aircraft. Break-up of the aircraft, it was assumed, occurred in the vicinity of 9,000 feet altitude. Those parts of the aircraft which impacted on the ground showed, except for the tail section, signs of severe burning. The rear truck and bomb bay area especially showed signs of a severe fuel fire. This aircraft was equipped with a T-249 Aircraft Monitor and Control Unit and a T-380 Readiness Switch. These were not recovered.
