VOLUME II
PHYSICAL DAMAGE
HIROSHIMA, JAPAN

Prepared by Major Noland Varley

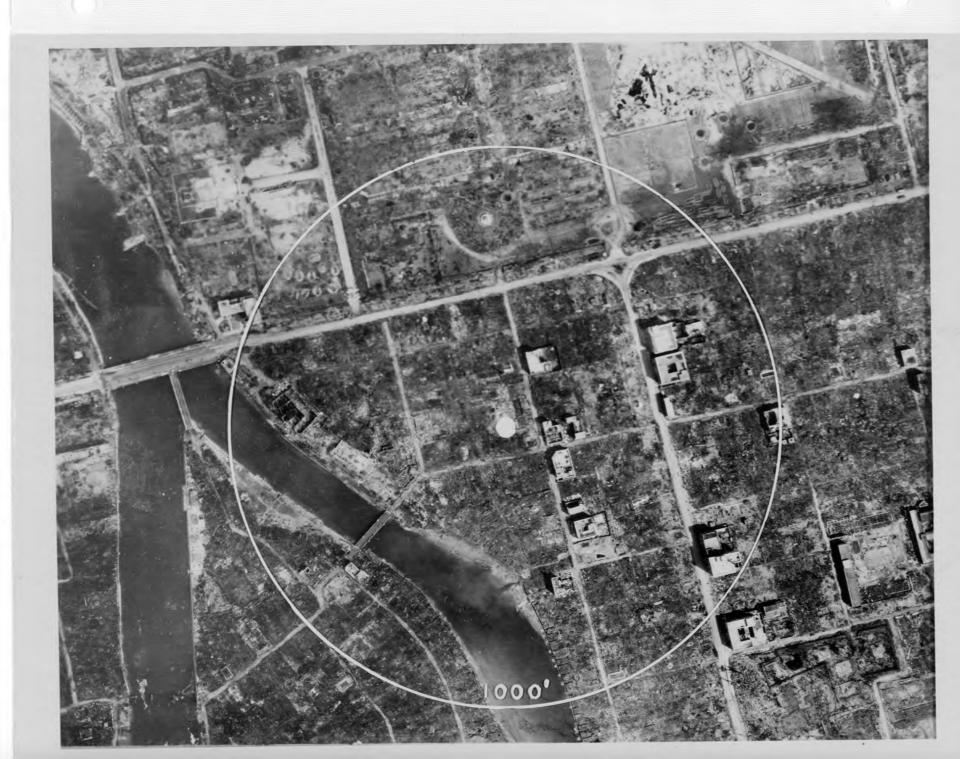
#### ABRIAL VIEW OF ZERO POINT

This view looking directly down on zero point shows the target area completely leveled except for multi-story reinforced concrete buildings.

Roofs and intermediate floors collapsed on five of these buildings leaving exterior walls partially standing.

The dark spots on the roofs of other buildings are depressions formed by the downward distortion of the roof structure.

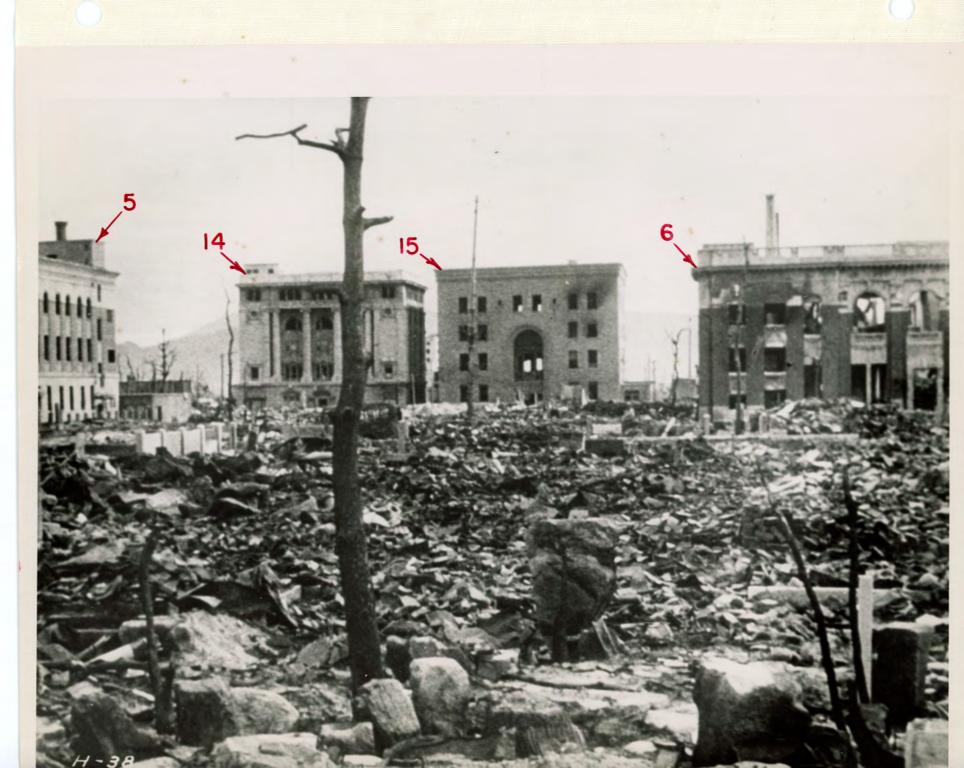
## VIEW AT "ZERO POINT"

This is a view from "Zero Point" looking East.

The trunk of a small tree remained standing since the force of the blast was directly down-ward in this area.

Survival of the tree indicates the absence of intense heat at the time of the explosion.

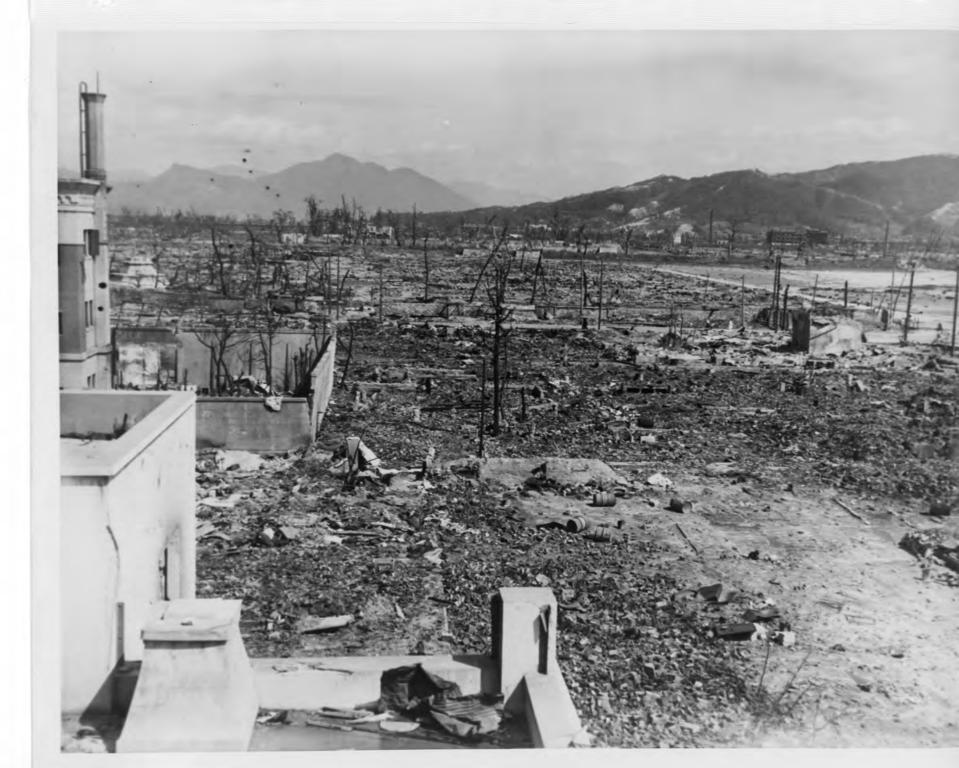
## VIEW NEAR ZERO POINT

From Building No. 7 (300 ft. East of Zero)

View looking north across the Military Area.

Building No. 5 is on the extreme left.

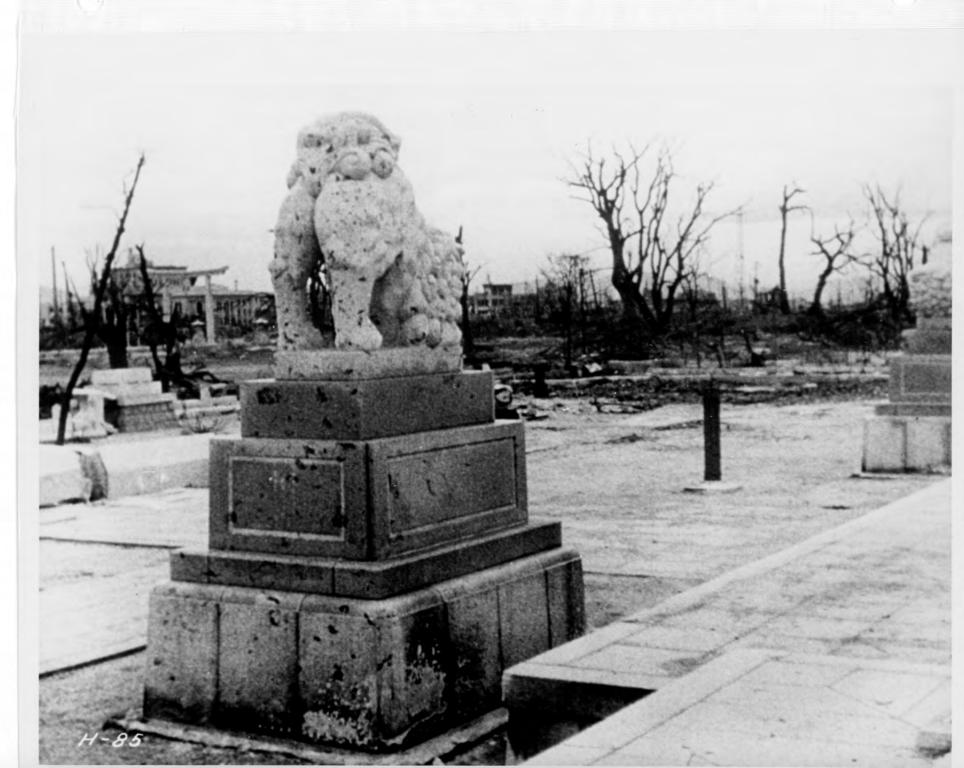
#### GOKOKU SHRINE

This is a "close-up" of one of the statues looking toward "Zero Point".

Light surfaces on the base of the statues are areas roughened by the blast. The original surface was polished granite, but the "sand blast" effect produced by the blast has roughened the exposed surfaces and a portion of the surface on the side away from the blast as shown here.

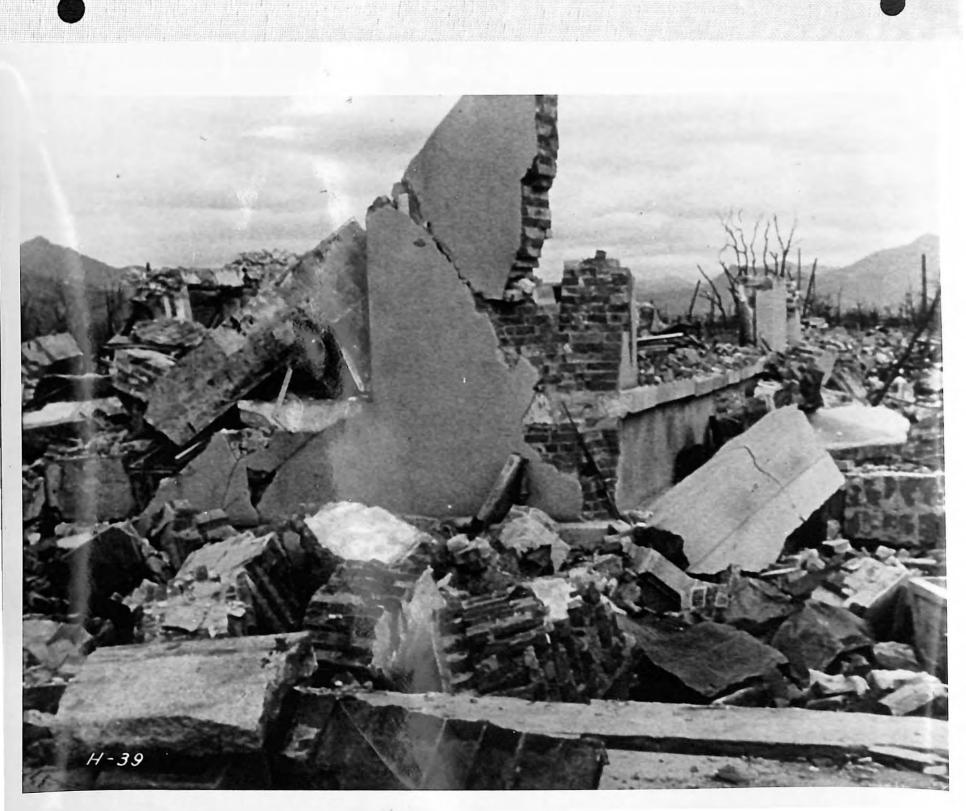
# VIEW NEAR "ZERO POINT"

Looking north from "Zero Point" at the shattered walls of a brick building.

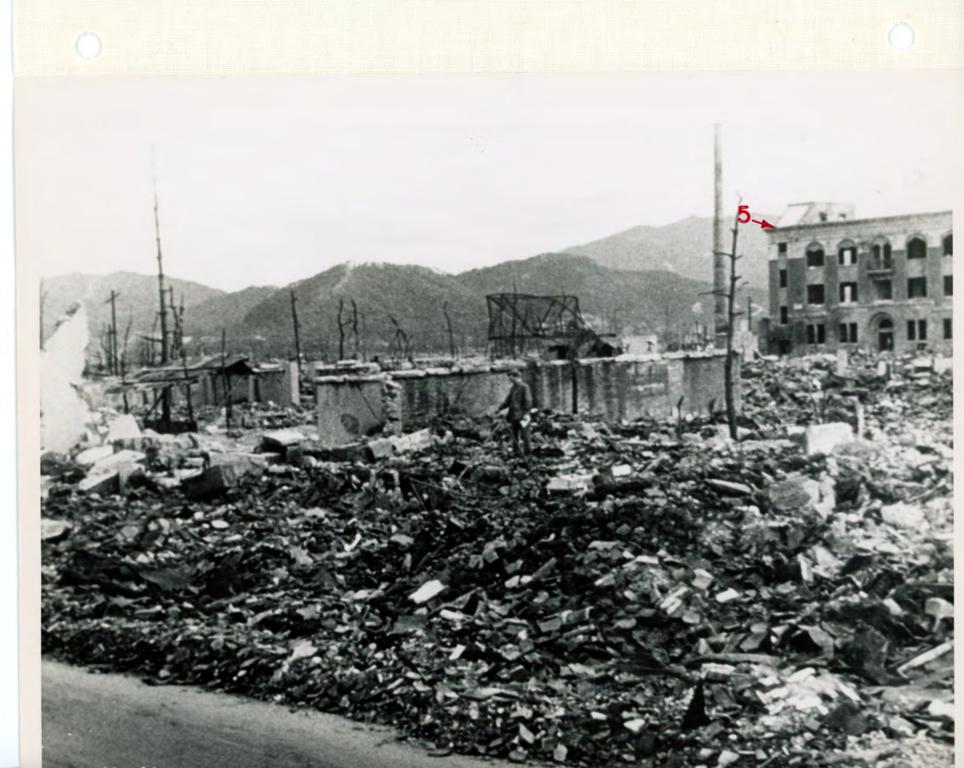
## VIEW AT "ZERO POINT"

This view is looking northeast across "Zero Point".

The concrete stack approximately 200 feet from "Zero Point" survived the blast since the direction of the blast was almost directly downward in this area.

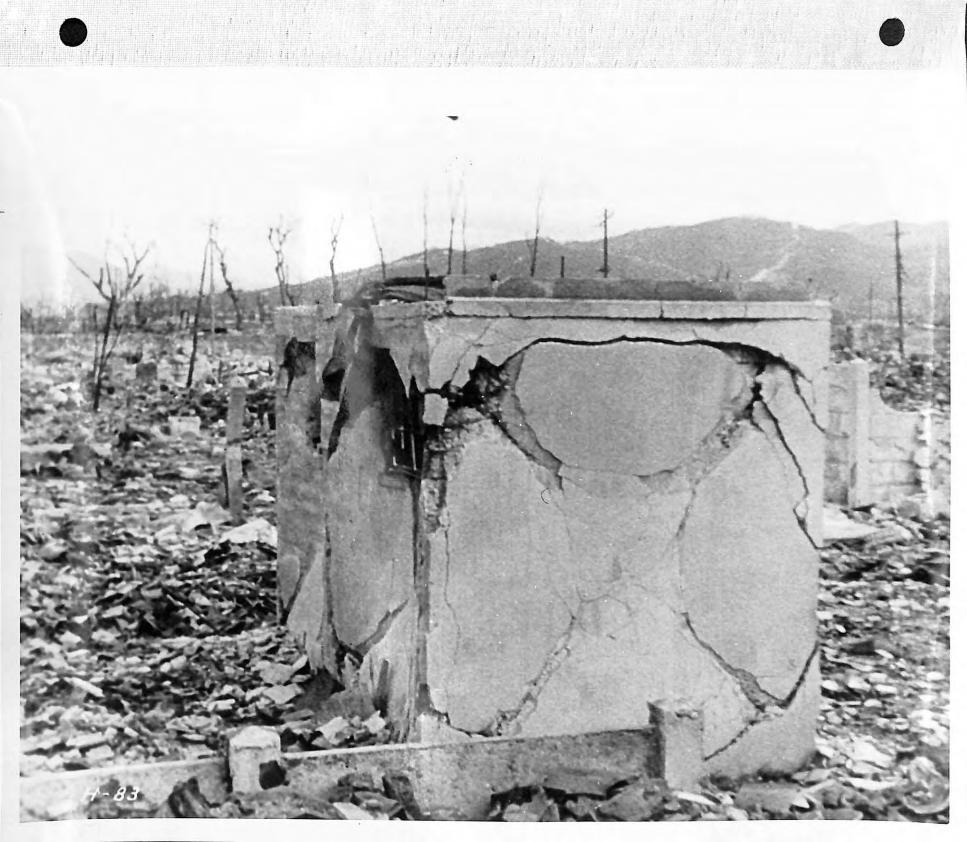
#### CONCRETE VAULT

Close-up showing damage described with preceding picture.

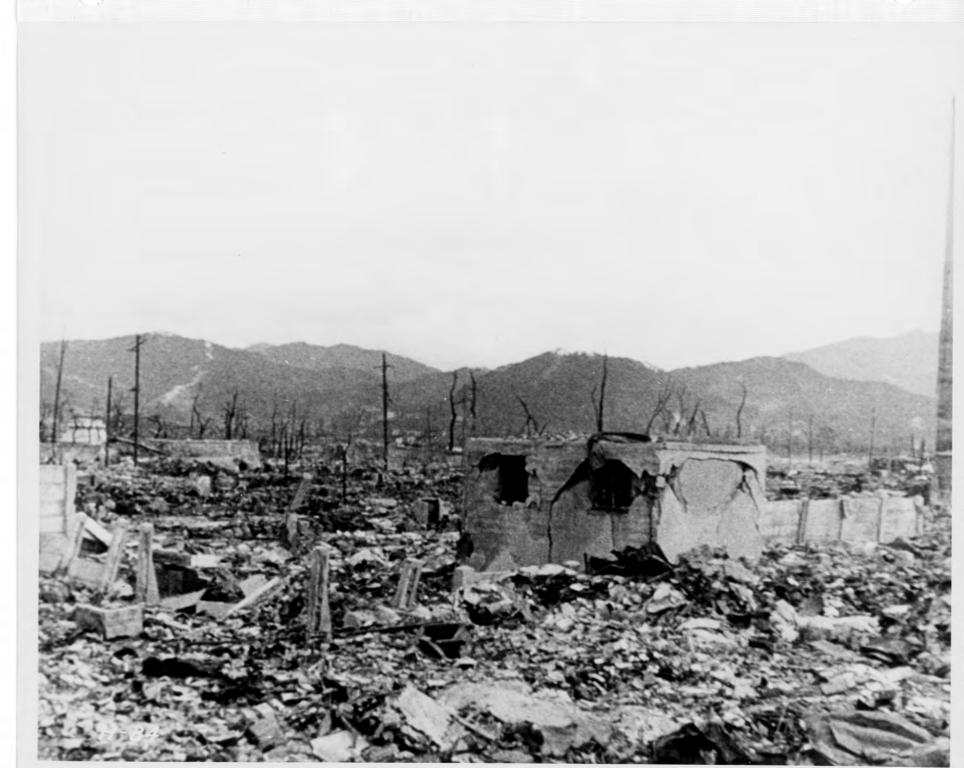
#### (200 ft. north of Zero Point)

This view looking northeast shows a concrete vault, all that remains of a building of wood construction.

The end wall and half the sidewalk nearest the blast failed under the blast pressure.

While the walls of the vault failed under the impact of the blast, the walls of a reinforced concrete building nearby are still structurally intact. This is apparently due to the difference in window space. The two small vault windows did not allow pressure to build up in the vault interior as rapidly as the building interior thereby, subjecting the vault walls to greater stresses.

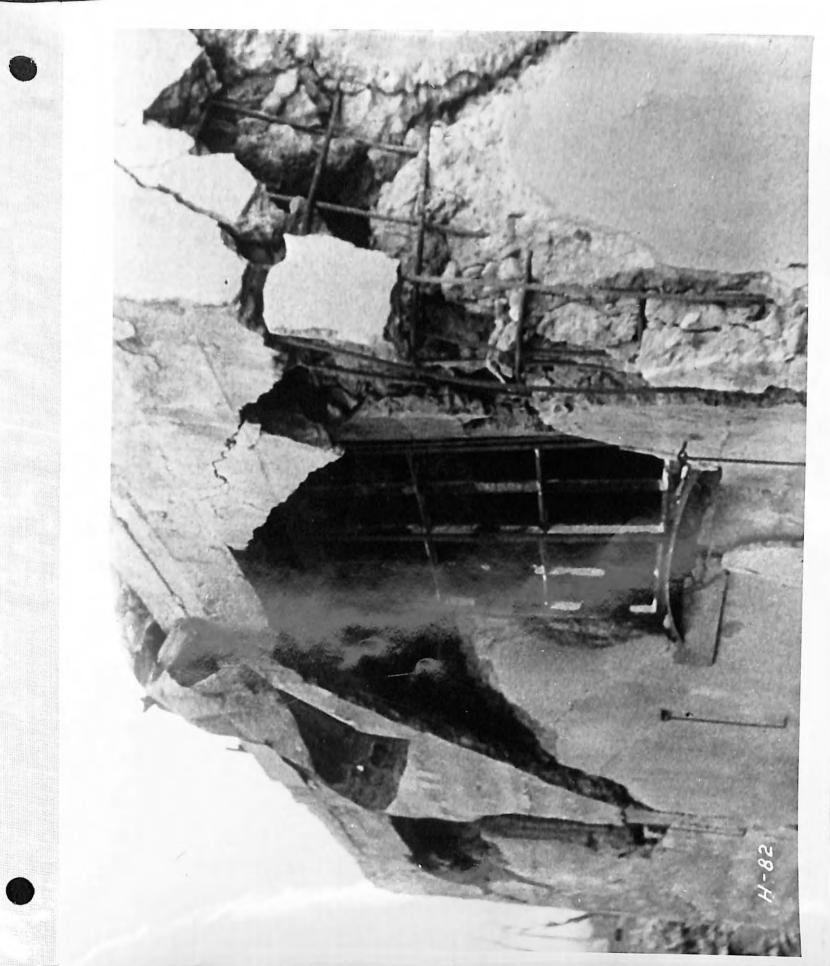
# CONCRETE VAULT

(200 ft. north of Zero Point)
Close-up showing reinforcing steel.

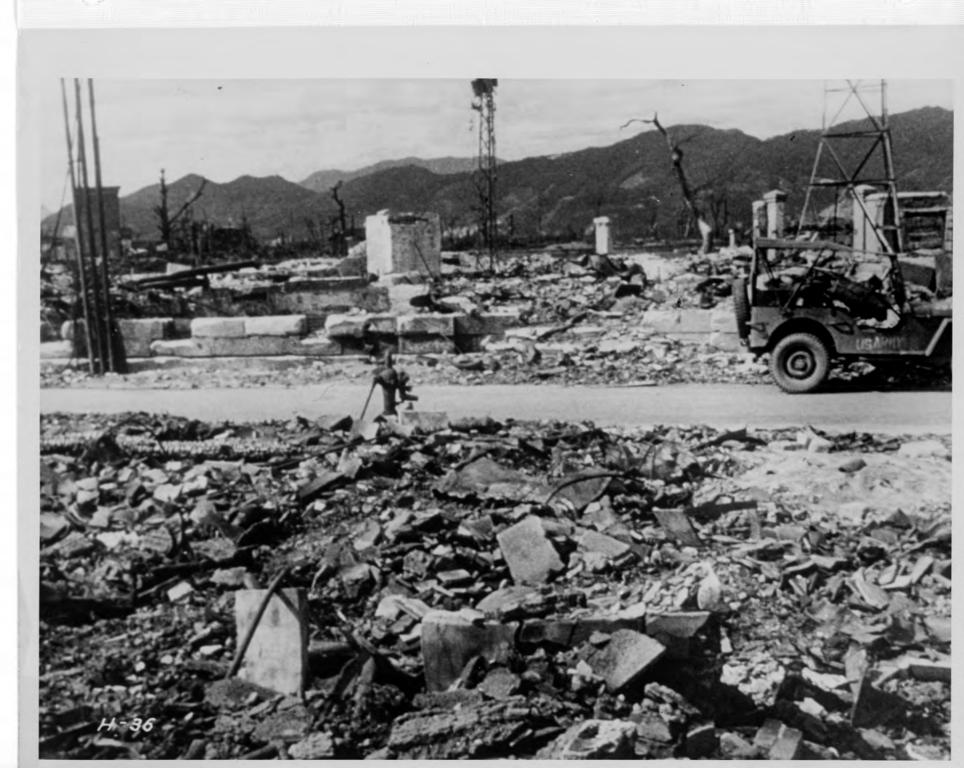
# DESTRUCTION NEAR ZERO POINT

This view looking west from near zero point shows rubble remaining after fires swept through the demolished buildings following the blast.

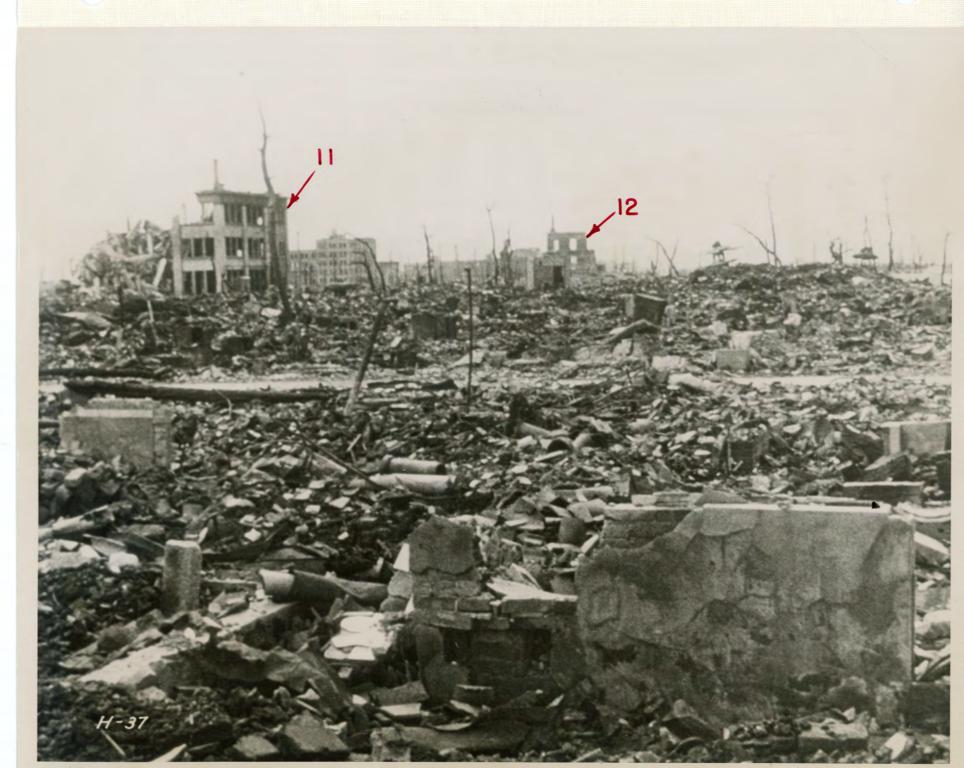
# DEVASTED AREA SOUTH OF "ZERO POINT"

This view looking south from near "Zero Point" shows complete devastation in the immediate vicinity.

The collapsed Hiroshima Gas Company (Bldg No. 11) may be seen on the extreme left of this picture.

A brick building (No. 12) is completely demolished except for one wall.

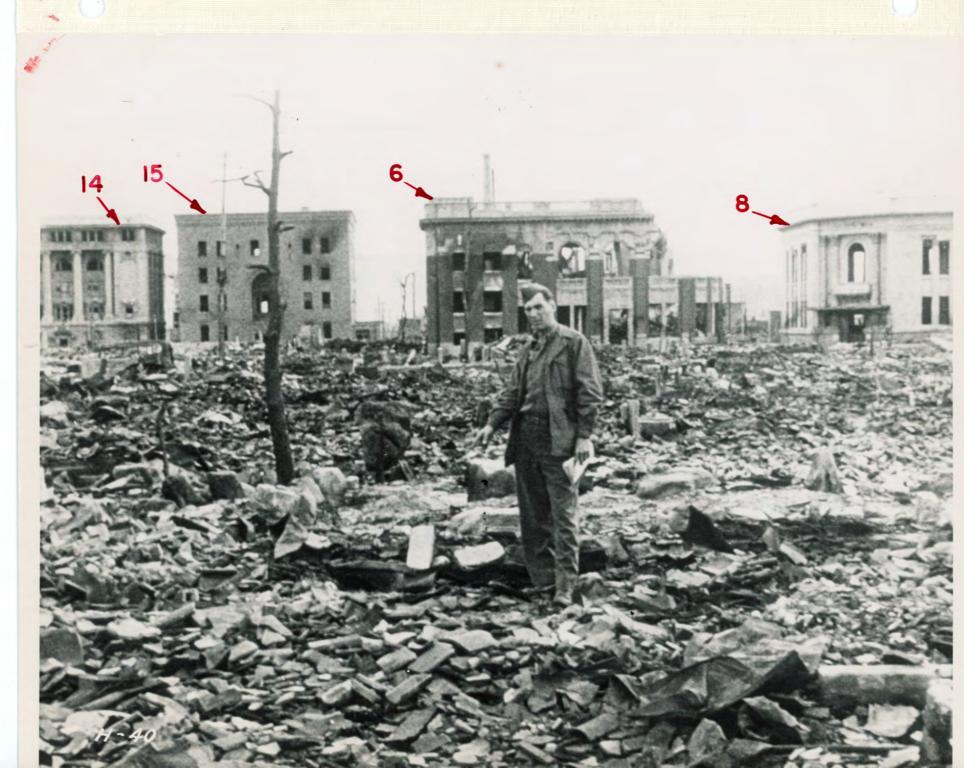
In this picture a soldier is standing at the epicenter or "Zero Point" of the explosion.

The buildings shown are east of "Zero Point", the two on the left, numbers 14 and 15, are approximately 600 feet from "Zero Point".

The two on the right, numbers 6 and 8, are approximately 200 feet from "Zero Point".

The blast pressure was almost directly down on the roofs of these buildings.

The roof and intermediate floors of building No. 6 collapsed to the ground floor, and may be seen more clearly in the preceeding aerial view and the following close-up.

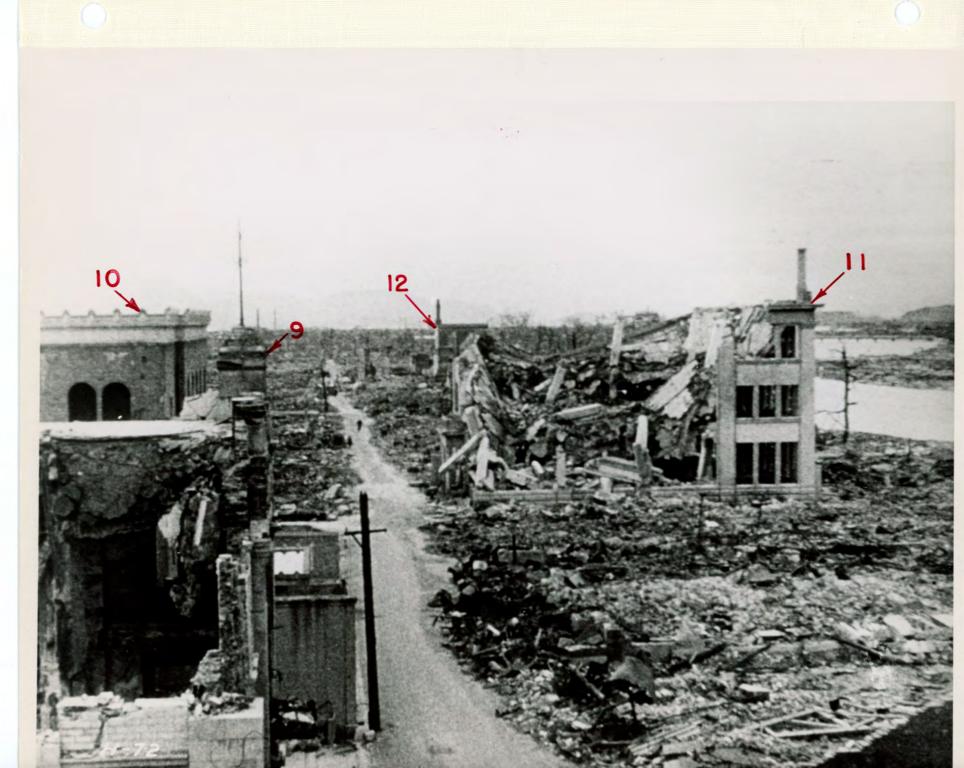
#### HIROSHIMA GAS COMPANY BUILDING

This view looking south from the roof of the Sanwa Bank Building (Bldg. No. 8) shows the collapsed three-story Hiroshima Gas Cempany Building O.l mile from "Zero Point".

The roof and intermediate floors of the building in the left foreground were collapsed by the blast.

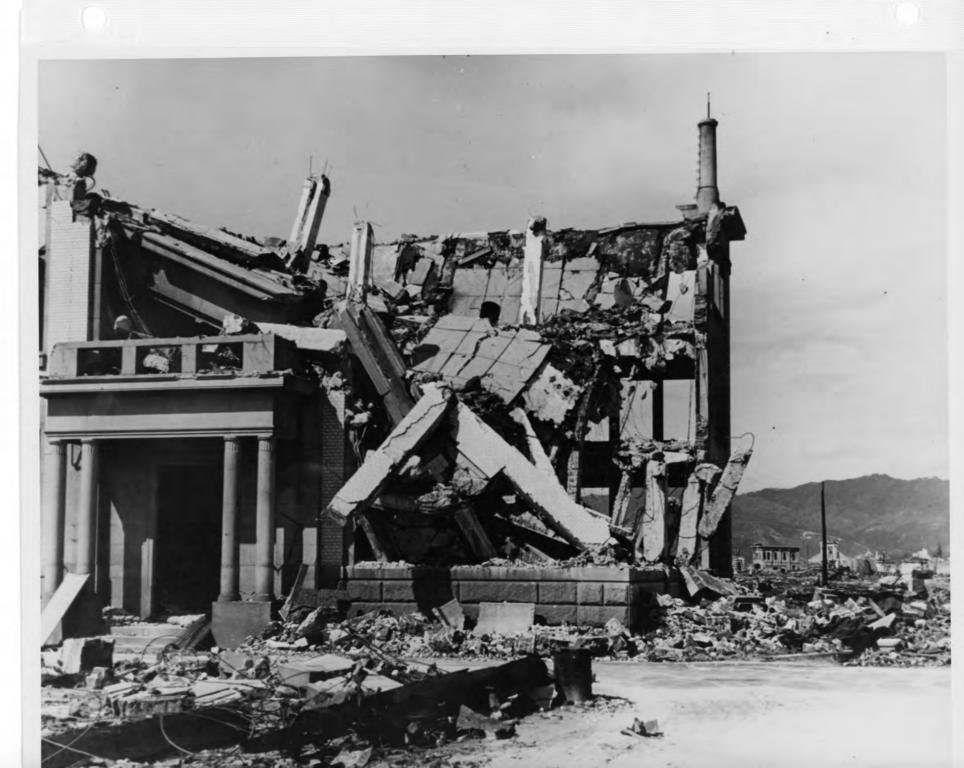
#### HIROSHIMA GAS COMPANY BUILDING

This close-up shows an unusual effect
of blast pressure acting almost vertically
downward on the roof of a reinforced concrete
frame building. Three interior columns that
supported roof beams are still standing, the
beams having sheared off allowing the roof to collapse.

The concrete stack on the corner did not fail under the compression loading caused by downward pressure.

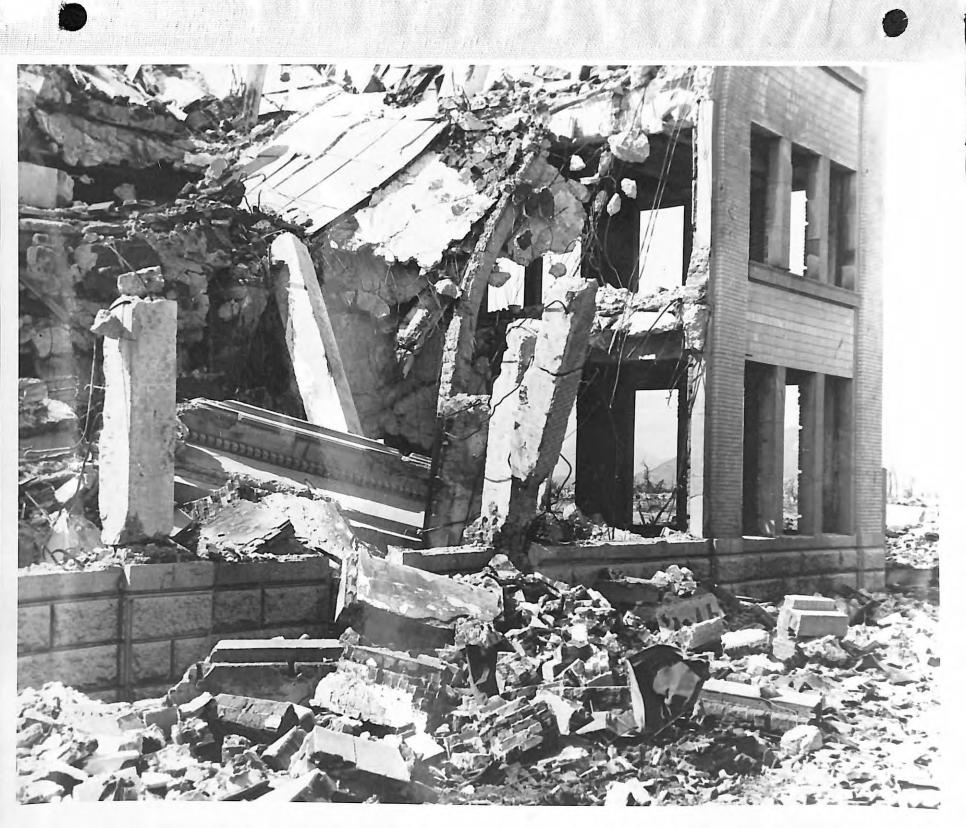
# HIROSHIMA GAS COMPANY BUILDING

This is a close-up of building No. 12
shown in the preceding picture.

The concrete frame and roof collapsed on the side facing the blast. A thin tile veneering was used on the exterior of the building.

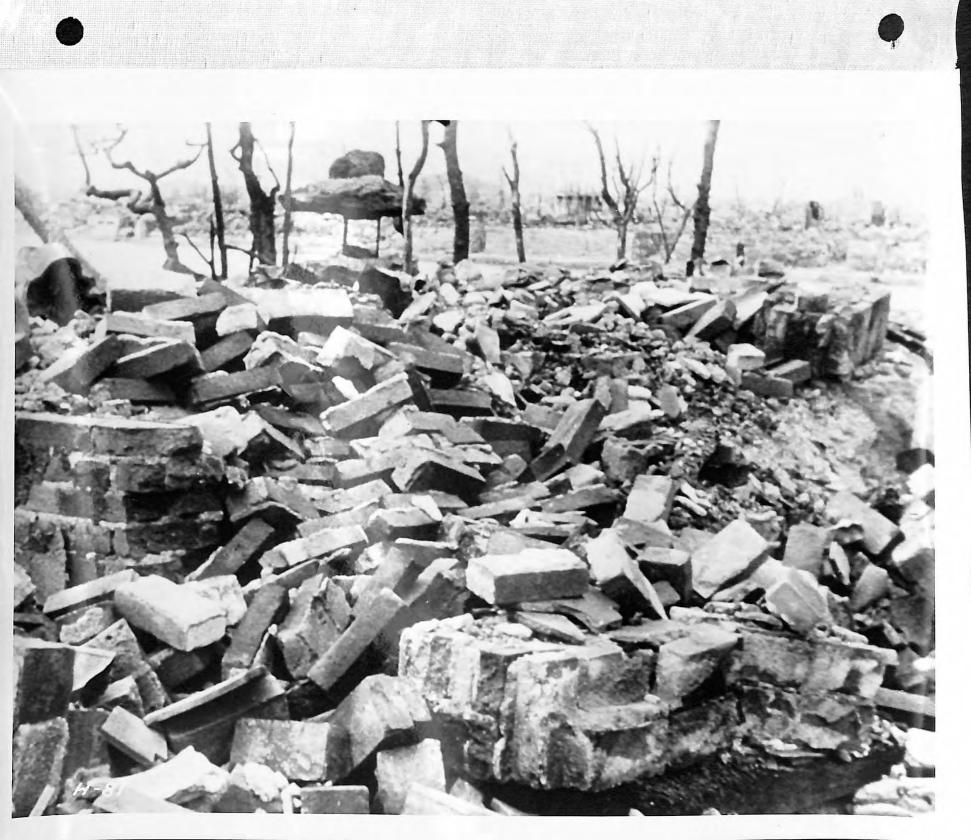
# BRICK RUBBLE

This view shows total demolition of brick
building near "zero point".

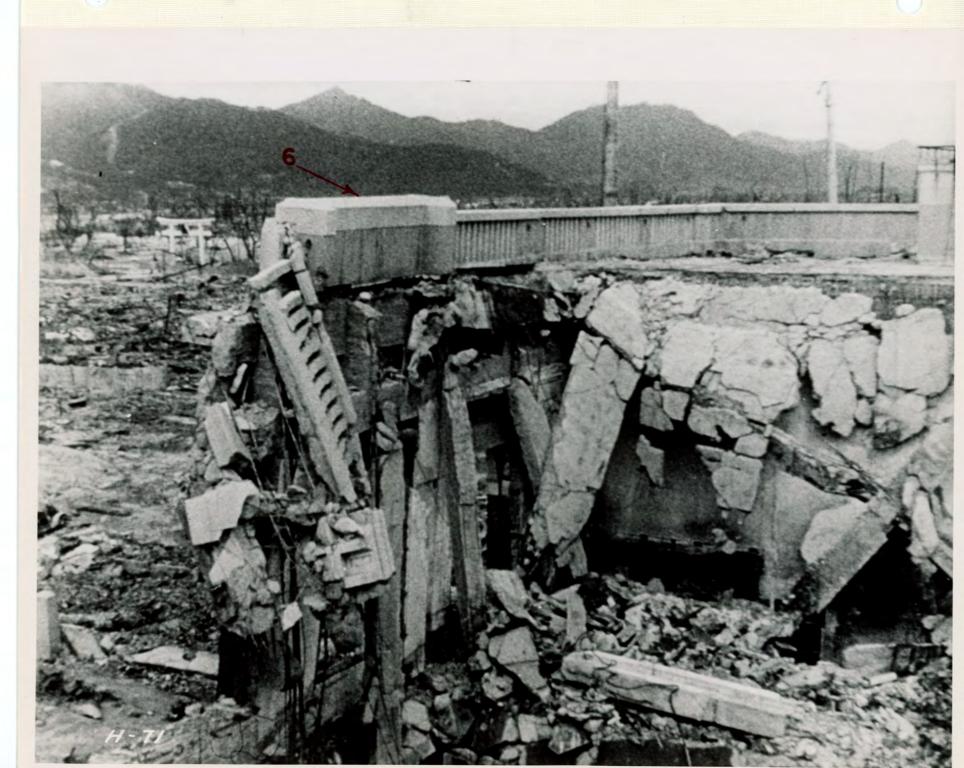
# INTERIOR OF BUILDING NO. 6 (200 feet east of Zero Point)

This view shows complete failure of roof and intermediate floor of two-story building by blast pressure striking downward.

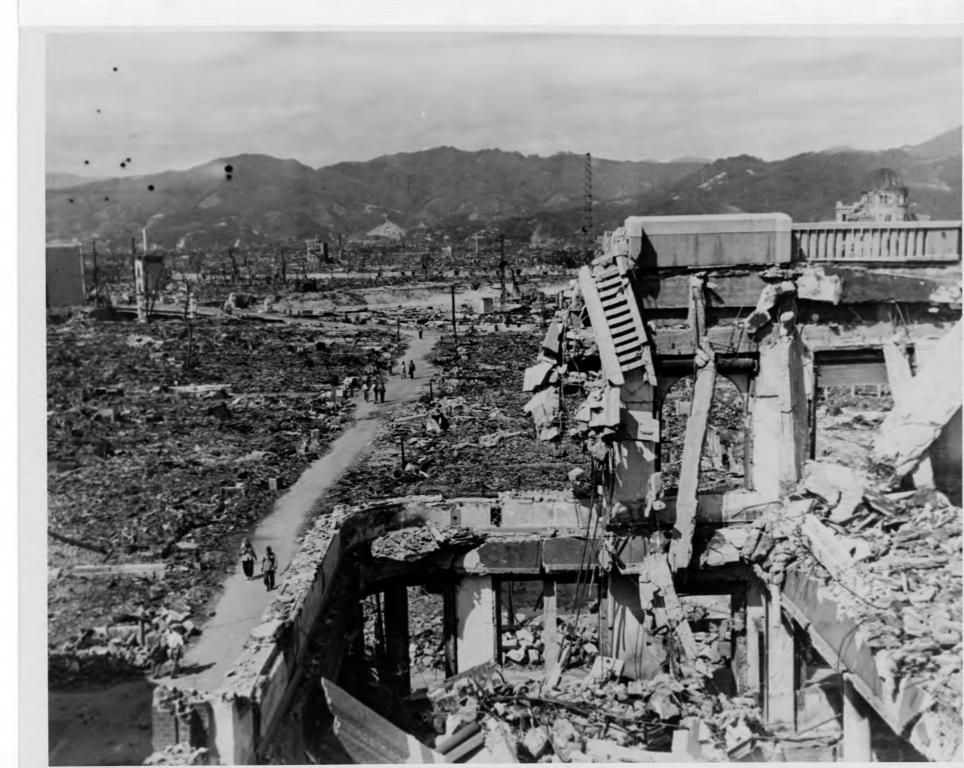
# BUILDING NO. 6

This view looking west from building No. 7 shows the collapsed portion of the building.

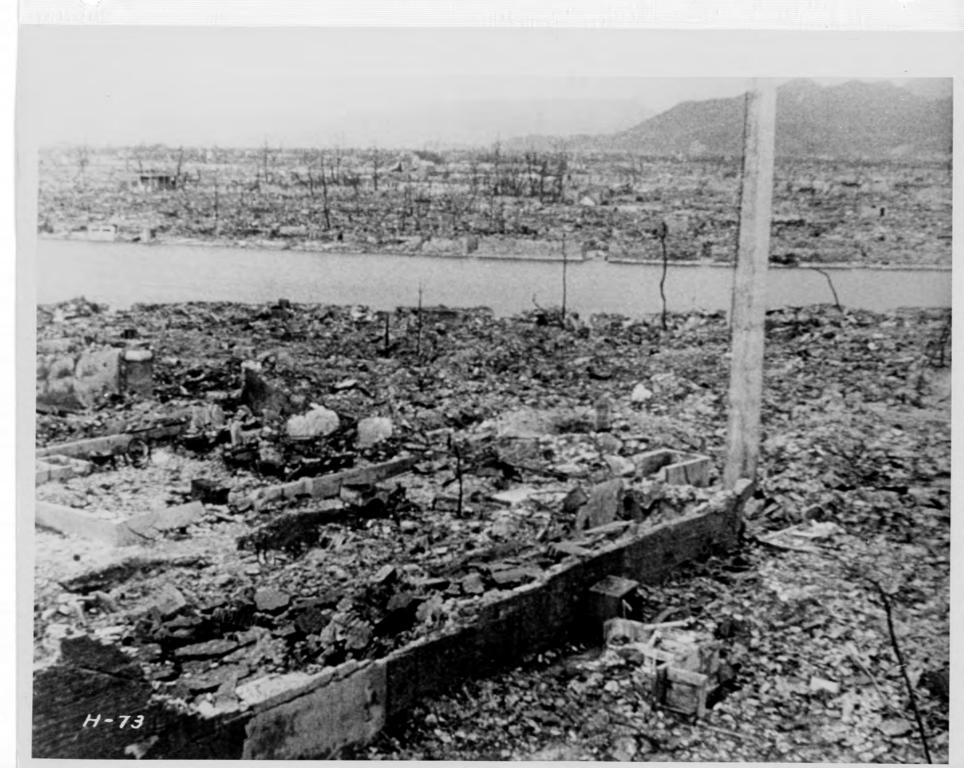
#### VIEW NEAR "ZERO POINT"

View looking southwest from Sanwa Bank
Building (No. 8) at brick rubble and foundation
walls 300 feet from "Zero Point". The concrete
stack survived the blast and is whitened on the
side nearest the blast.

The brick building outlined by the foundation walls was completely demolished.

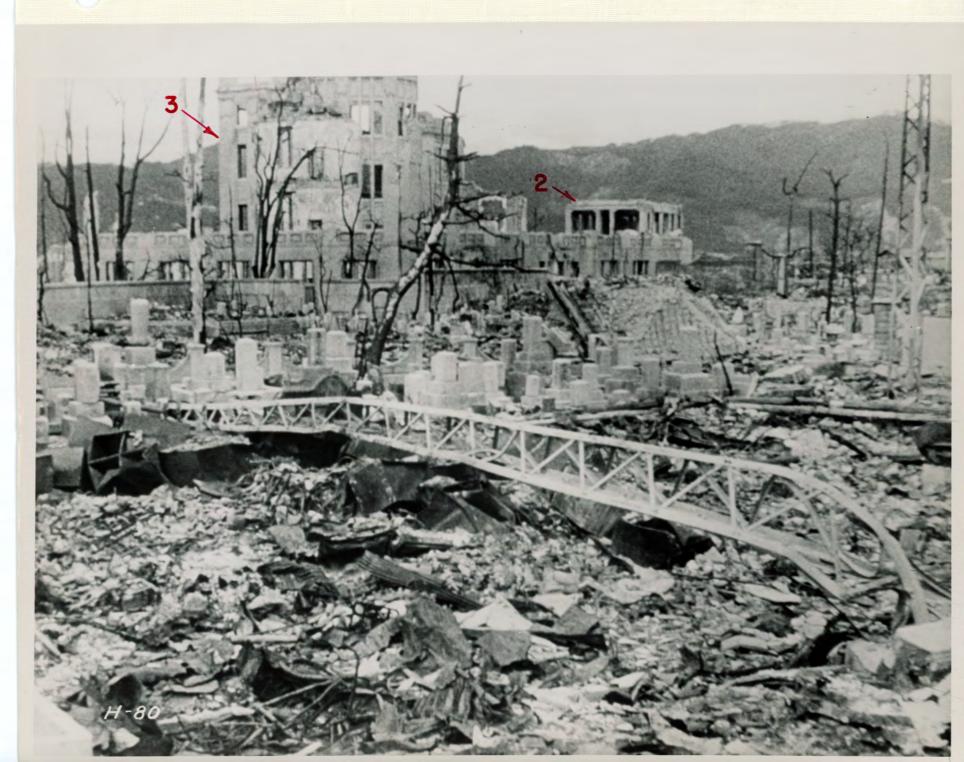
#### COMMERCIAL MUSEUM

This view from near "Zero Point" shows the remaining walls of the Commercial Museum in the background. The steel tower in the foreground collapsed in the direction of the blast.

The monuments in the cemetery shown here were not overturned since the blast pressure was downward in this area.

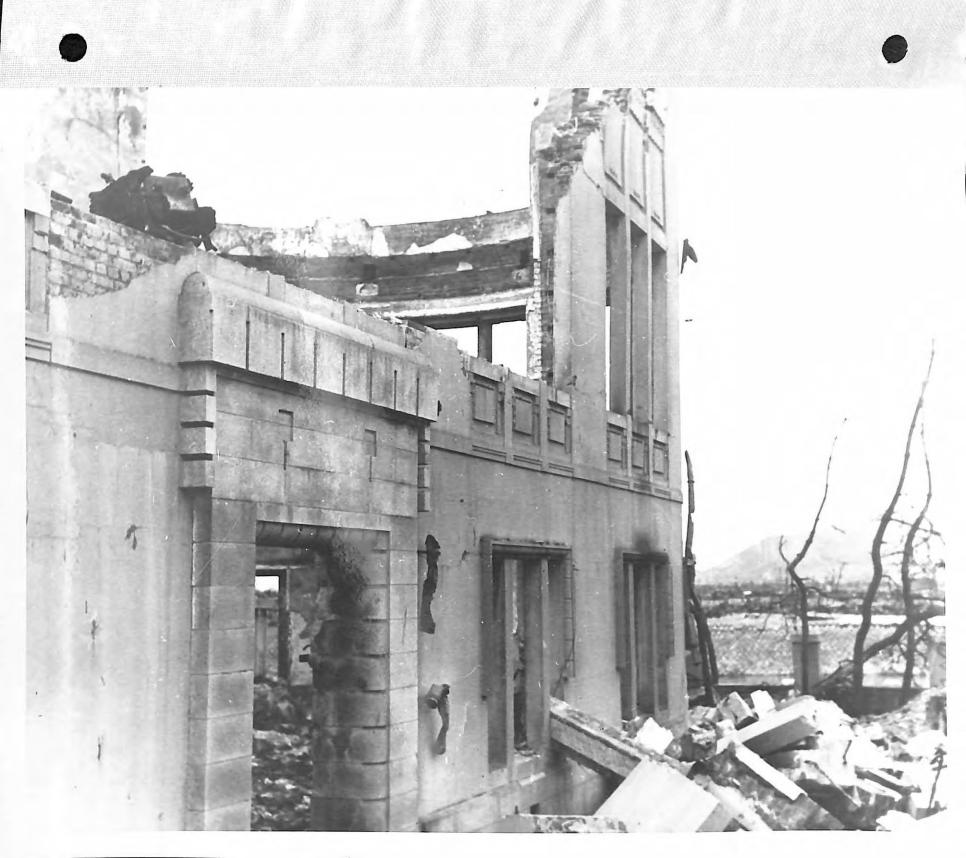
#### COMMERCIAL MUSEUM

Closeup showing load bearing walls of masonry and brick construction.

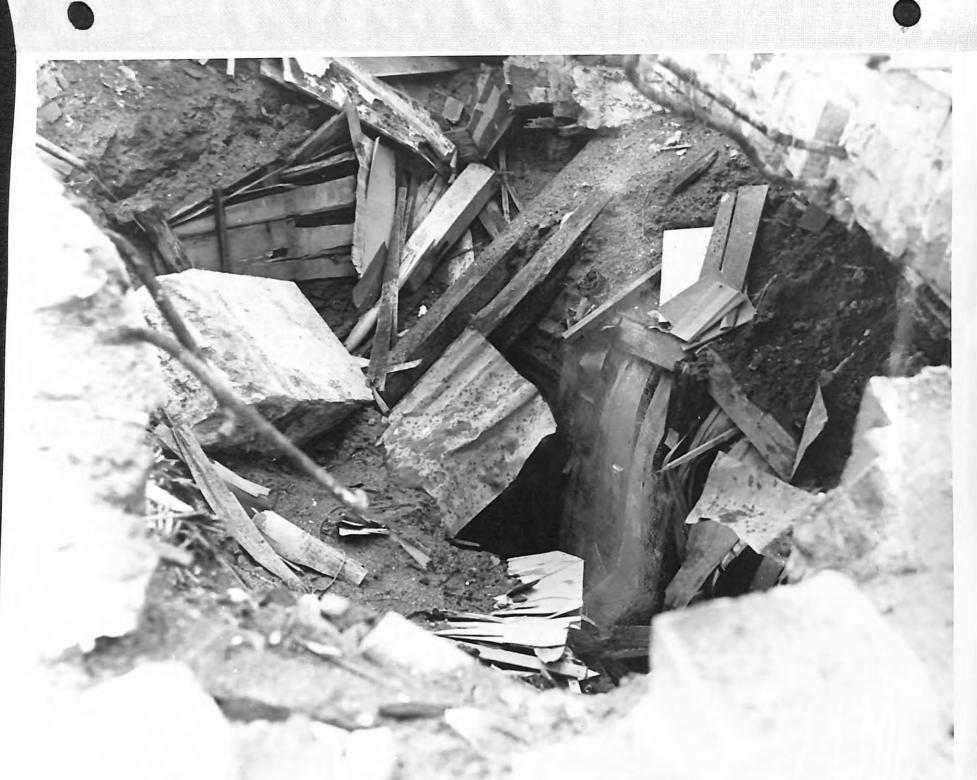
#### COLLAPSED AIR RAID SHELTER

This shelter was collapsed by the blast pressure. Brick and concrete debris fell from the Museum.

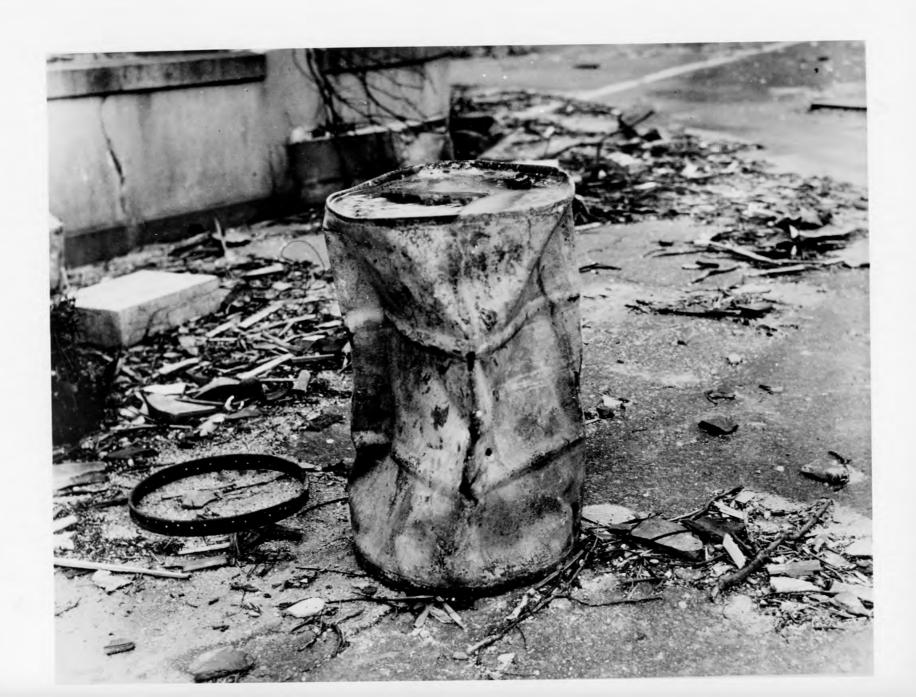
# JAPANESE GASOLINE DRUM

Showing partial collapse from blast pressure.

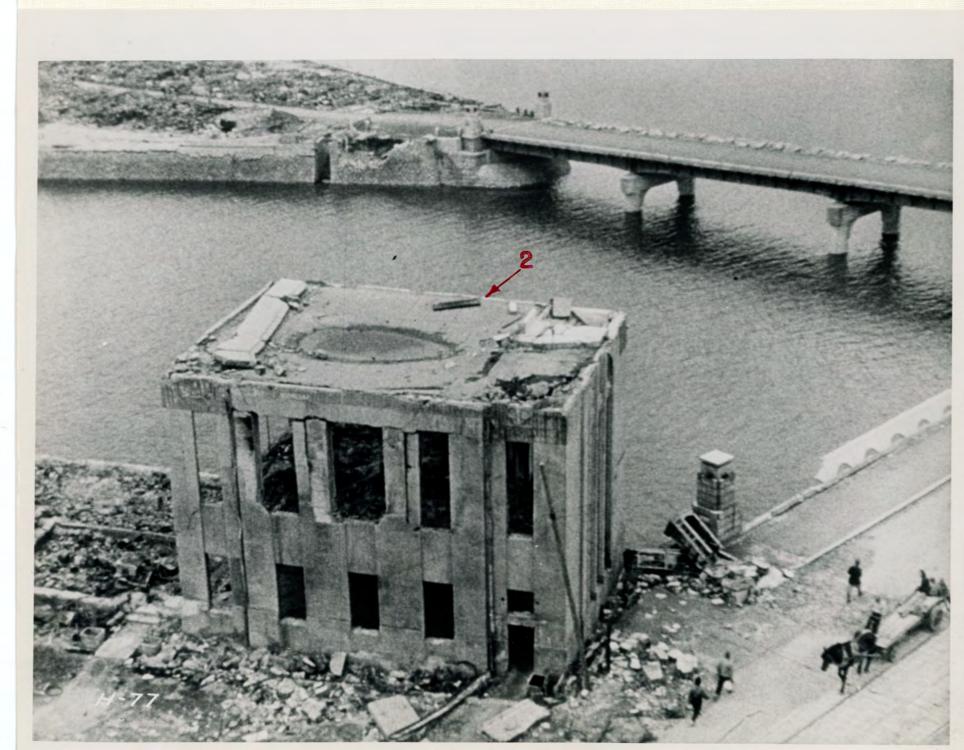
#### STRUCTURAL FAILURE

This two-story concrete building is located .2 mile northwest of "Zero Point". The concrete roof slab was supported by concrete beams with no interior columns. The interior beams failed, causing the roof slab to settle as shown.

The entire parapet wall was demolished, one section resting on the roof, having blown in the direction of the blast.

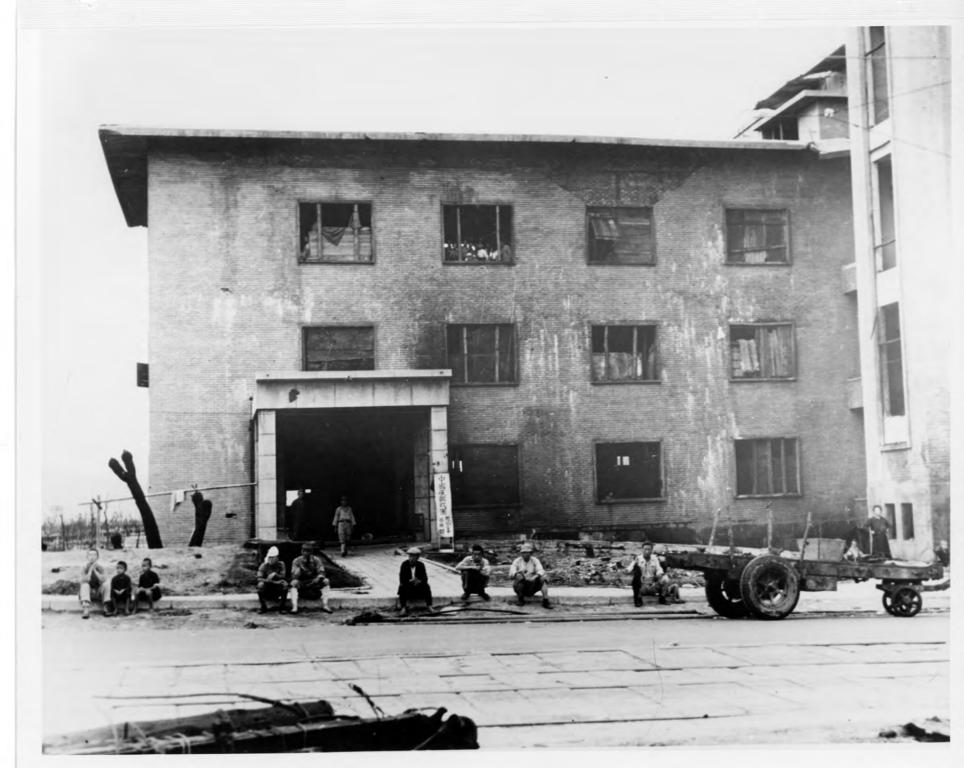
#### BUSINESS MEN'S CLUB

Structural damage was chiefly to the roof which was
distorted downward and badly cracked.

Eaves were also distorted downward.

The concrete floor at the entrance was distorted down-ward by the blast.

Interior partitions were collapsed by the blast pressure and fires of secondary origin gutted the building.

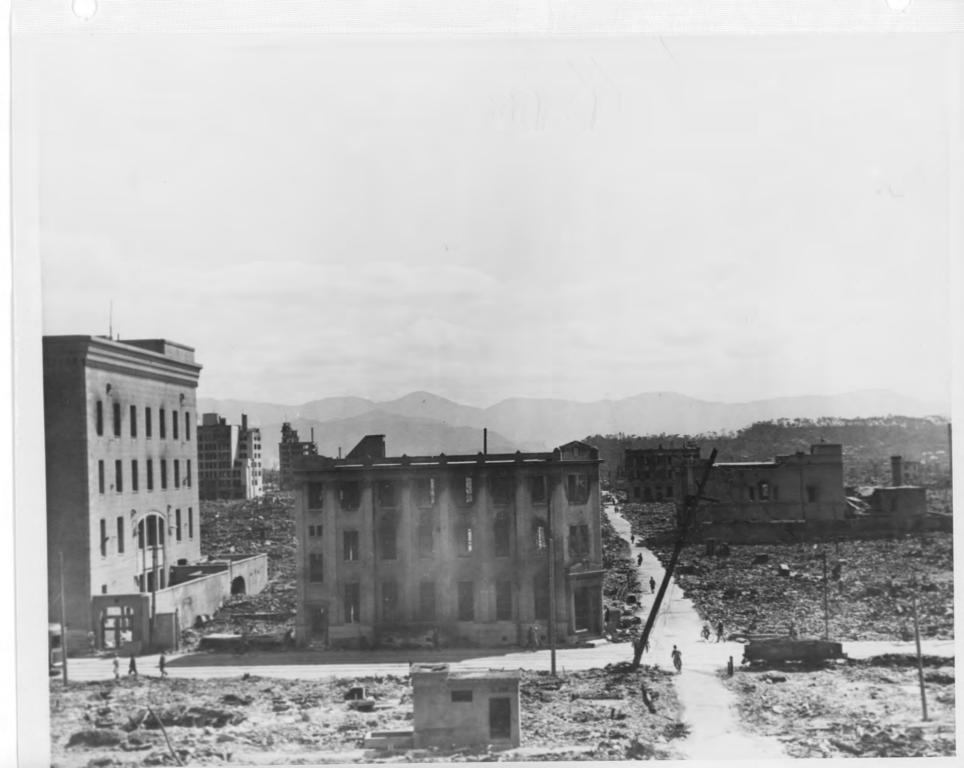
#### VIEW NEAR ZERO POINT

This view looking east from the roof of building No. 7, 250 feet east of zero point, shows a small 3-story commercial building in the center foreground, No. 16, 600 feet from zero point. Interior partitions were blown out by the blast and the interior was burned out by fires of secondary origin.

The first building in the right background is 1000 feet from zero point. The roof of this building was collapsed by the blast as shown in the aerial view of zero point.

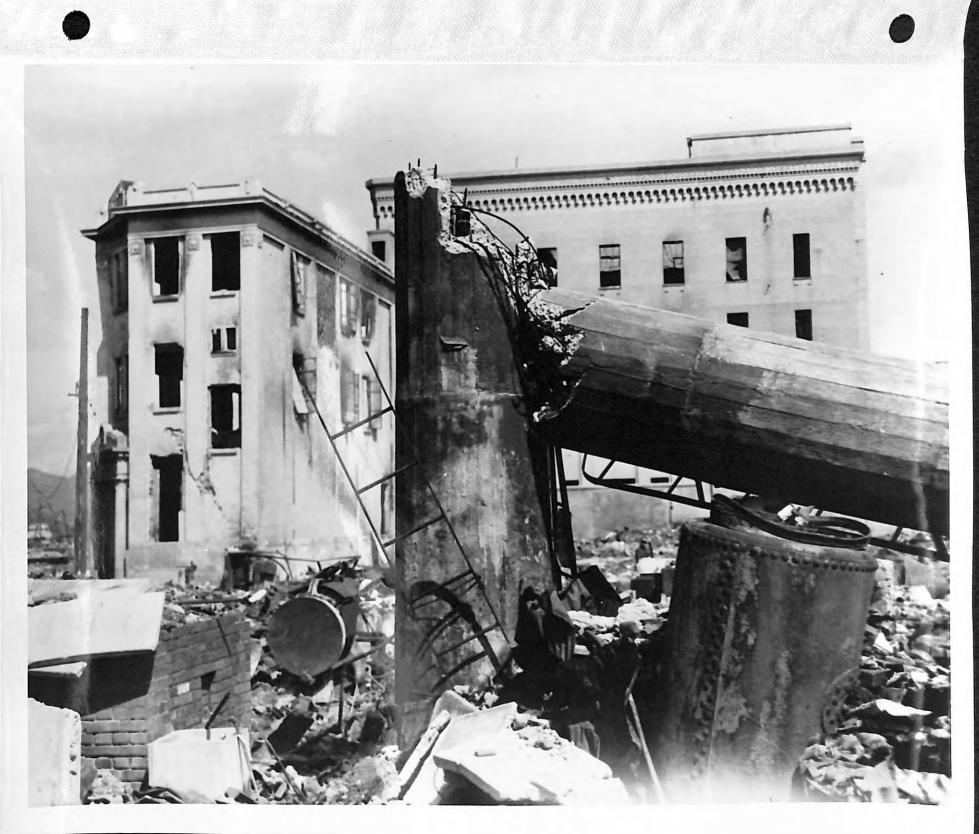
#### VIEW NEAR ZERO POINT

This view is looking north at buildings No. 16 and No. 15 shown in the preceding picture. (600 ft. from zero point).

The concrete stack in the foreground was toppled in the direction of the blast.

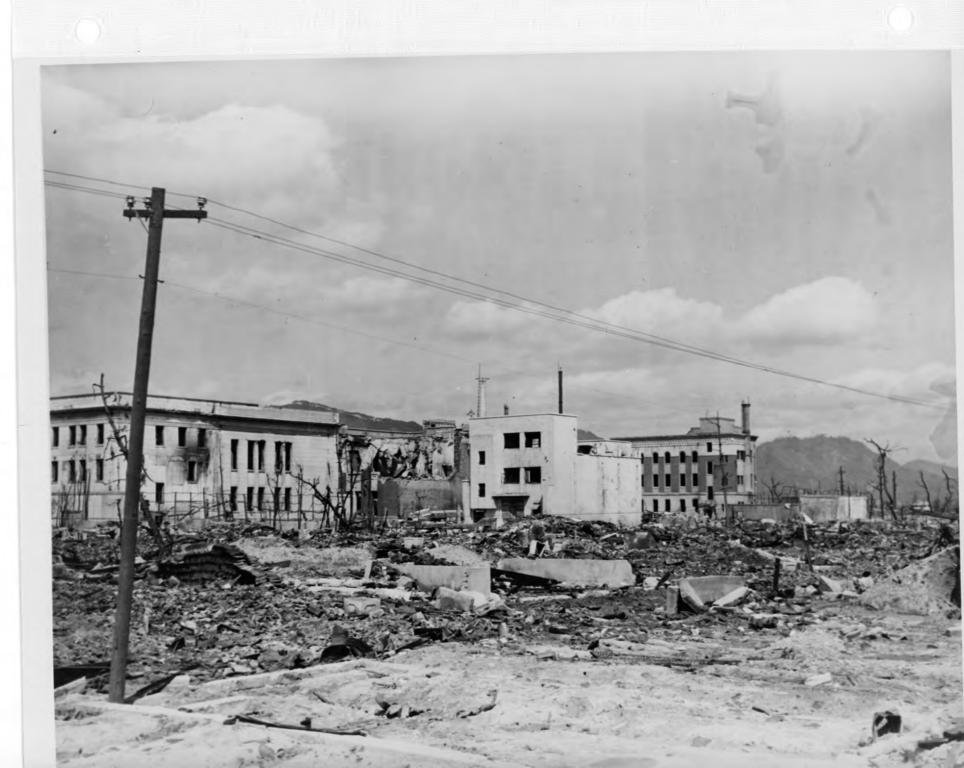
#### BUILDINGS NEAR ZERO POINT

This view looking northwest shows the Sanwa Bank Building (No. 8) on the left. The parapet wall nearest the camera is leaning out. A break in the wall may be seen at the corner just to the left of the power pole.

The demolished section of building No. 6 may be seen to the right of the bank building.

Building No. 7 is structurally intact except for downward distortion of the roof.
