VOLUME II
PHYSICAL DAMAGE
HIROSHIMA, JAPAN

Prepared by Major Noland Varley

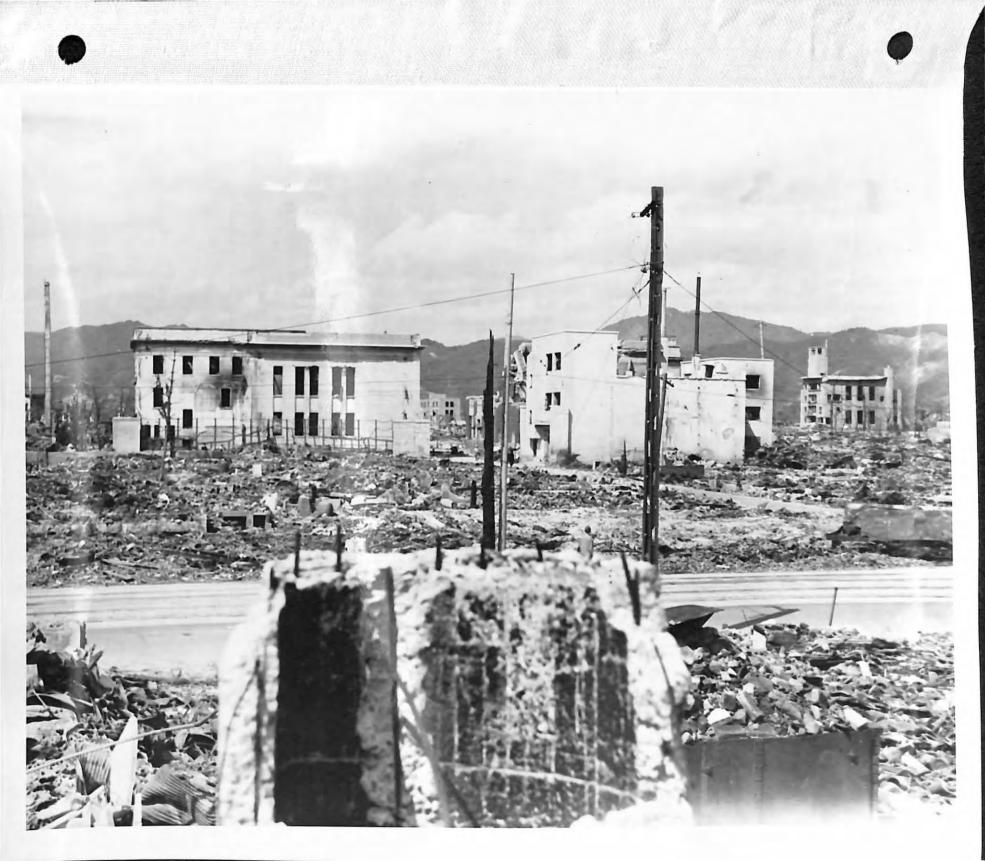
#### BUILDINGS NEAR ZERO POINT

The concrete stack in the foreground was broken off by the blast, the shaft falling in the direction of the blast as shown in a preceding picture.

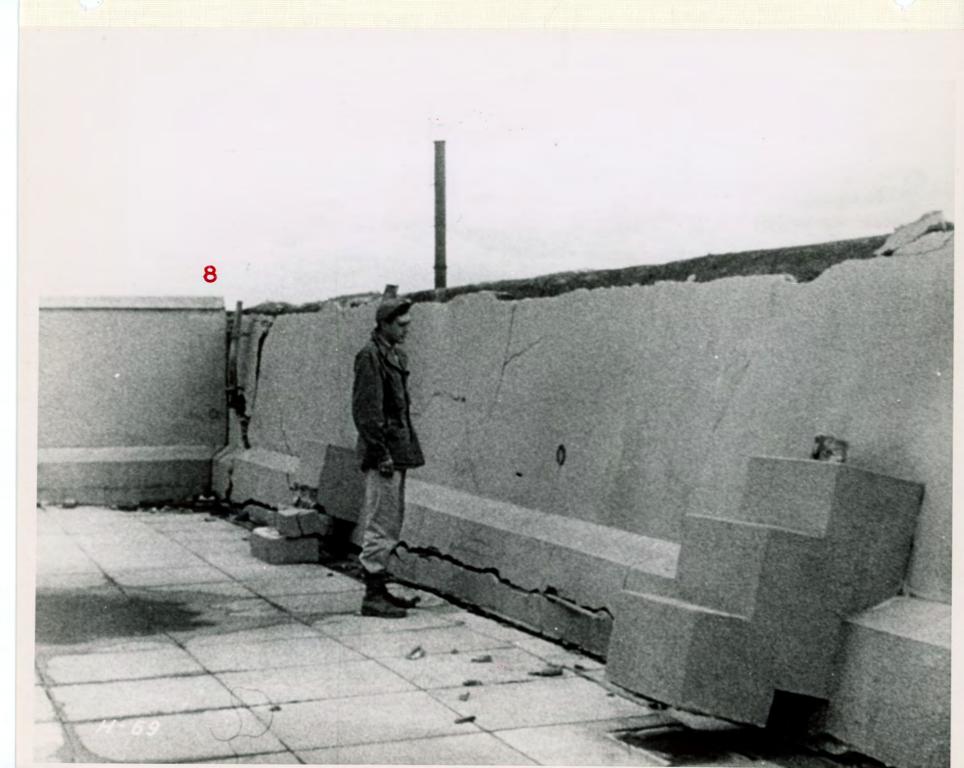
# SANWA BANK BUILDING (NO. 8)

This view shows a section of the parapet wall of the building forced out by the force of the blast.

The direction of the blast was downward on the roof. Depressions were formed in the roof, one of which may be seen directly behind the soldier.

Window space in this building was sufficient for an equalizing pressure to build up inside the building before the roof failed entirely.

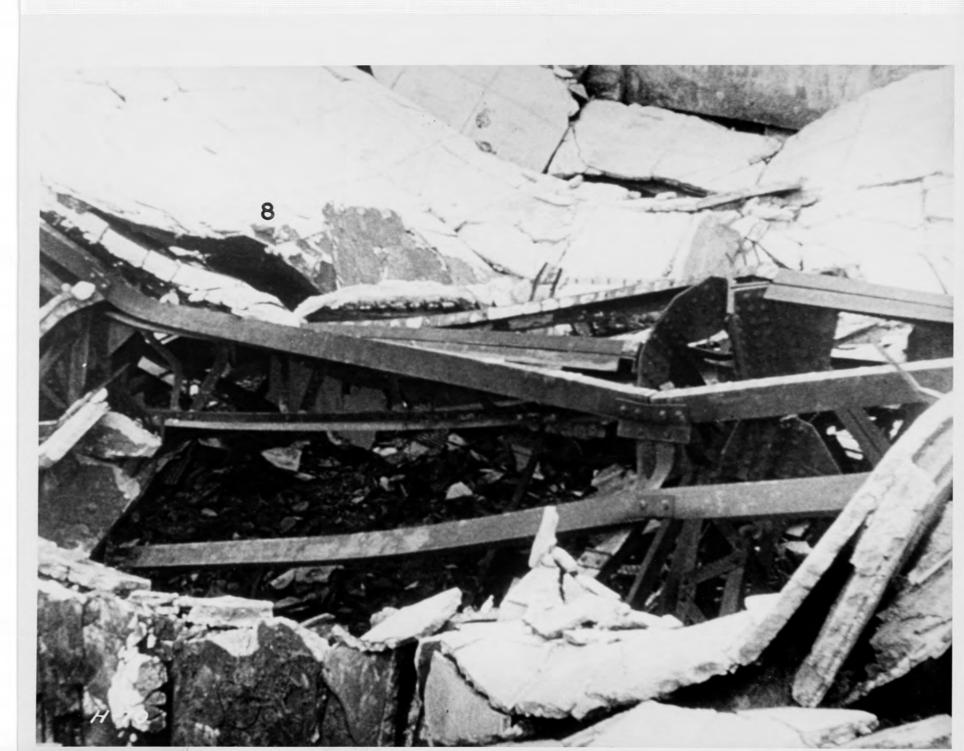
## SANWA BANK BUILDING (NO. 8)

This is a view of a section of the roof, on the side of the building away from the blast center, that failed under the impact of the blast before an equalizing pressure built up inside the building.

The roof consisted of concrete roof slabs supported on steel purlins and trusses.

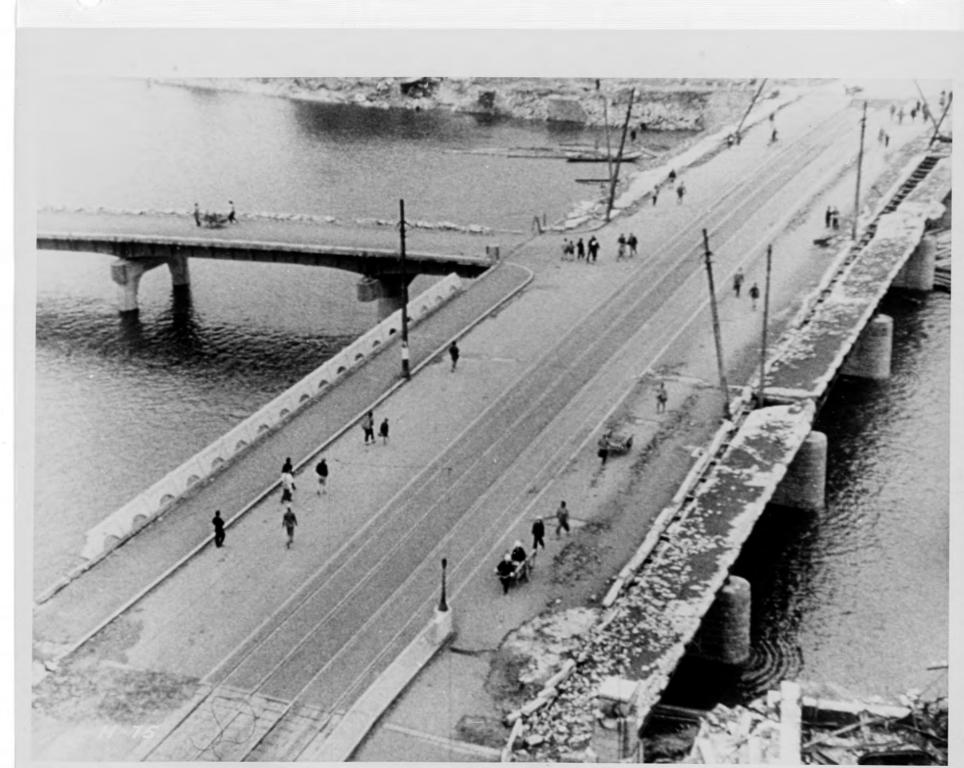
# "T"-BRIDGE 0.2 MILE NORTHWEST OF "ZERO POINT"

This plate girder bridge was not demolished by the blast which struck the bridge at an angle of 30 degrees left of vertical.

Along the center and left side of the bridge, the floor slab is undamaged, however, to the right of the center, the floor slab is distorted downward in several places. One depression can be seen in the right foreground of this picture.

This is apparently due to the slightly longer time interval required for a counteracting pressure to develop beneath the bridge along the side away from the blast.

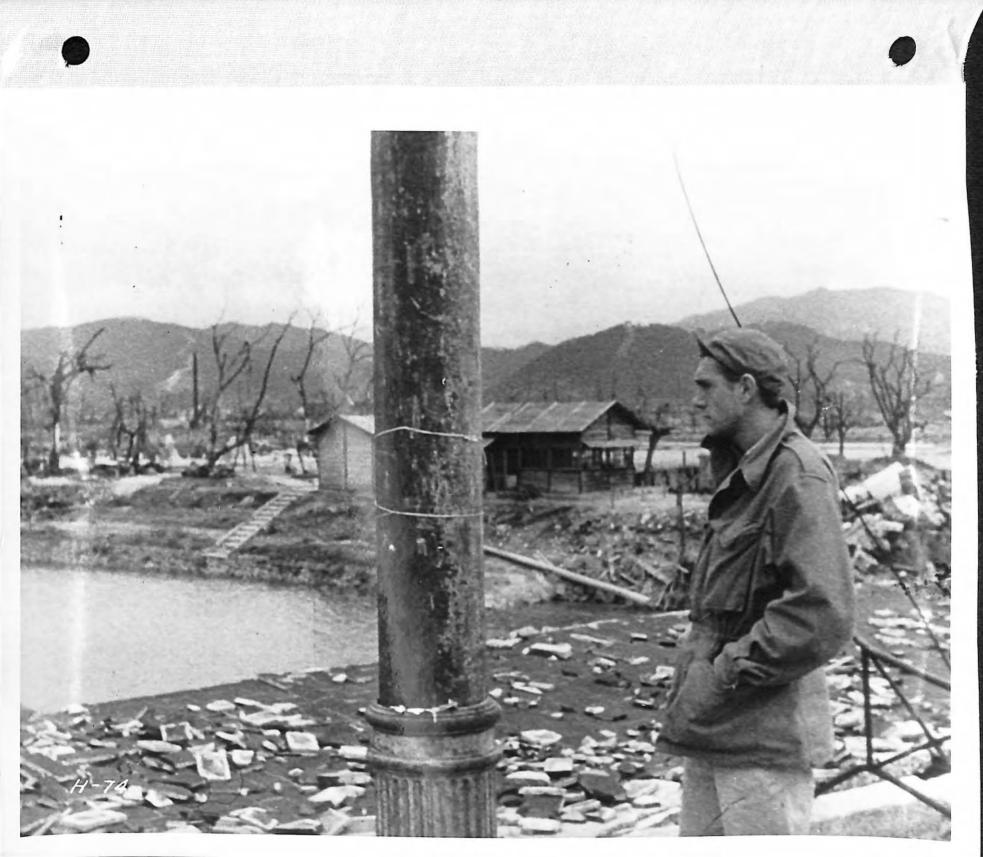
#### T-BRIDGE

The steel post in the foreground shows flash burns on the side facing the blast.

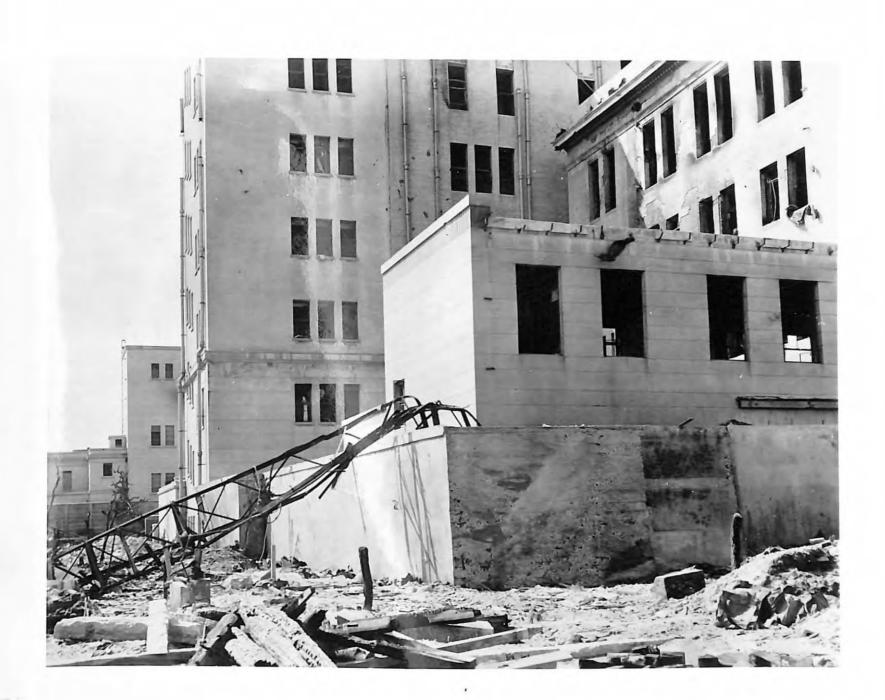
# EXTERIOR VIEW OF BUILDING NOS. 17 and 18.

Structural damage was confined to downward distortion of the roofs.

A low parapet wall along the side of the building in the foreground was collapsed by the blast.

The steel tower in the foreground collapsed in the direction of the blast.

Building interior suffered severe nonstructural damage and were partially burned out by fires of secondary origin.

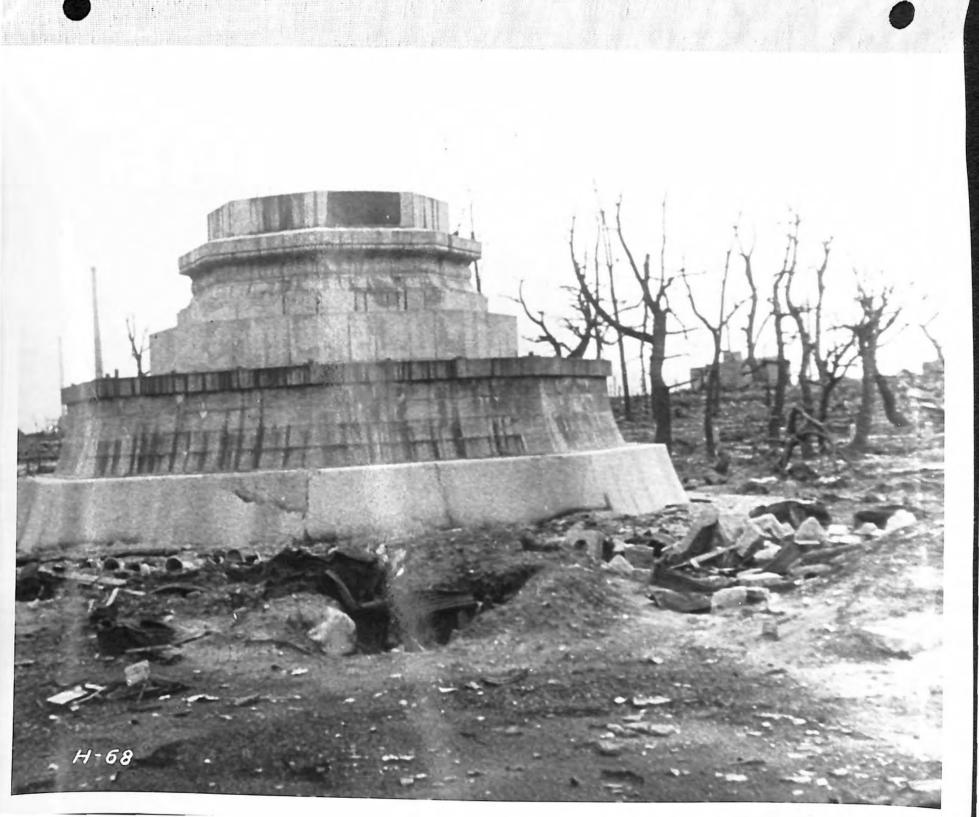
# RUSSO-JAPANESE WAR MEMORIAL (800 ft. North of Zero Point)

Exposed stone surfaces were roughened by the blast.

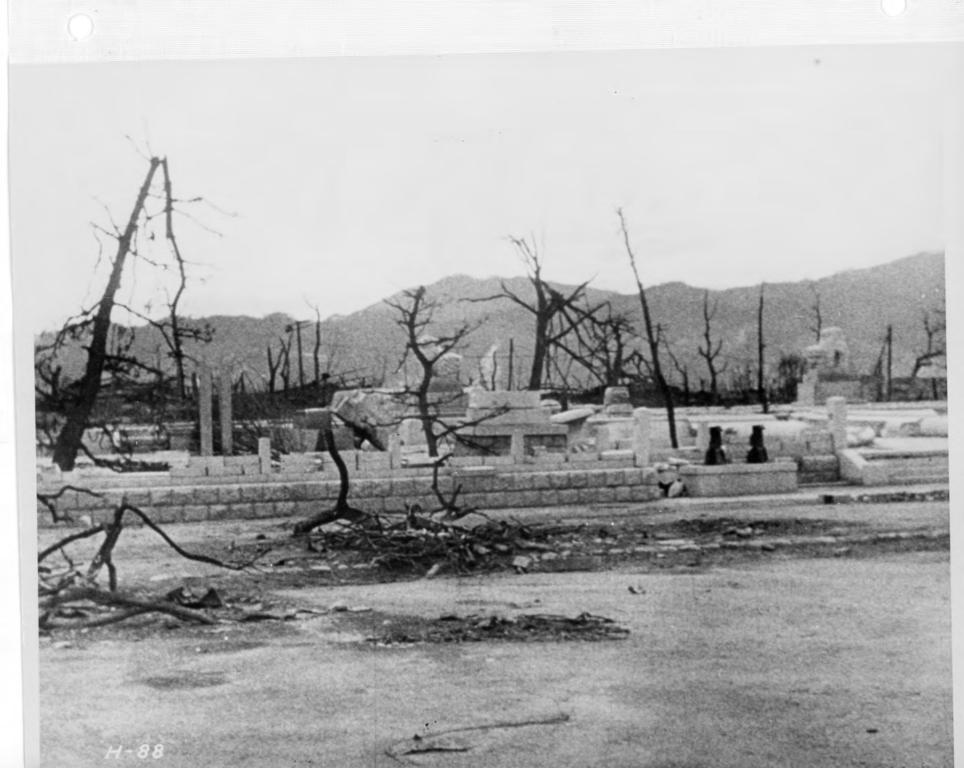
#### GOKOKU SHRINE

This Gokoku Shrine is located in the southwest corner of the Military Area. Trees were not uprooted since the direction of the blast was downward. The tops of the larger trees, however, were broken out by the downward pressure.

Many of the small monuments were overturned by the blast.

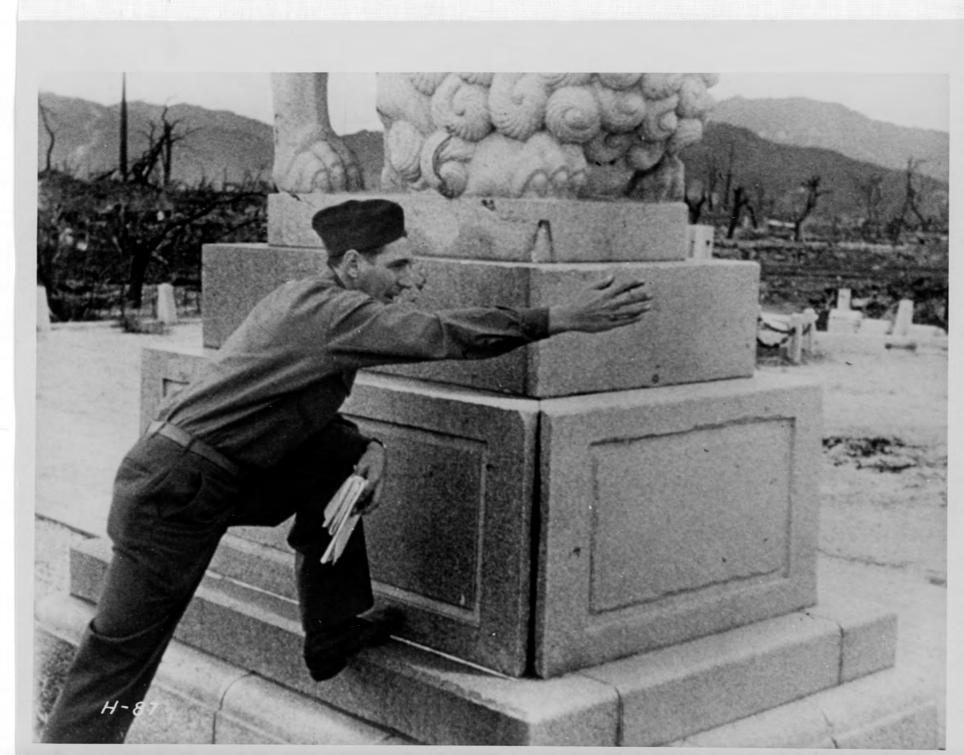
## GOKOKU SHRINE

In this close-up, a soldier is pointing toward "zero point". The stone surfaces on the right were roughened by the blast while the darker surfaces on the left retained a polished surface.

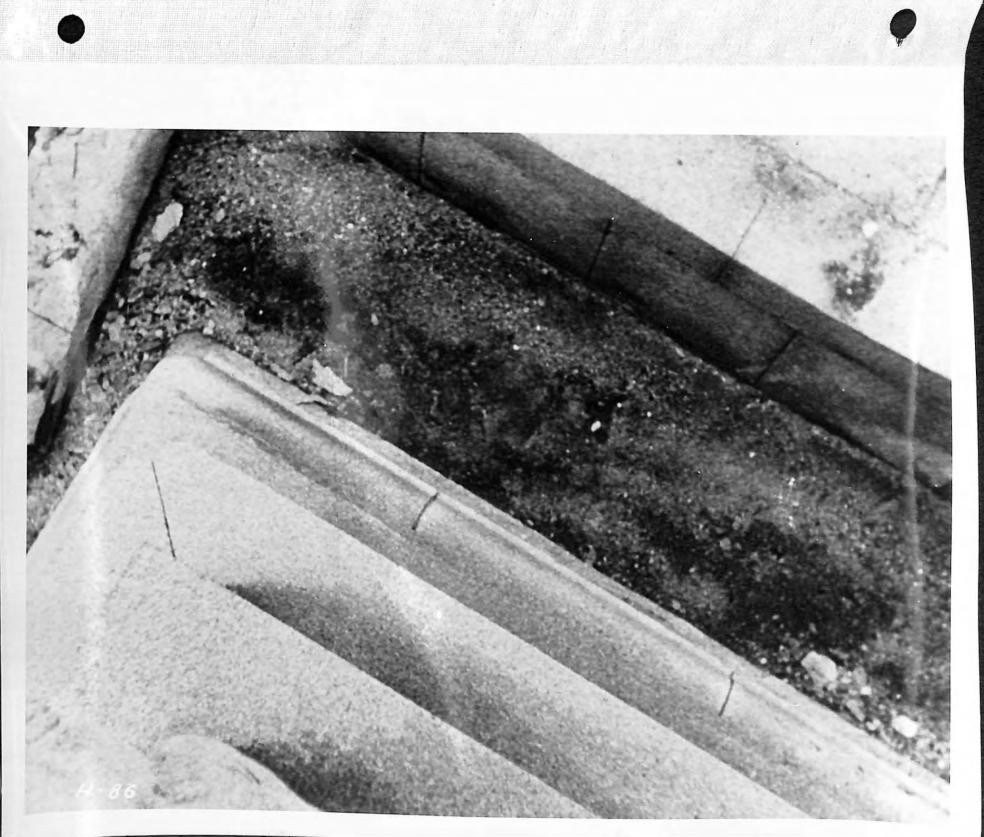
# GOKOKU SHRINE

This close-up of the base of the monument shown in the preceding picture shows the roughened surface of the stone at a corner exposed to the blast.

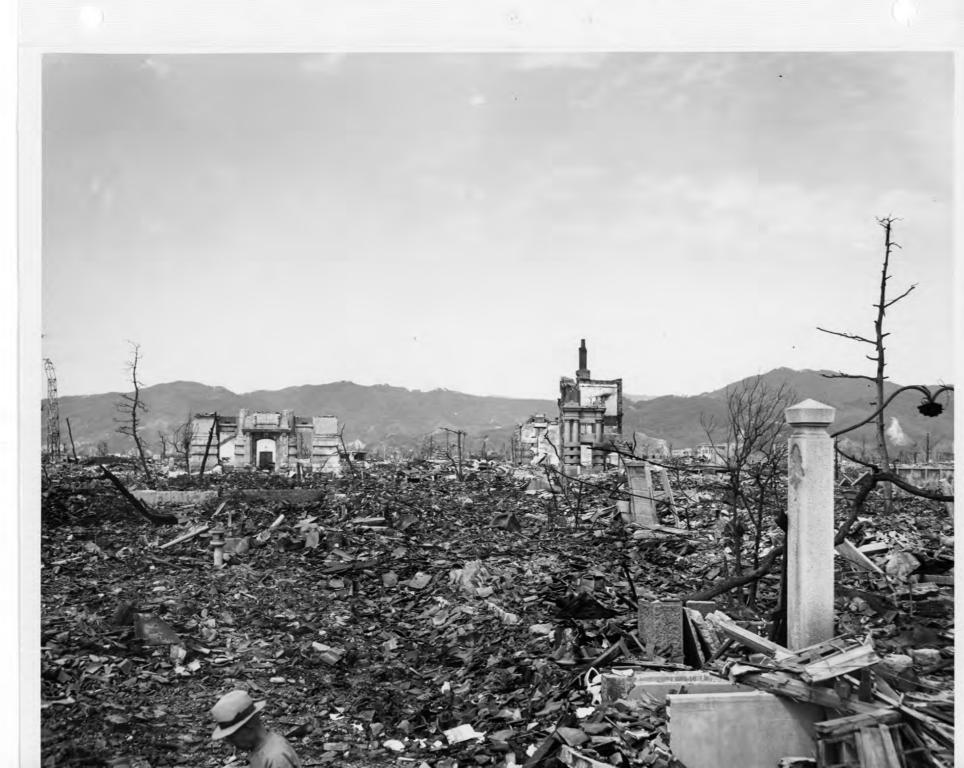
Portions of the walls of two building of brick and

masonry construction remain standing. These walls are

parallel with the direction of the blast. The top of the

steel tower on the left was deflected in the direction of

the blast.

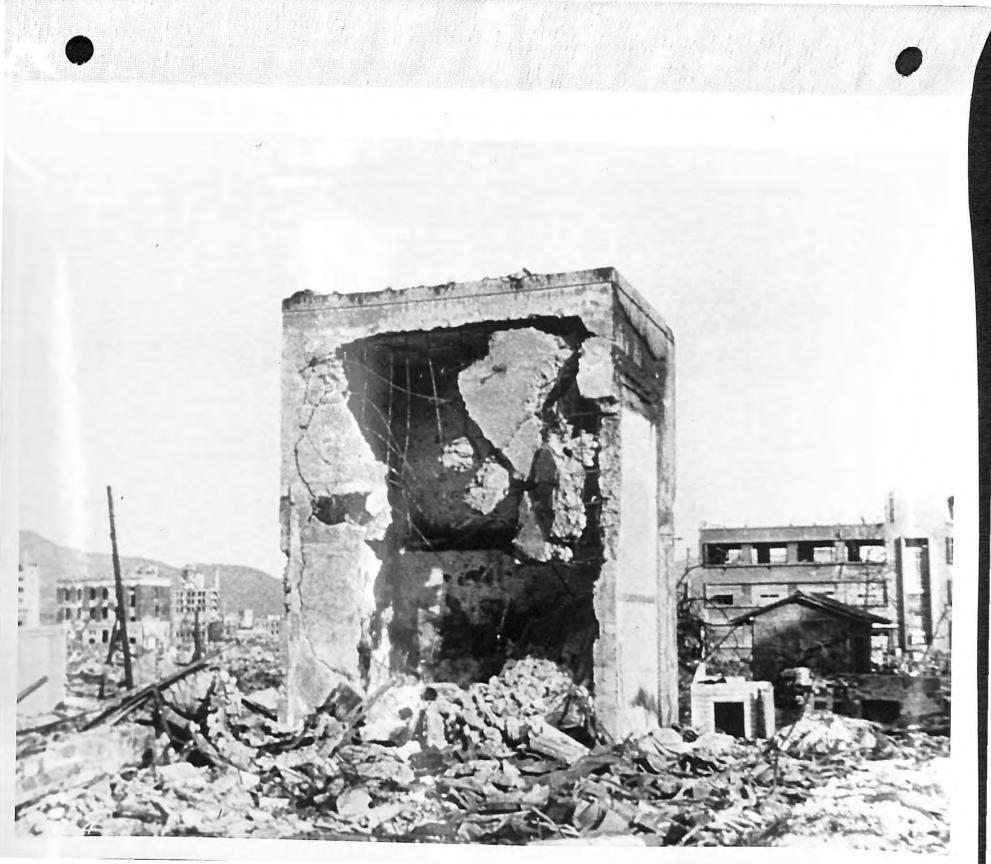
#### CONCRETE VAULT

The reinforced concrete wall facing the blast was almost entirely demolished by the blast pressure. This vault was entirely enclosed except for doors.

Buildings with exterior walls of reinforced concrete were not subjected to peak hydrostatic pressure, since window openings allowed a compensating pressure to build up inside the building before the peak pressure developed.

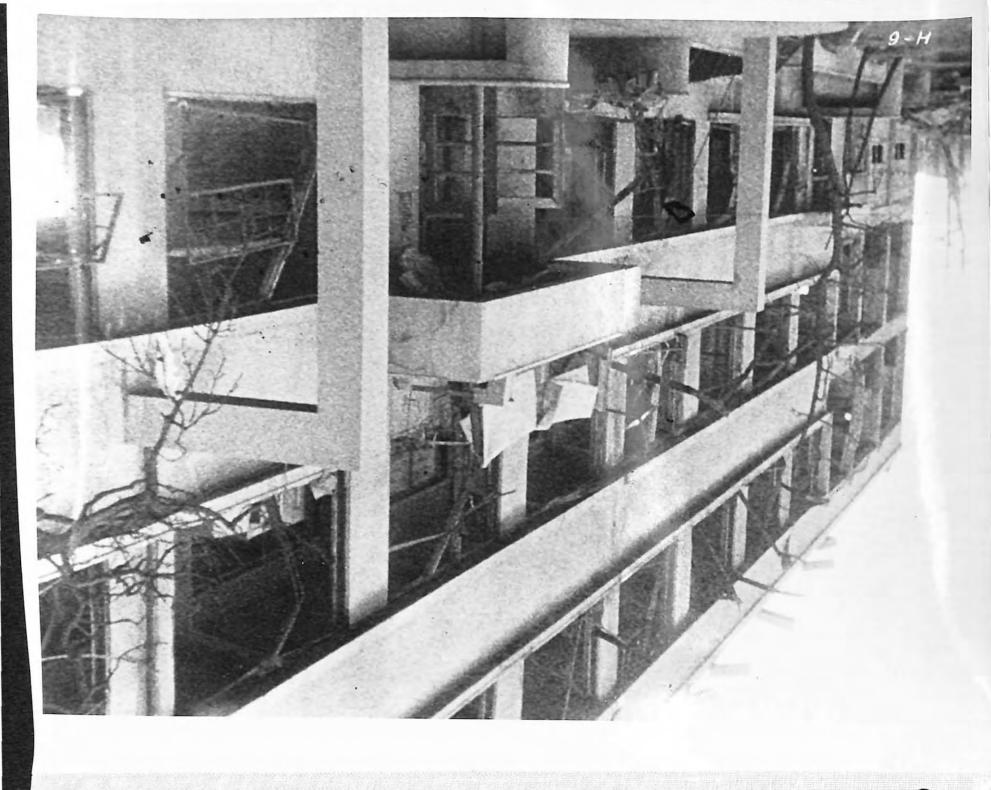
(No. 3 of 5 Views)

This view of the side away from the blast center shows windows blown out by the force of the blast driving through the building.

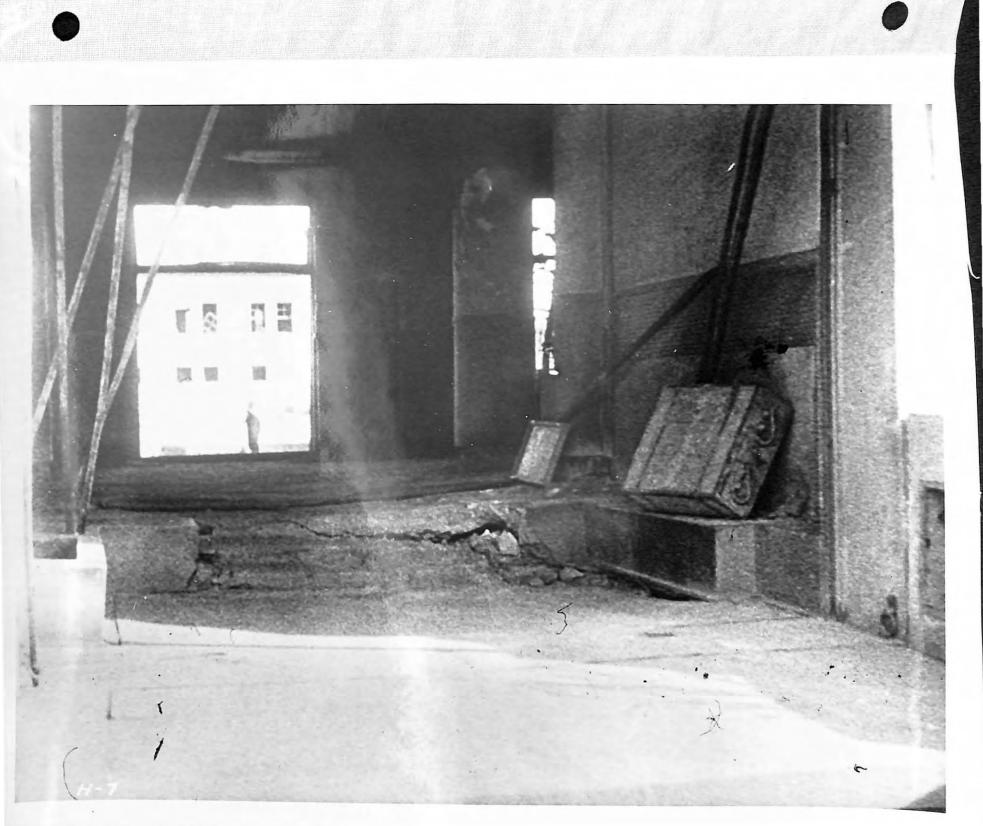
(No. 4 of 5 Views)

This view of the entrance shows a failure in the concrete floor slab over a section of the basement. Due to the basement being entirely enclosed, the full pressure of the blast was exerted on this floor.

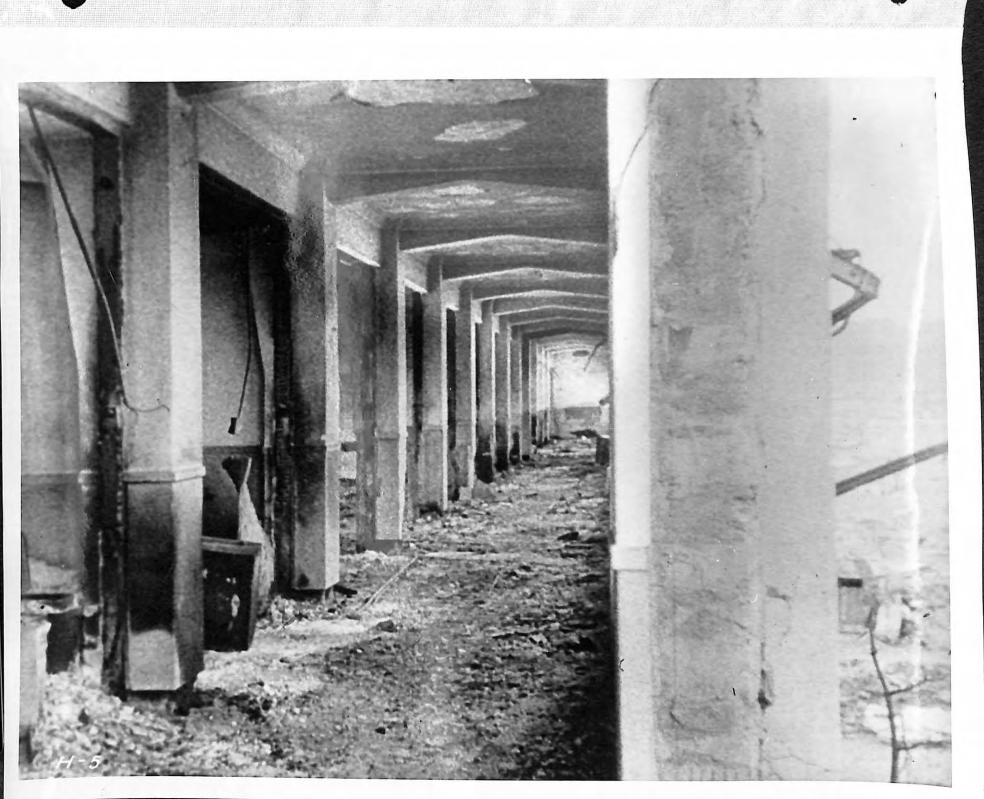
(No. 5 of 5 Views)

This view along the corridor shows the wood flooring entirely burned away. Doors were blown down by the blast and only the charred frames remain. Plaster has fallen from the ceiling as a result of the fire.

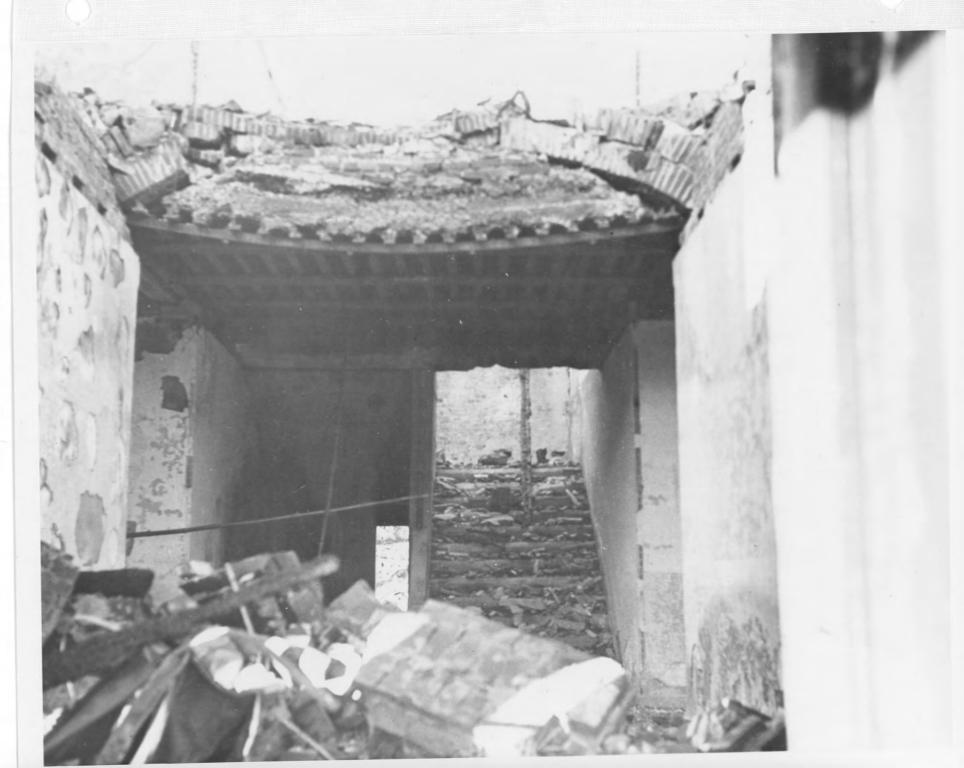
(0.5 Mile North of Zero Point)

Street car rails were used to support the roof. The roof framing was poorly designed since the supporting transverse rails were widely spaced while the non-supporting longitudinal rails were closely placed. This framework was covered with 10 inches of concrete followed by two courses of brickwork.

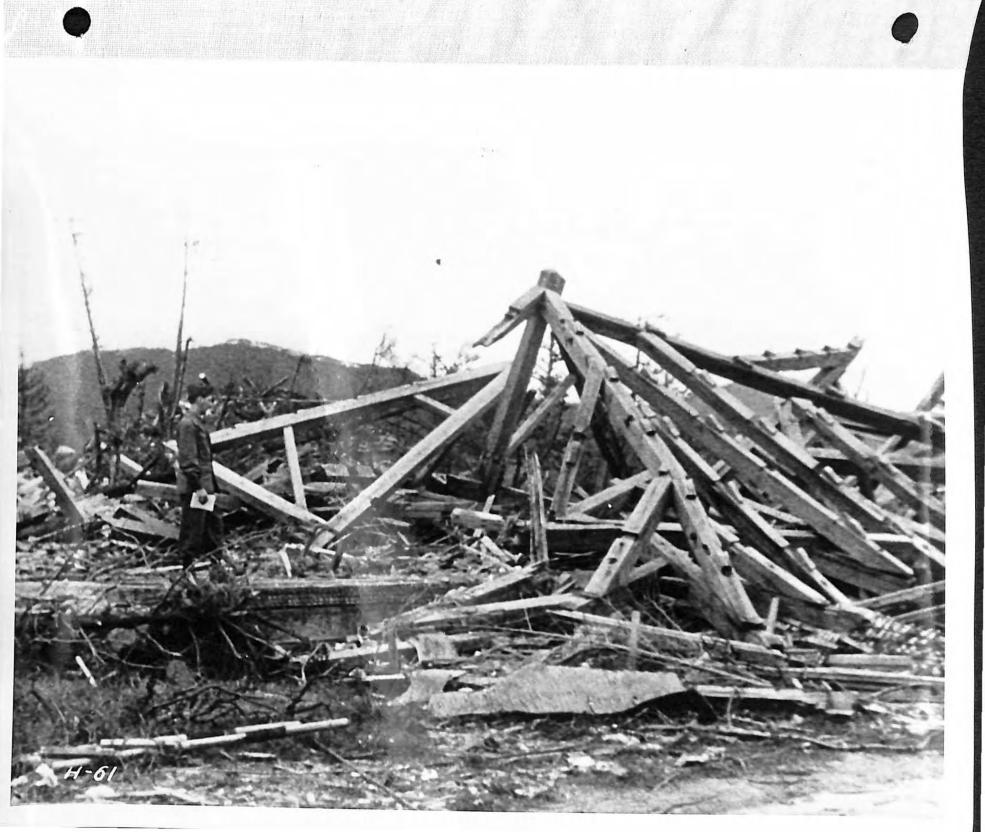
Wood Frame Building

This one-story wood frame building was demolished by the blast but was not burned.

The blast was from left to right. The heavy timbers shown here were part of the roof framework.

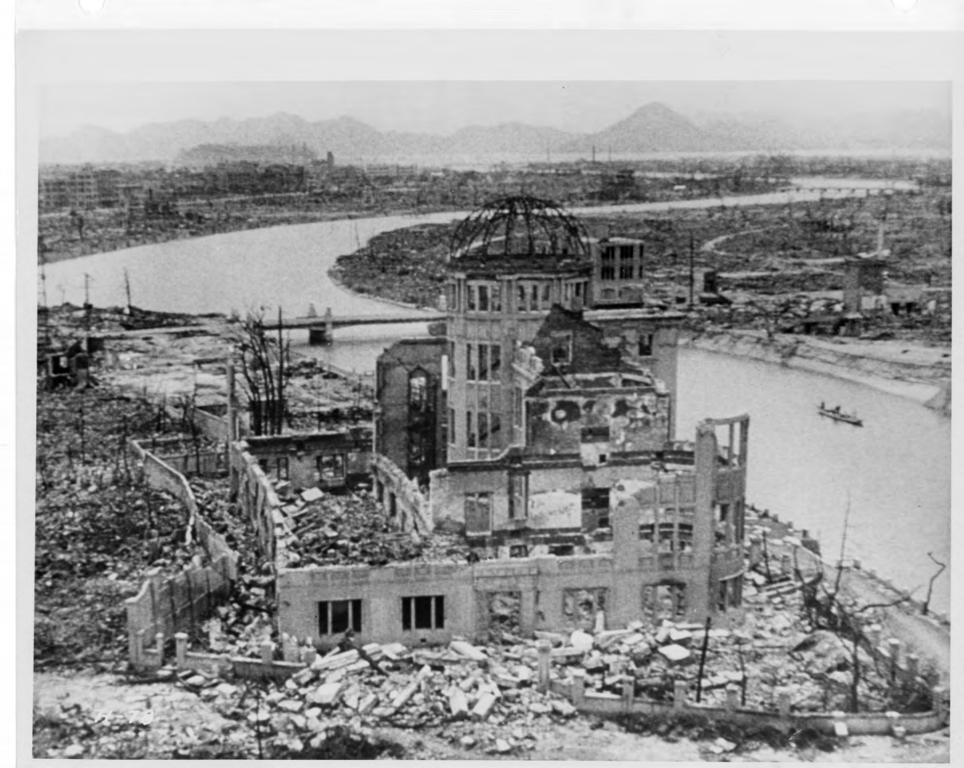
#### COMMERCIAL MUSEUM

The exterior walls of the main building are still standing, but the roof and intermediate floors and walls collapsed. The
circular tower enclosing the stairway is
still standing.

Exterior walls on the left are deflected in the direction of the blast.
