NAGASAKI ATOMIC BOMB DAMAGE  
Nagasaki, Japan

9 August 1945 (Japanese Time)

UNITED STATES  
ATOMIC ENERGY COMMISSION  
OAK RIDGE, TENNESSEE

NAGASAKI ATOMIC BOMB DAMAGE

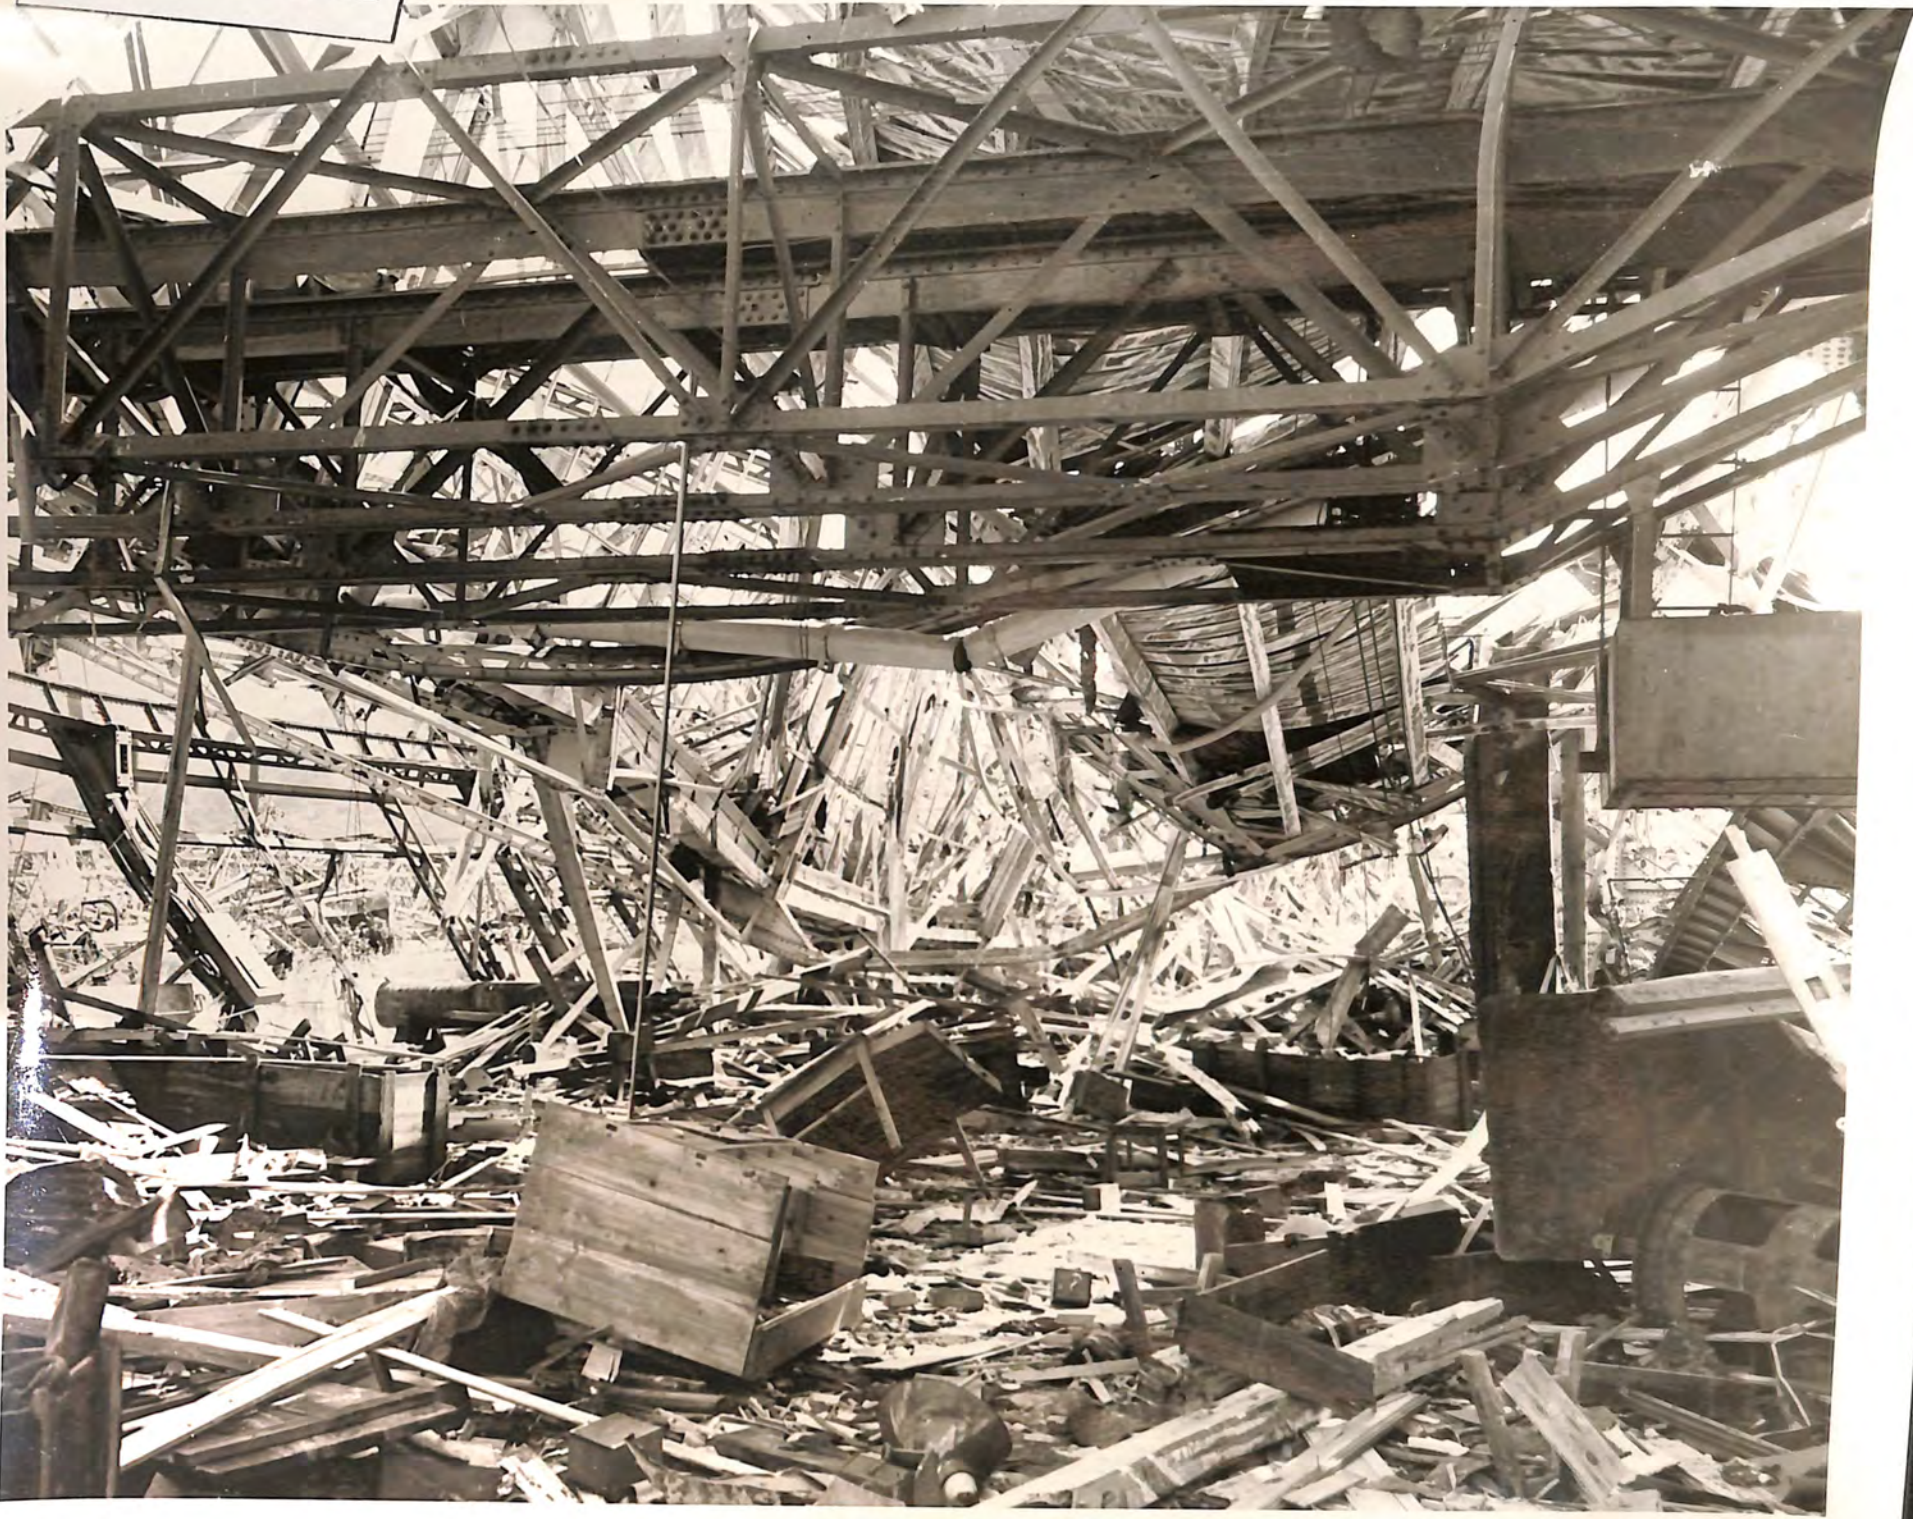
FIGURE 74

This view shows the failure of a very large factory building with saw-tooth roof truss 0.9 miles from zero point. These trusses were very flimsily constructed of light angles; the trusses had a span of approximately 30-feet and were spaced about 20-feet apart. The purlins were of wood, 4-inches by 5-inches, spaced on about 24-inch centers. The roof and siding consisted of 1-inch lumber, covered with corrugated asbestos, which, in turn, was covered with camouflage cloth. The roof failed from the thrust of the bomb blast, which collapsed the purlins and caused the roof to fall in generally. The upper chords of many of the roof trusses also failed. The buildings, in general, at the torpedo works, were flimsy in construction and the damage was quite severe.

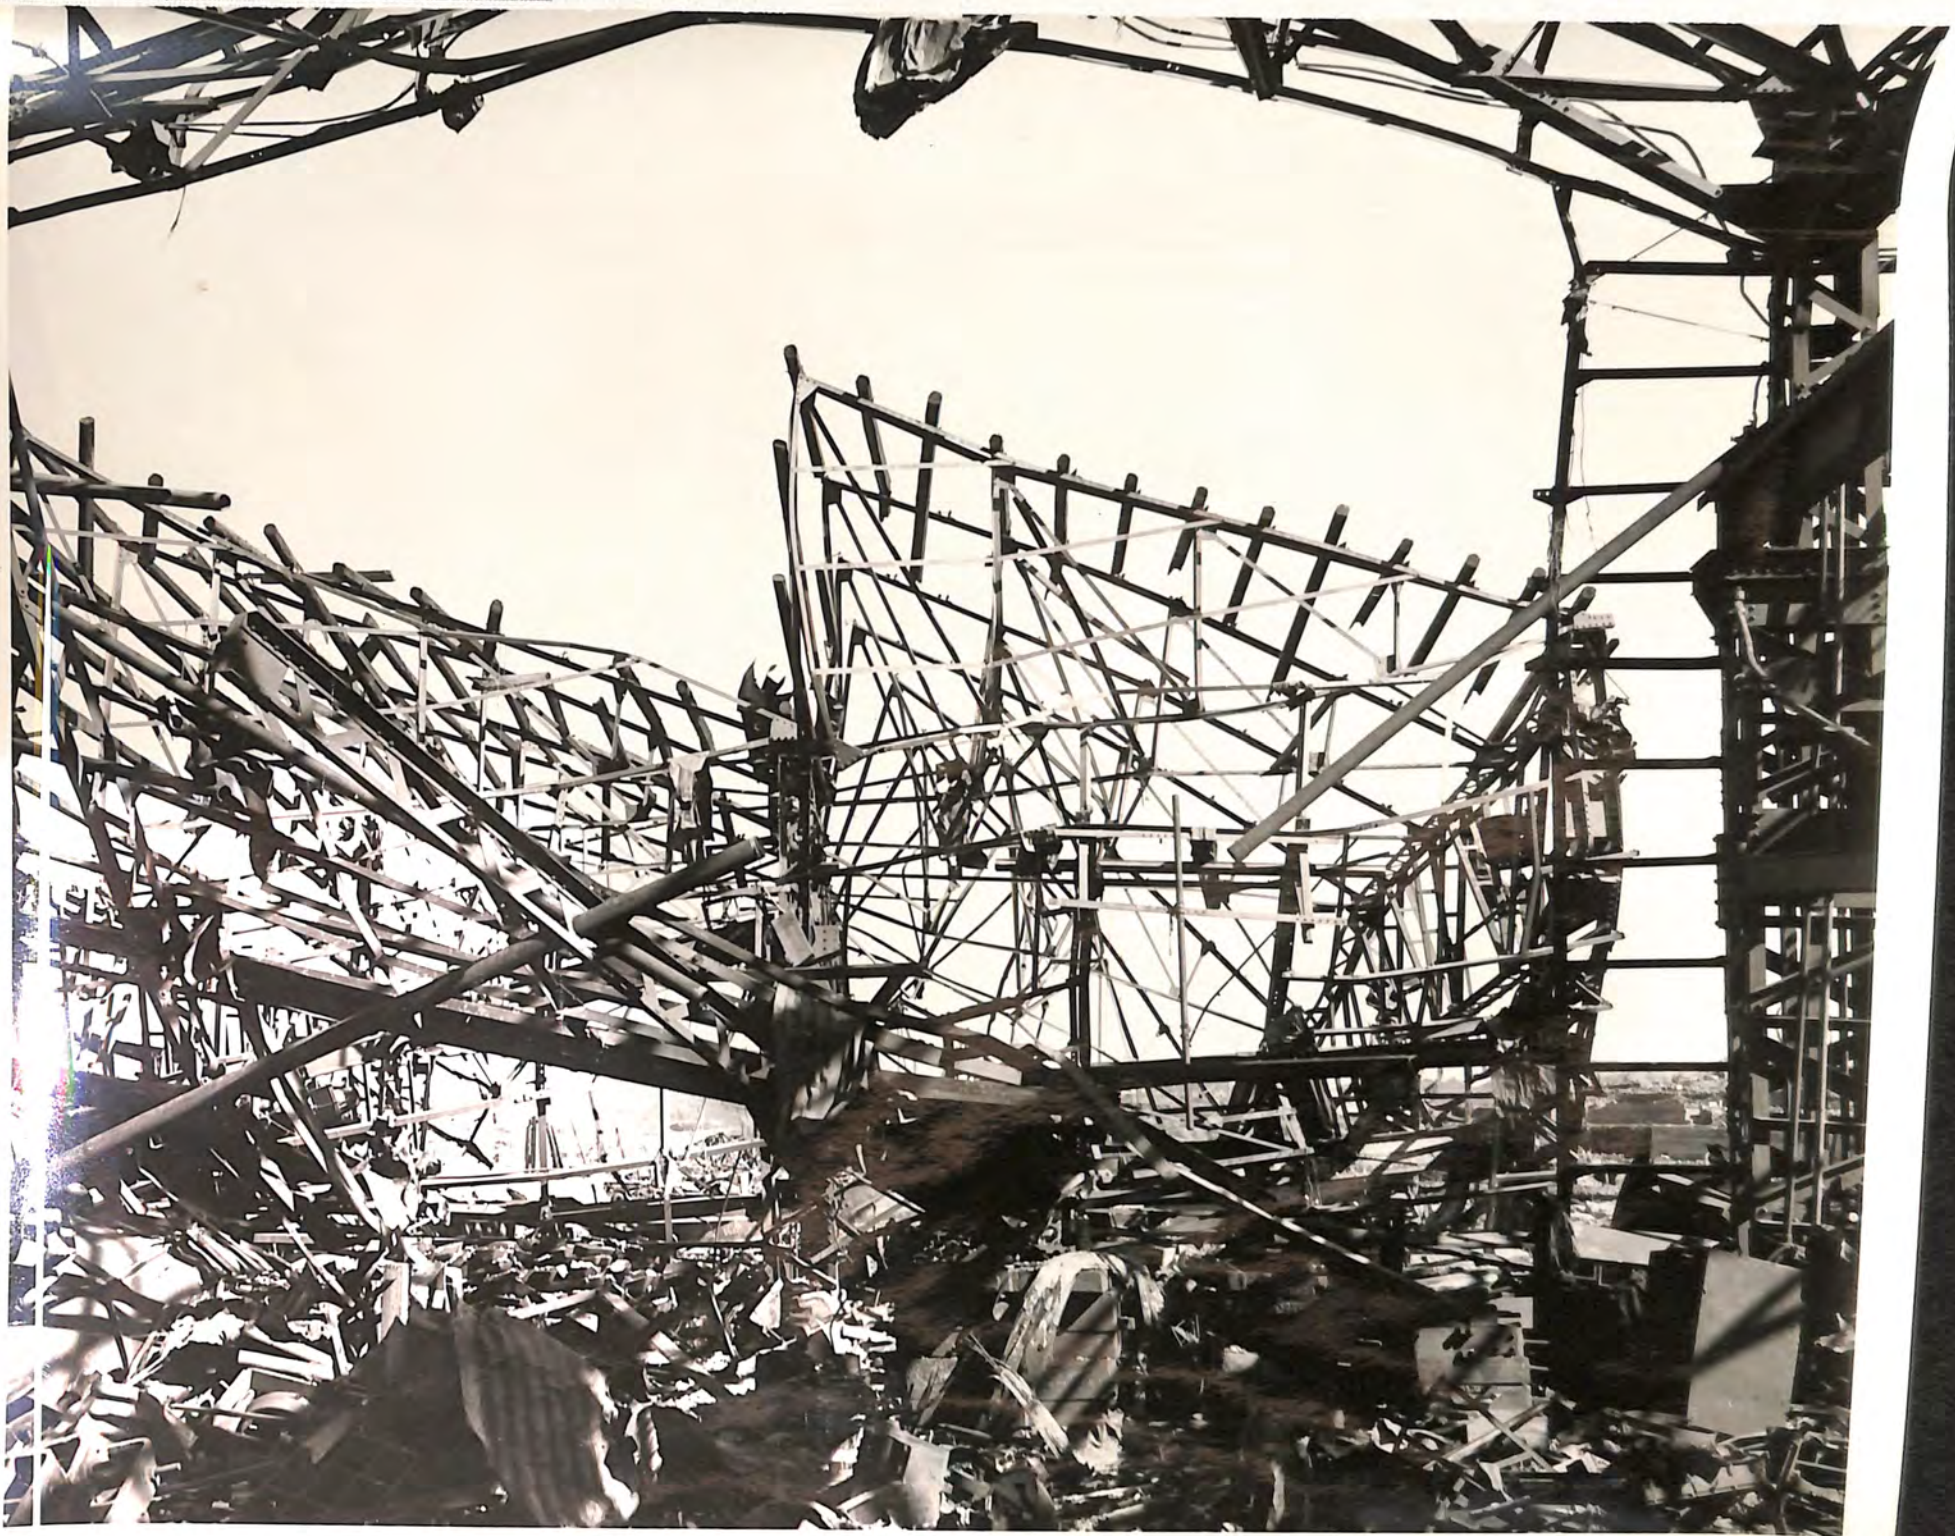
Interior view of one of the machine shops approximately 0.9 miles from zero point, showing badly damaged structural steel framework. Note that siding and roofing were stripped by the blast. Reinforced concrete Pill-Boxes in this building (aisle in center of picture) indicates that prison labor was used here.

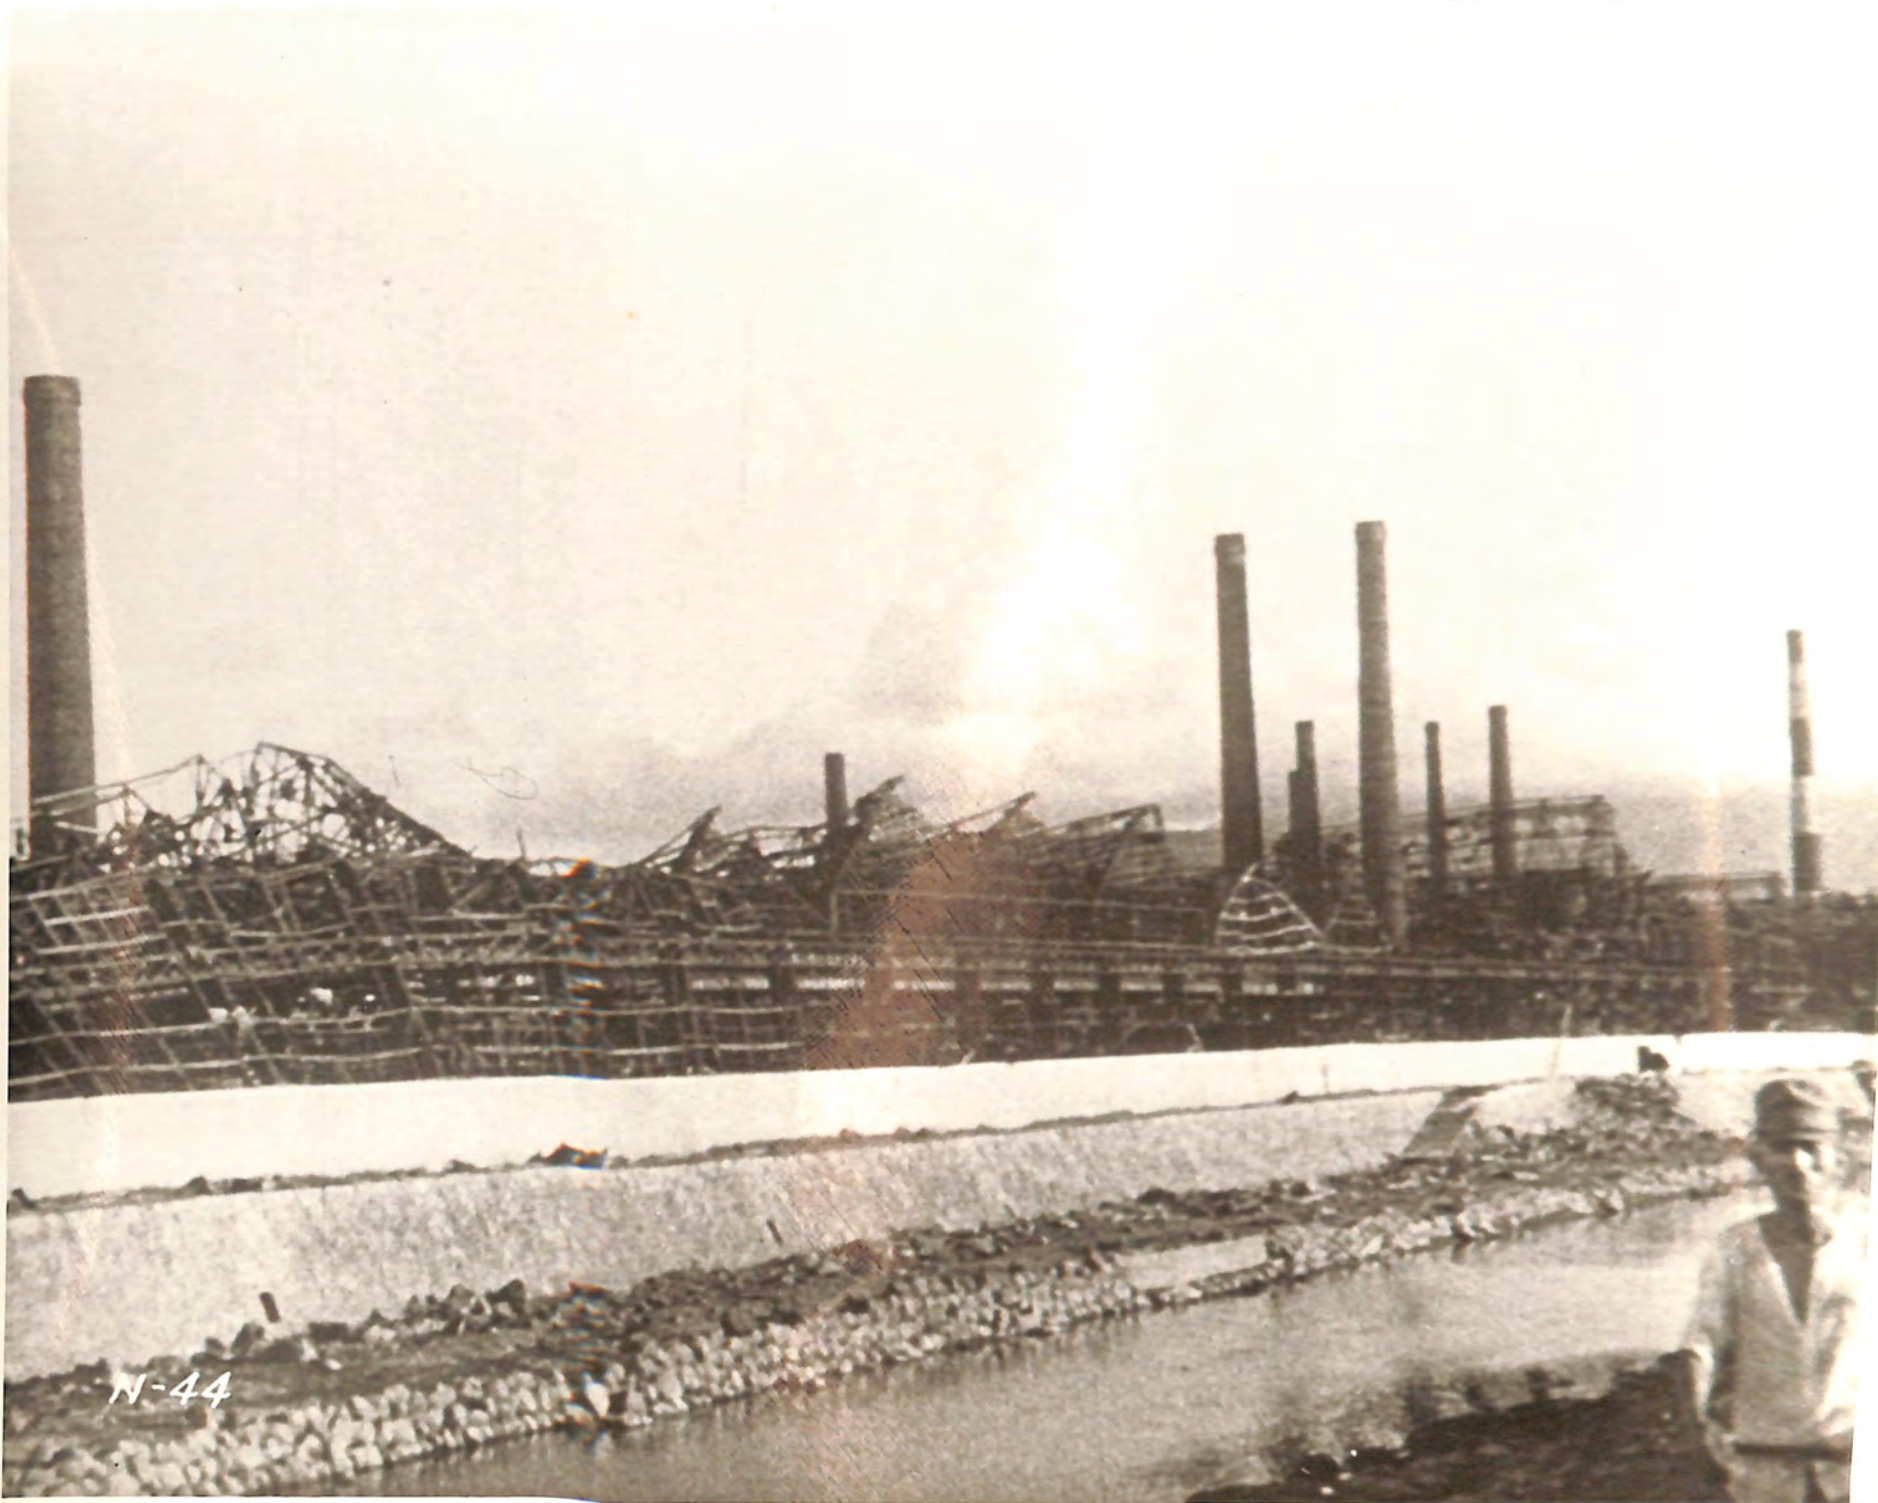
View approximately 3/4 of a mile from zero point, showing heavy steel frame work stripped of roof and siding, but only slightly injured by the blast. Reinforced concrete office building sustained only minor damage.

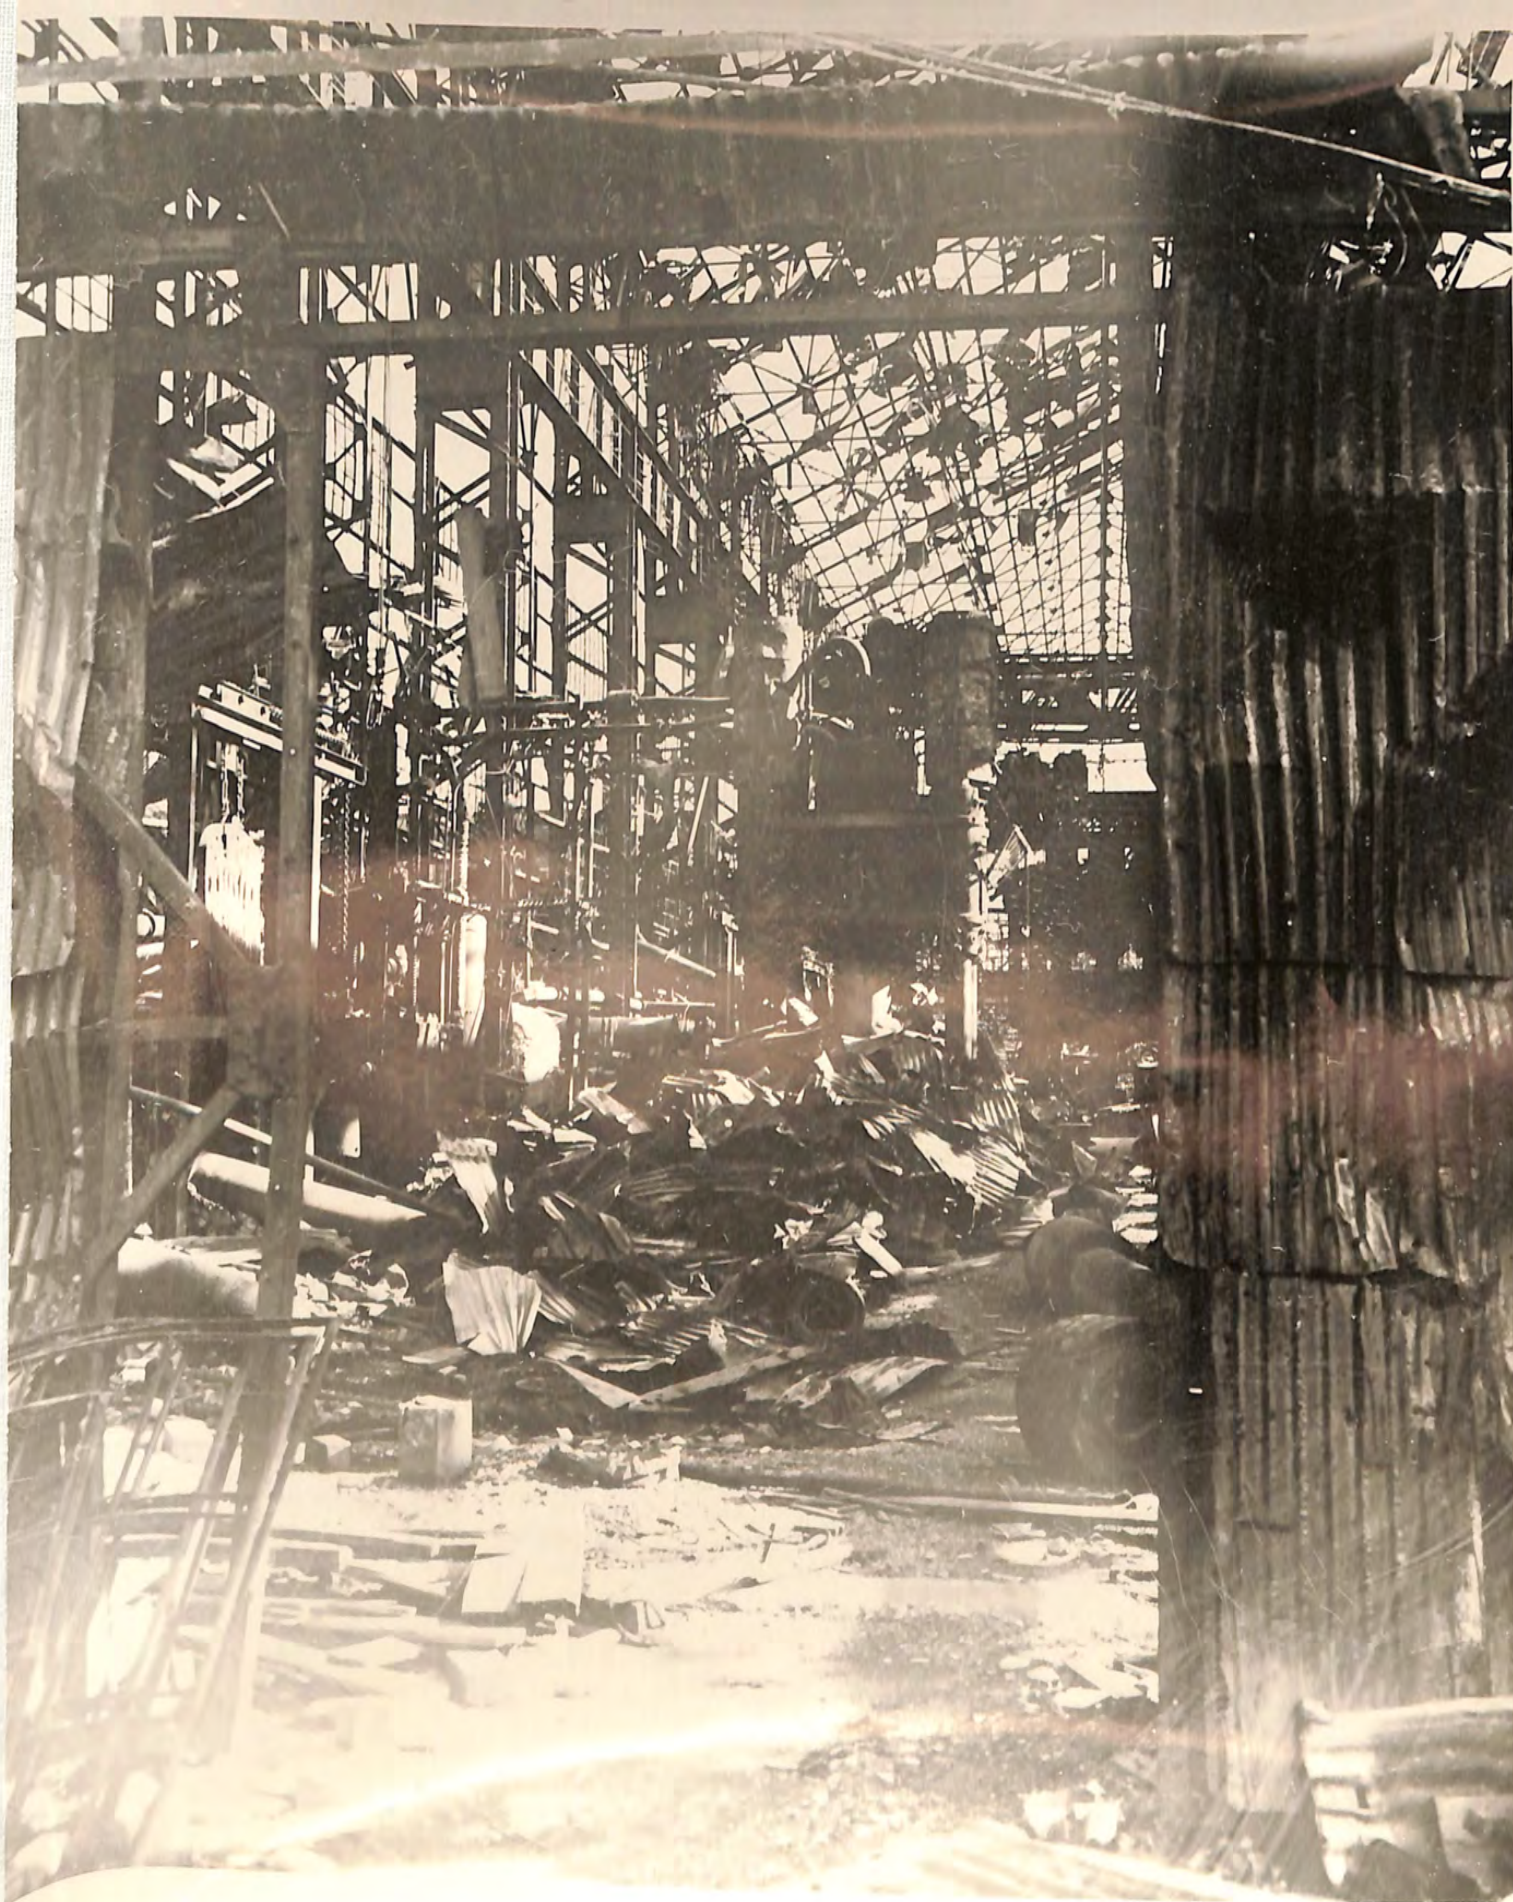
FIGURE 81

This is a view of the interior of one of the heavy machine shops. Note that although the steel frame sustained minor damage, the corrugated iron roof and siding were stripped by the blast.

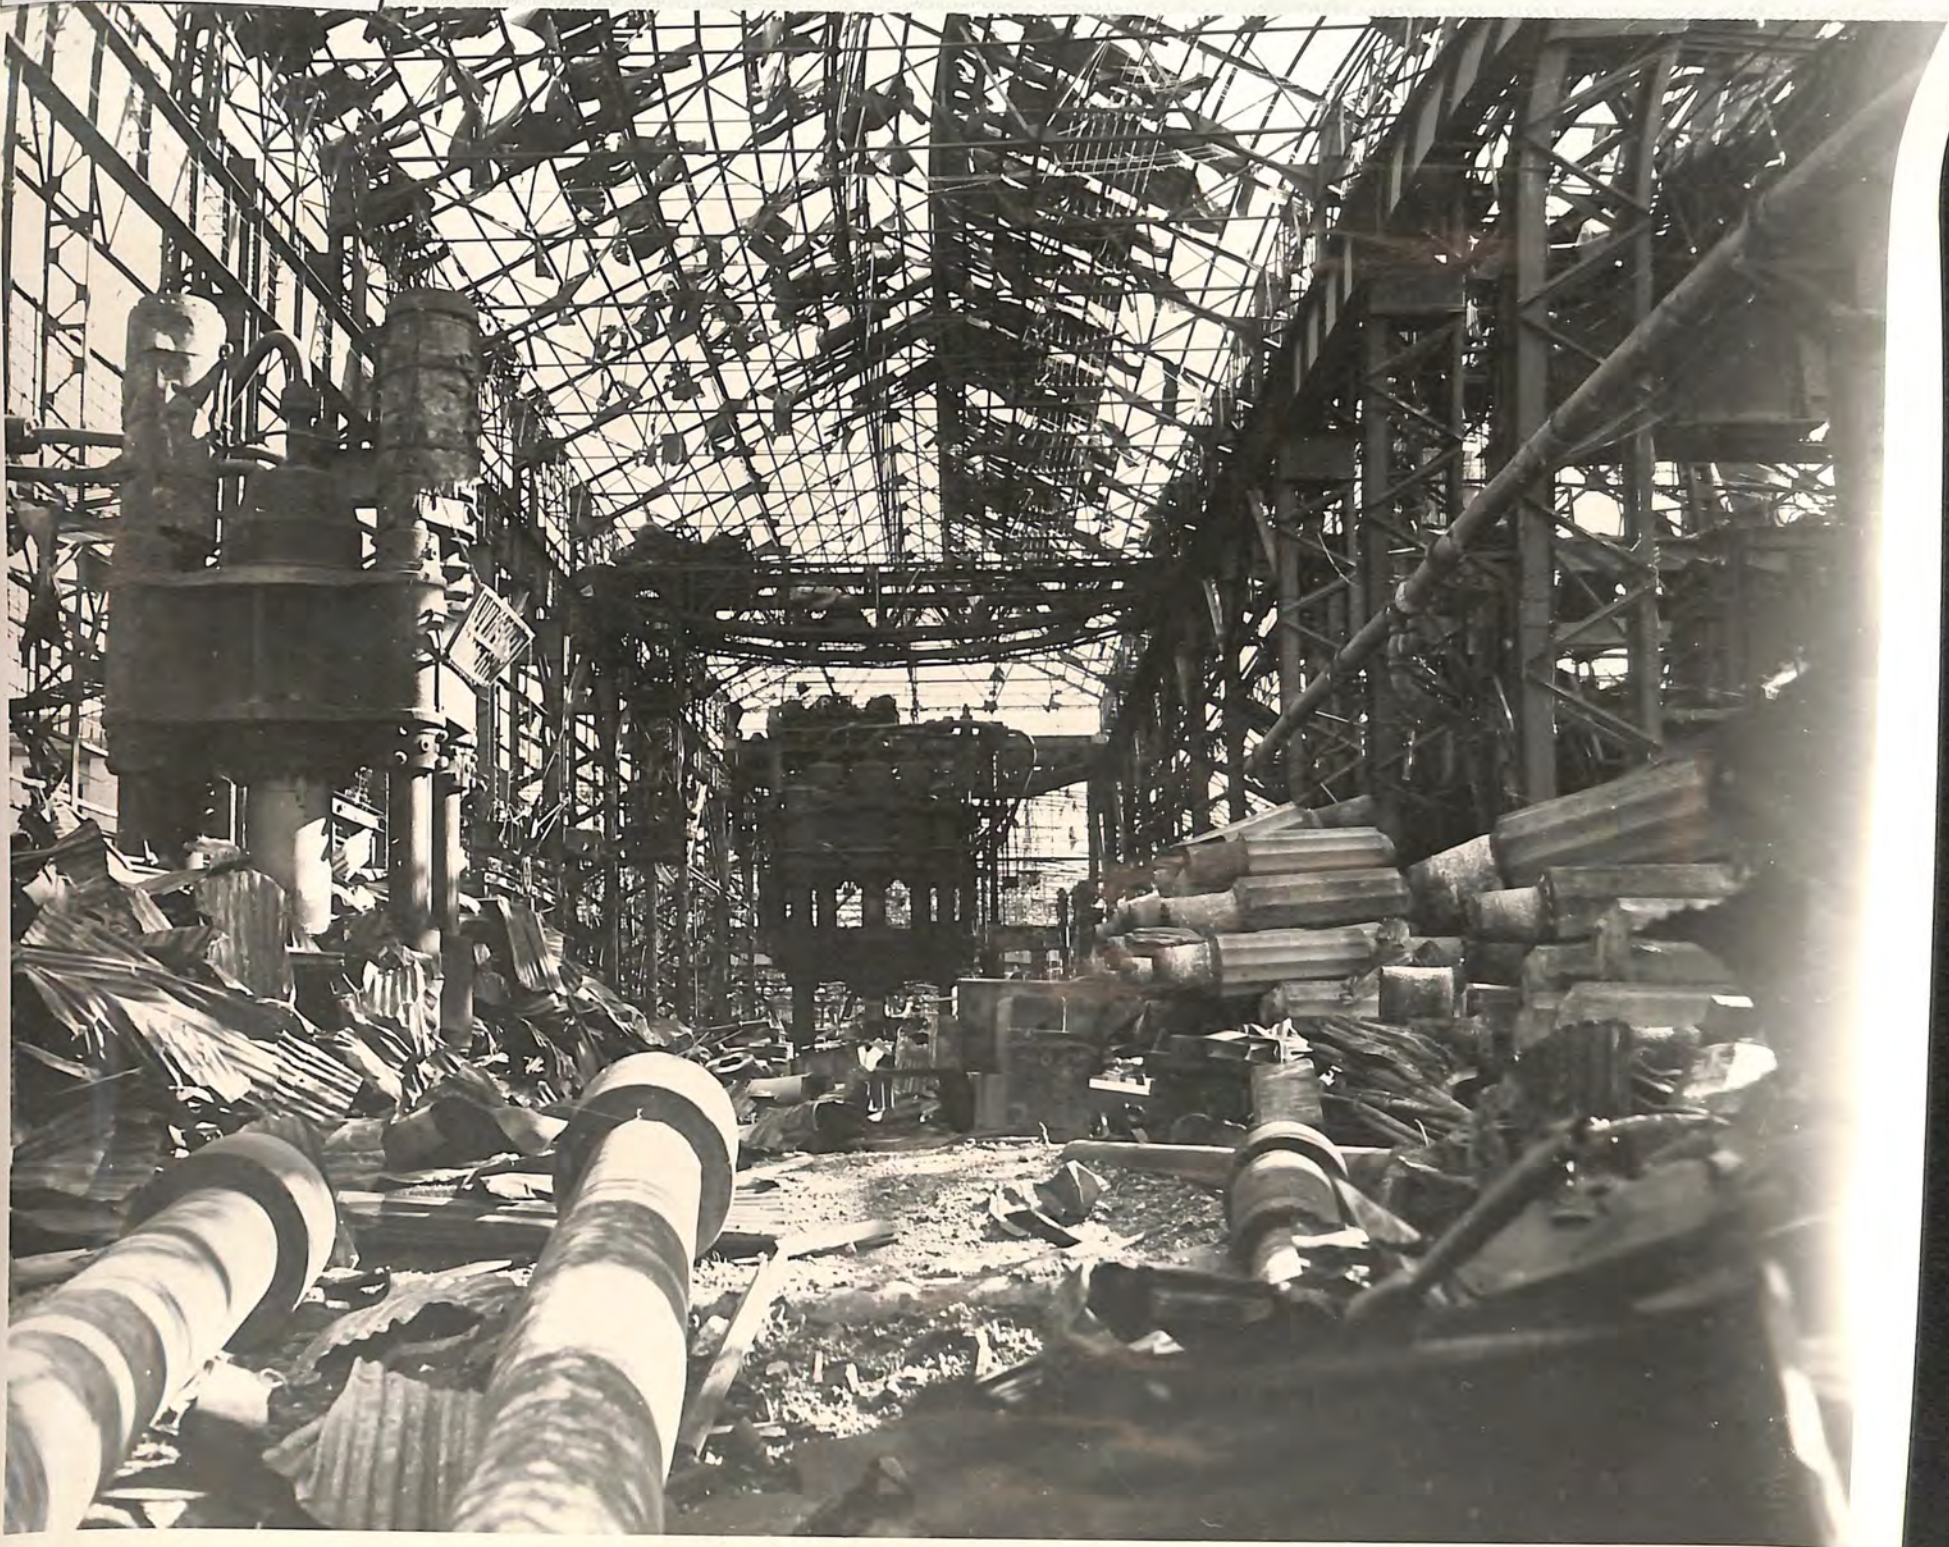
Interior view of heavy machine shop about 3/4 of a mile from zero point. This building was built strongly to support overhead cranes and heavy loads and the framework was only slightly damaged by the blast. Corrugated iron roof and siding were stripped by the blast and windows were knocked out. While building contents were tumbled and damage to equipment is significant, it is not believed to be very serious. The main damage to heavy equipment like this is from rust.

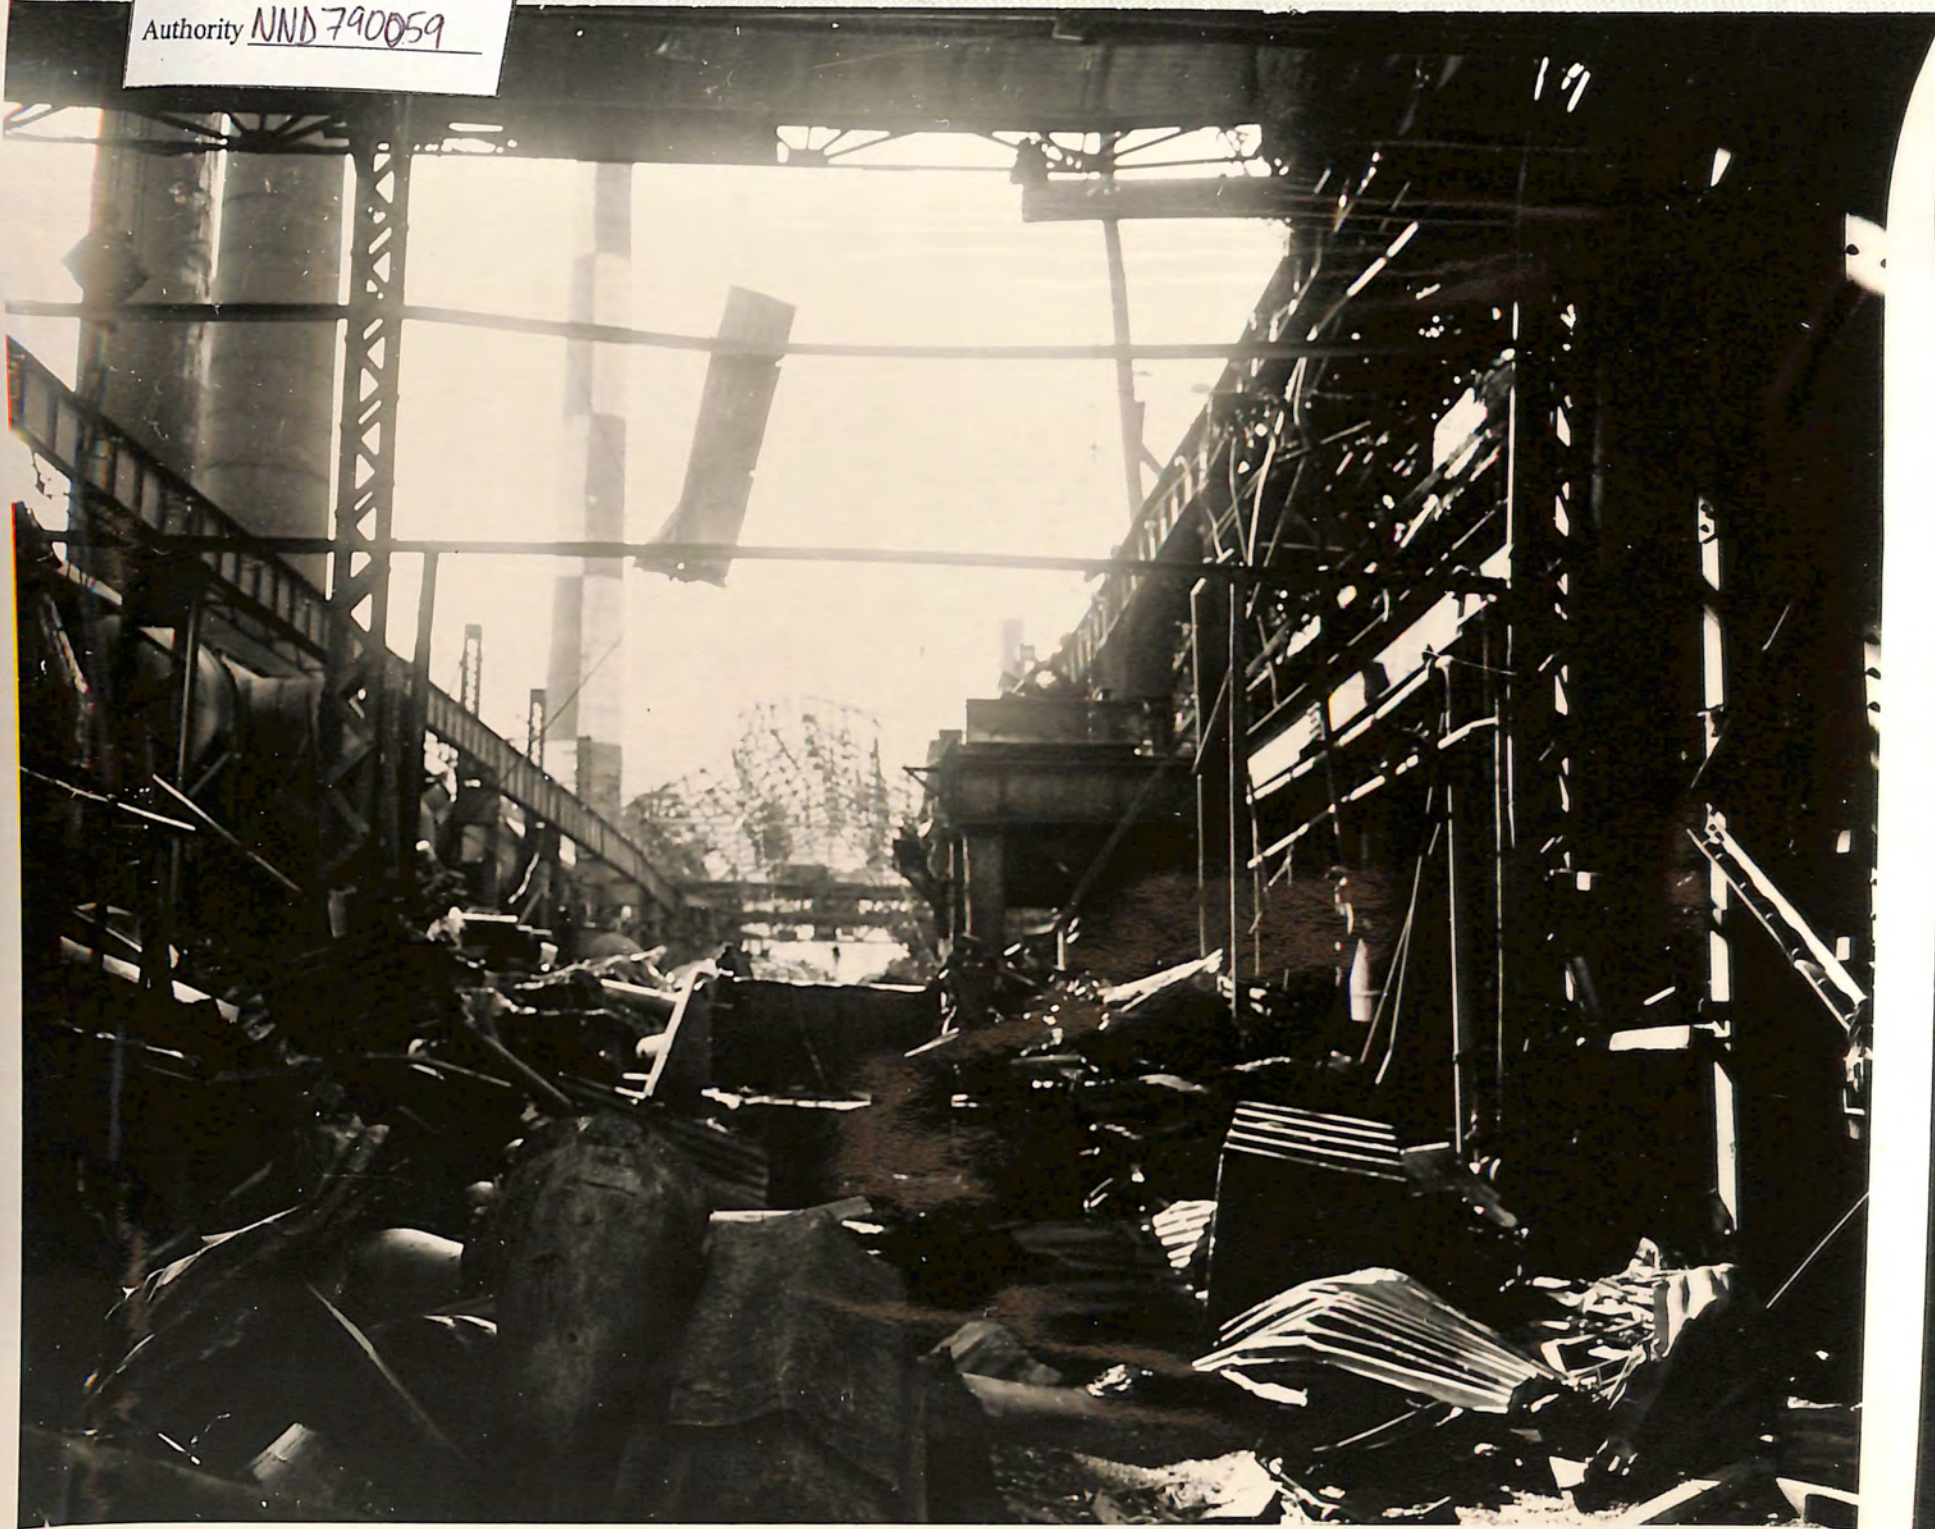
This is a general view of damage caused by the blast to buildings in the South portion of the plant. Note the corrugated metal ripped from the steel frame work and damage to building contents. Reinforced concrete chimneys at this location were apparently uninjured.

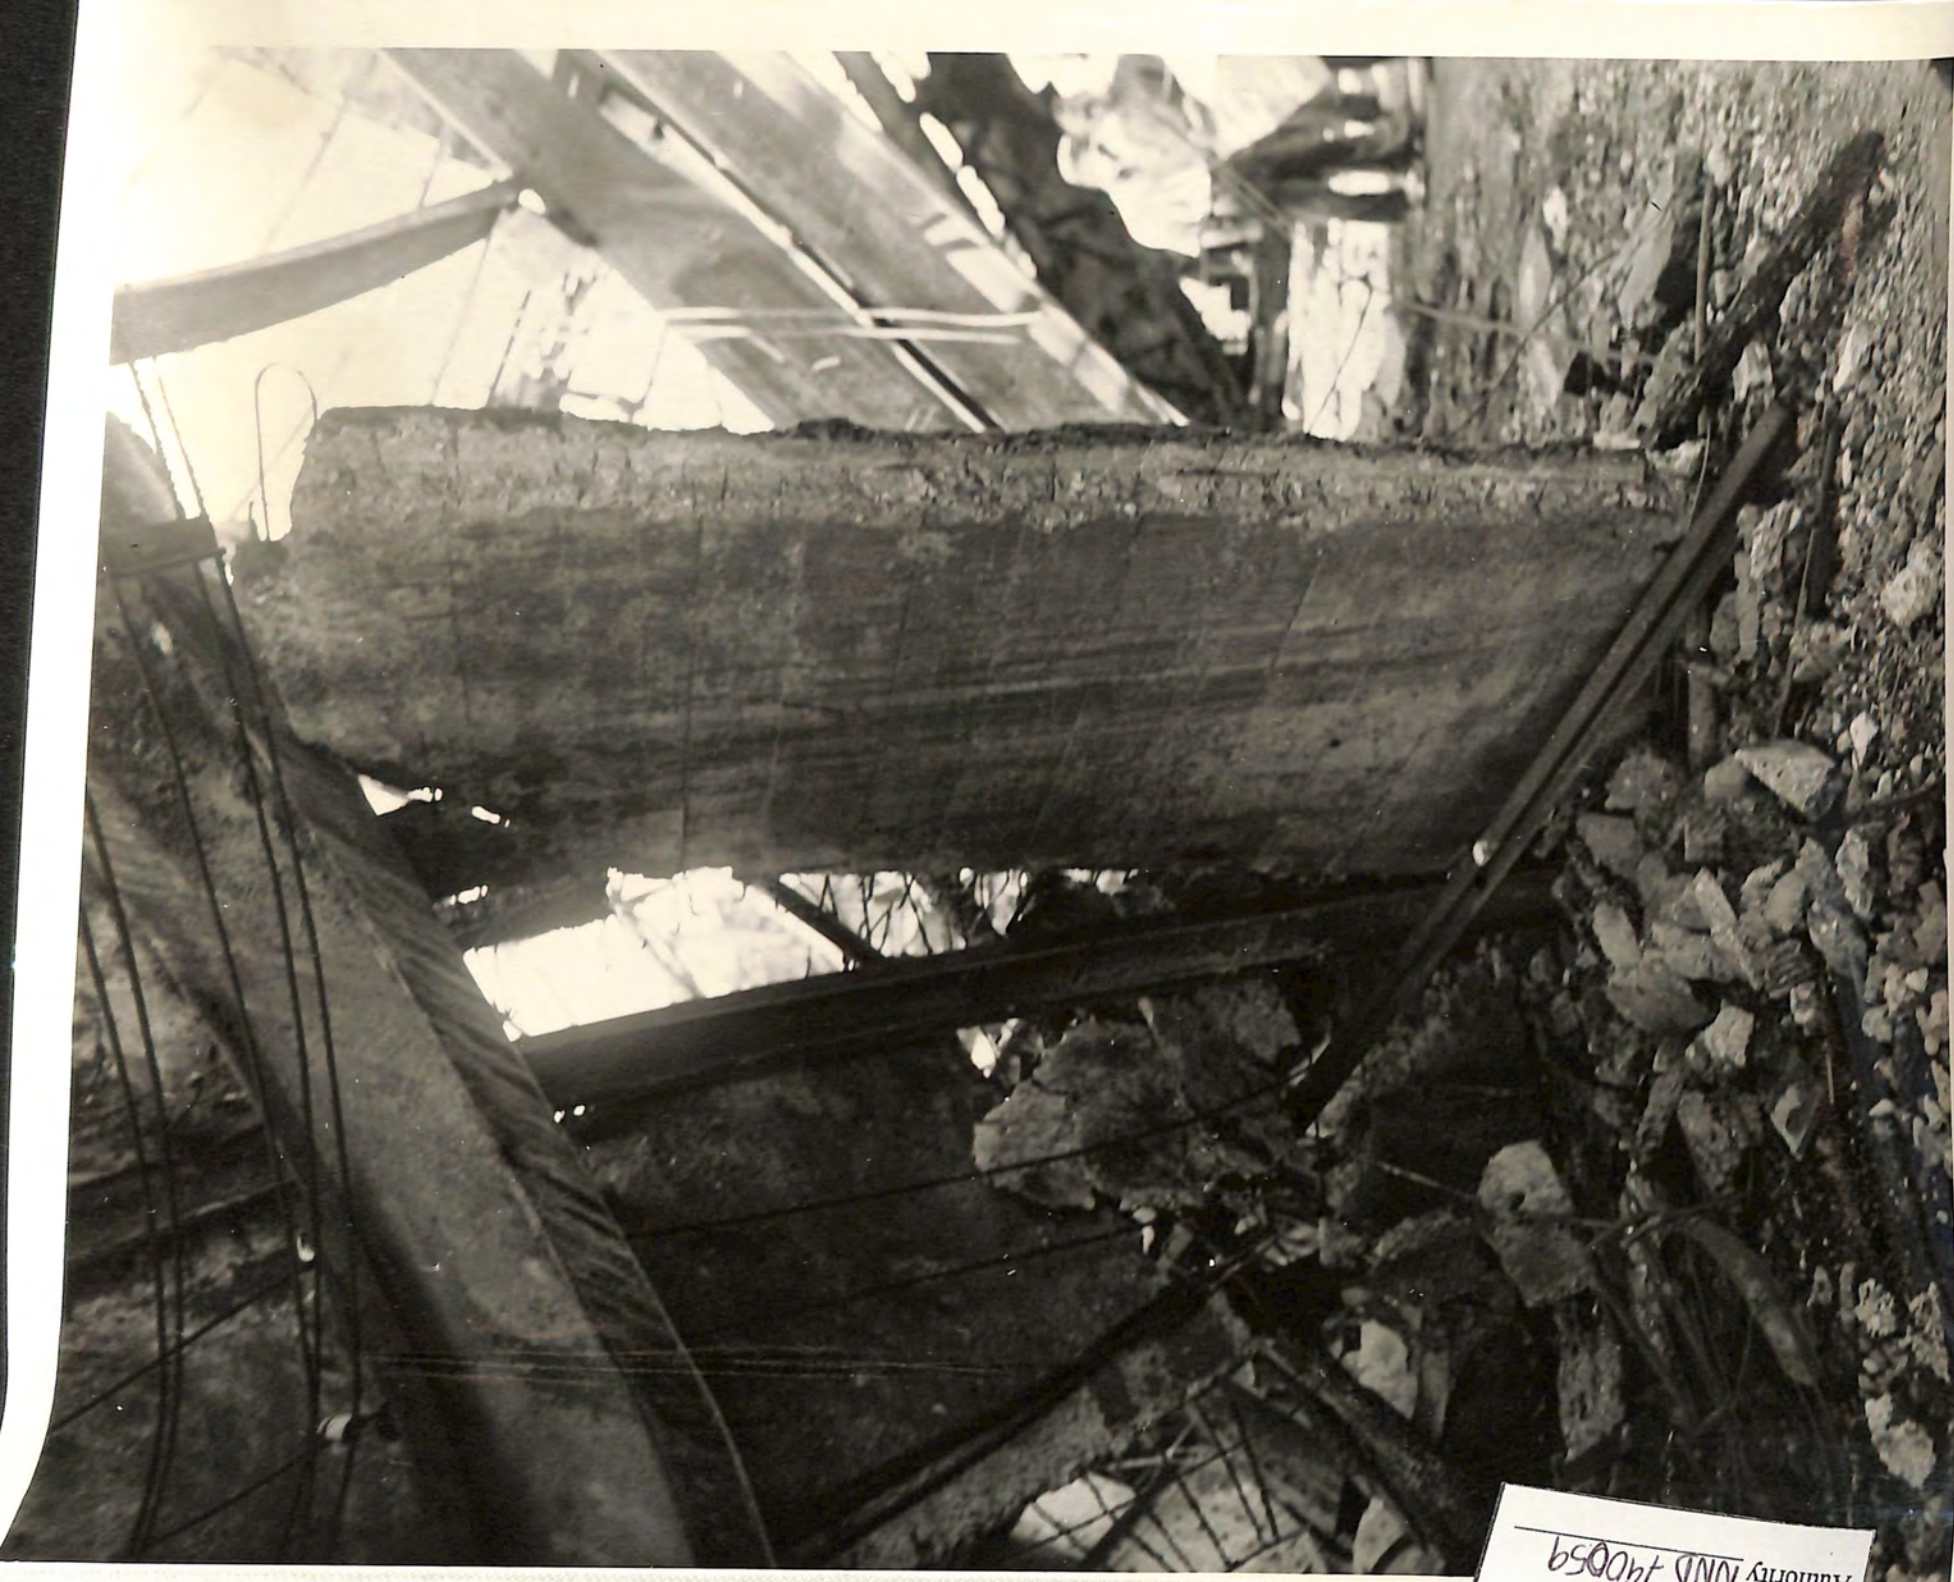
FIGURE 88

This view shows the collapse of the first floor of a reinforced concrete building. First floor of the building was supported by a structural steel frame. The failure was caused by the collapse and failure in bending of relatively light wall columns. Occupants in this building (about 3/4 mile from zero point) who were not killed in the wreckage, were shielded from Gamma radiation, while occupants in the adjoining building, with corrugated metal roof and siding, were injured by this type of radiation.
