NAGASAKI ATOMIC BOMB DAMAGE  
Nagasaki, Japan

9 August 1945 (Japanese Time)

UNITED STATES  
ATOMIC ENERGY COMMISSION  
OAK RIDGE, TENNESSEE

NAGASAKI ATOMIC BOMB DAMAGE

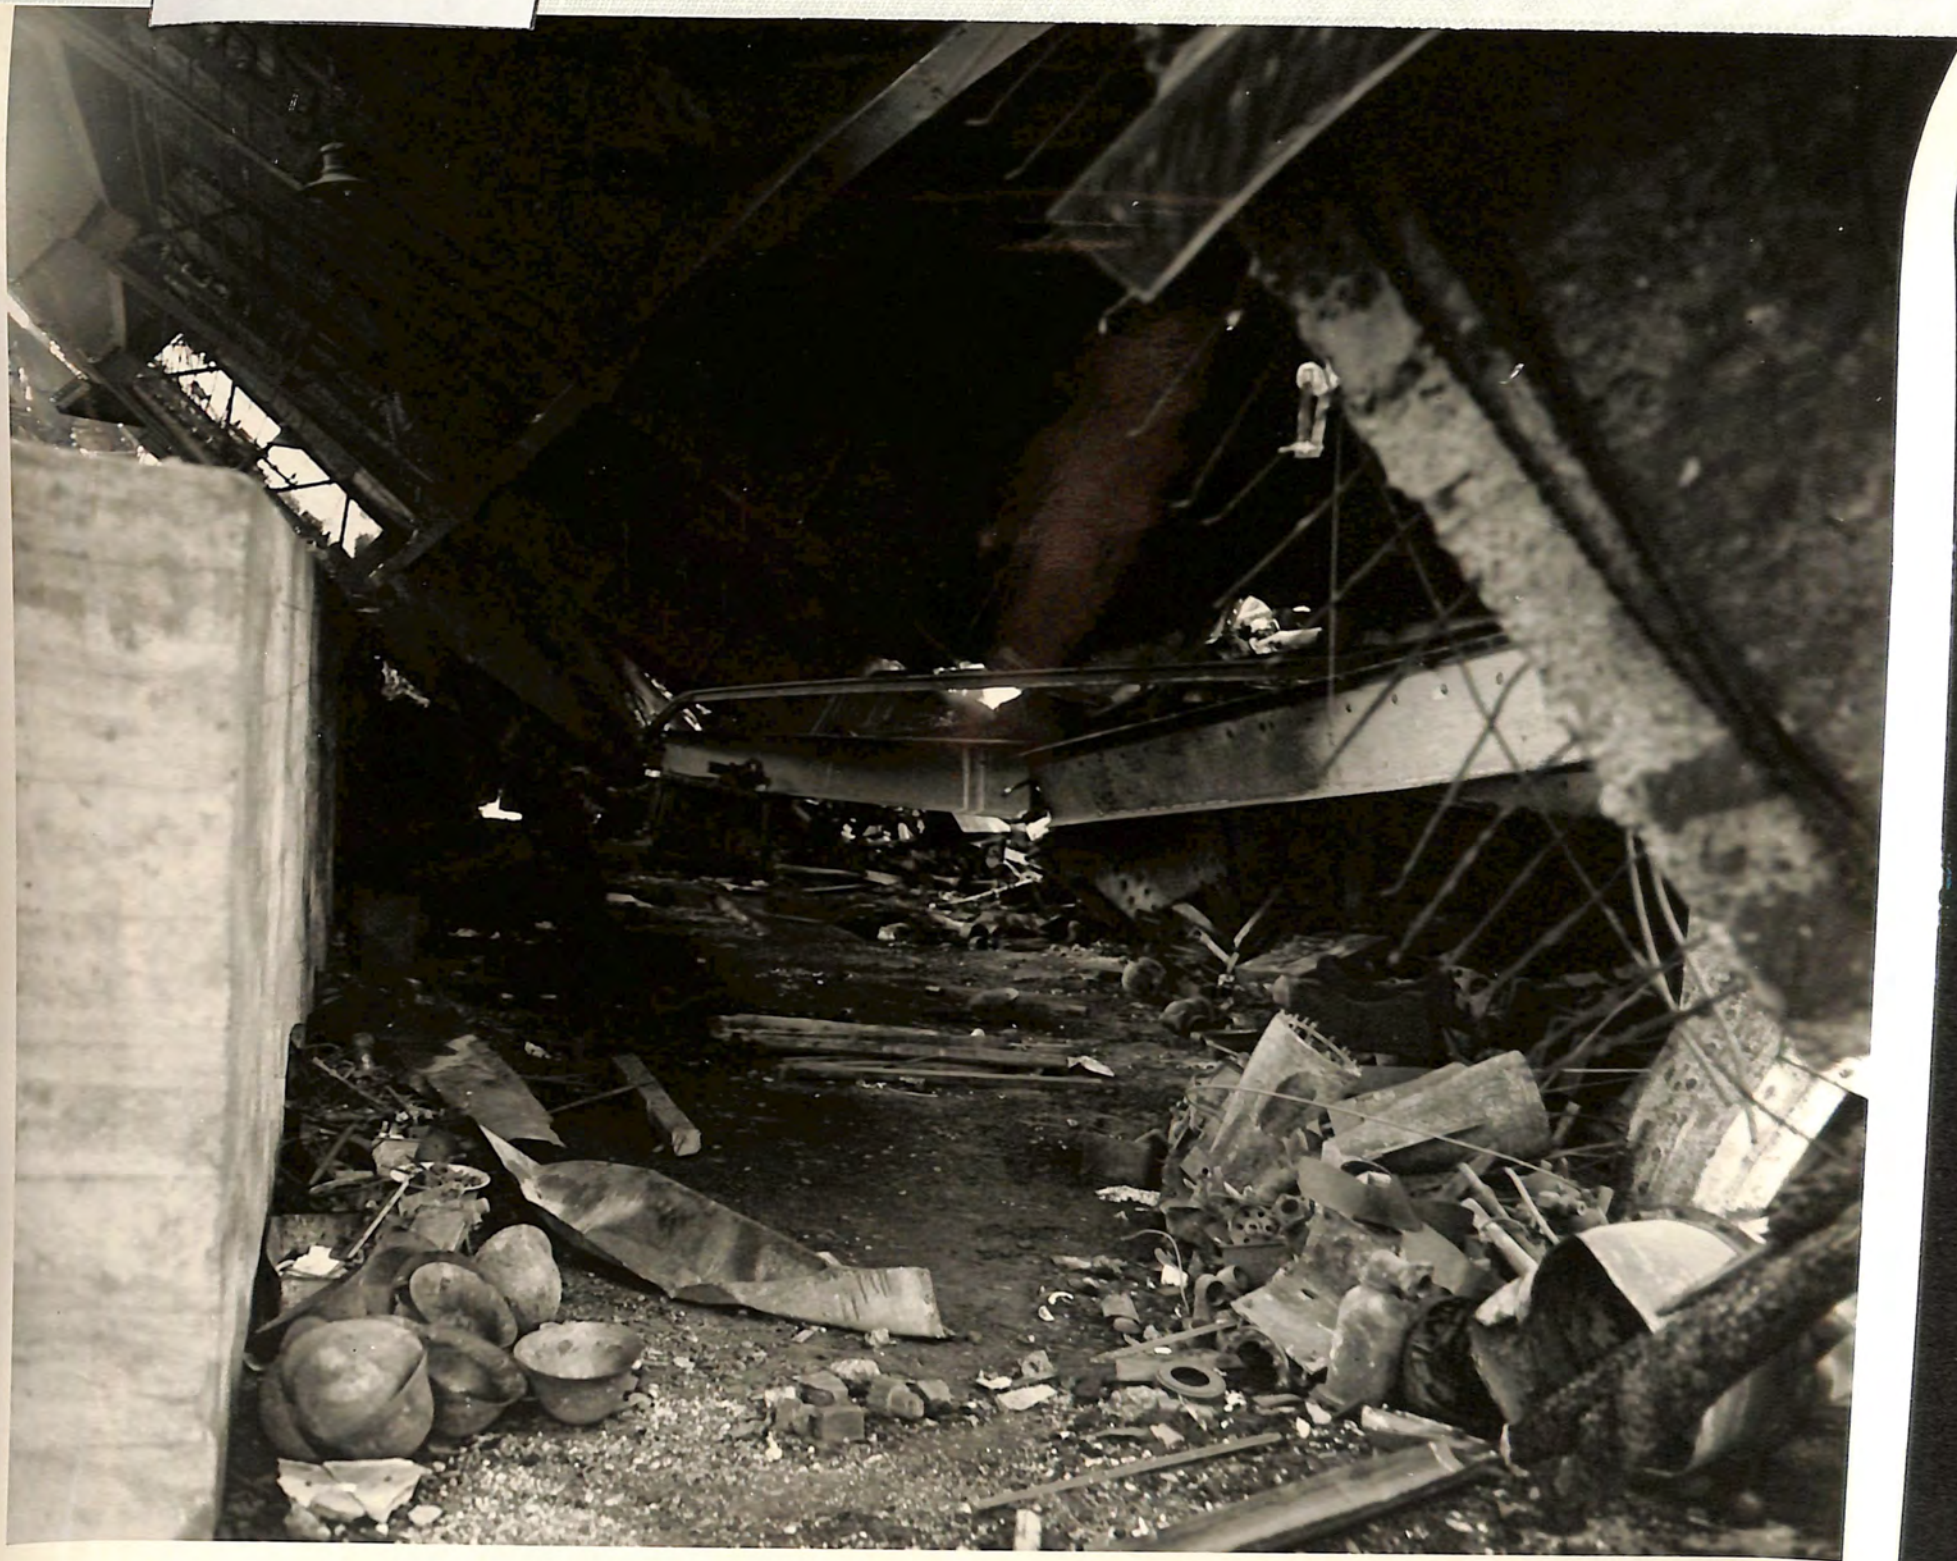
This is another view, showing failure of concrete and structural steel building.

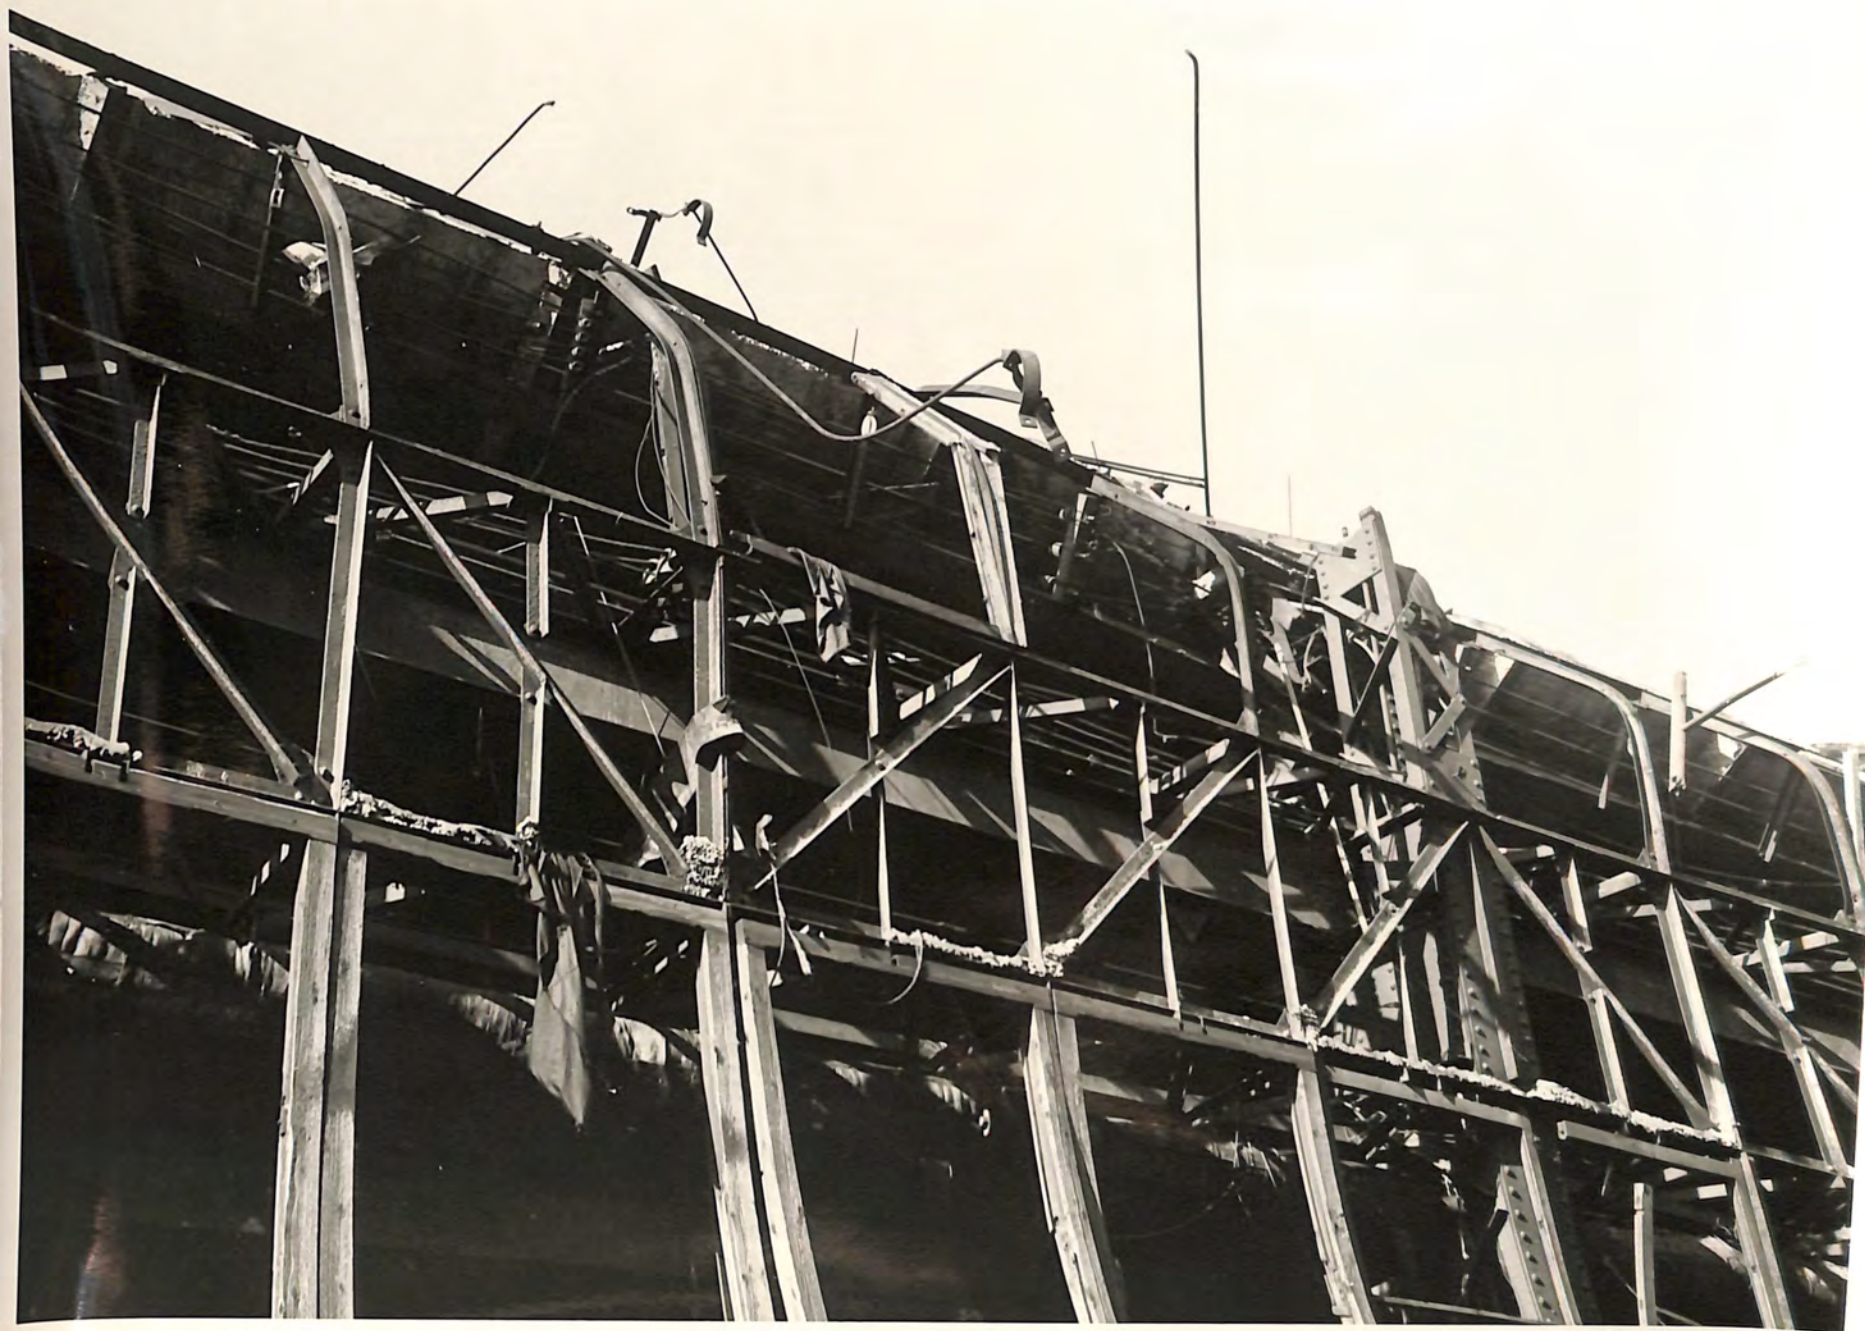
This building was approximately 0.9 miles from zero point, and shows the failure of wall columns which caused the collapse of the reinforced concrete and structural steel roof.

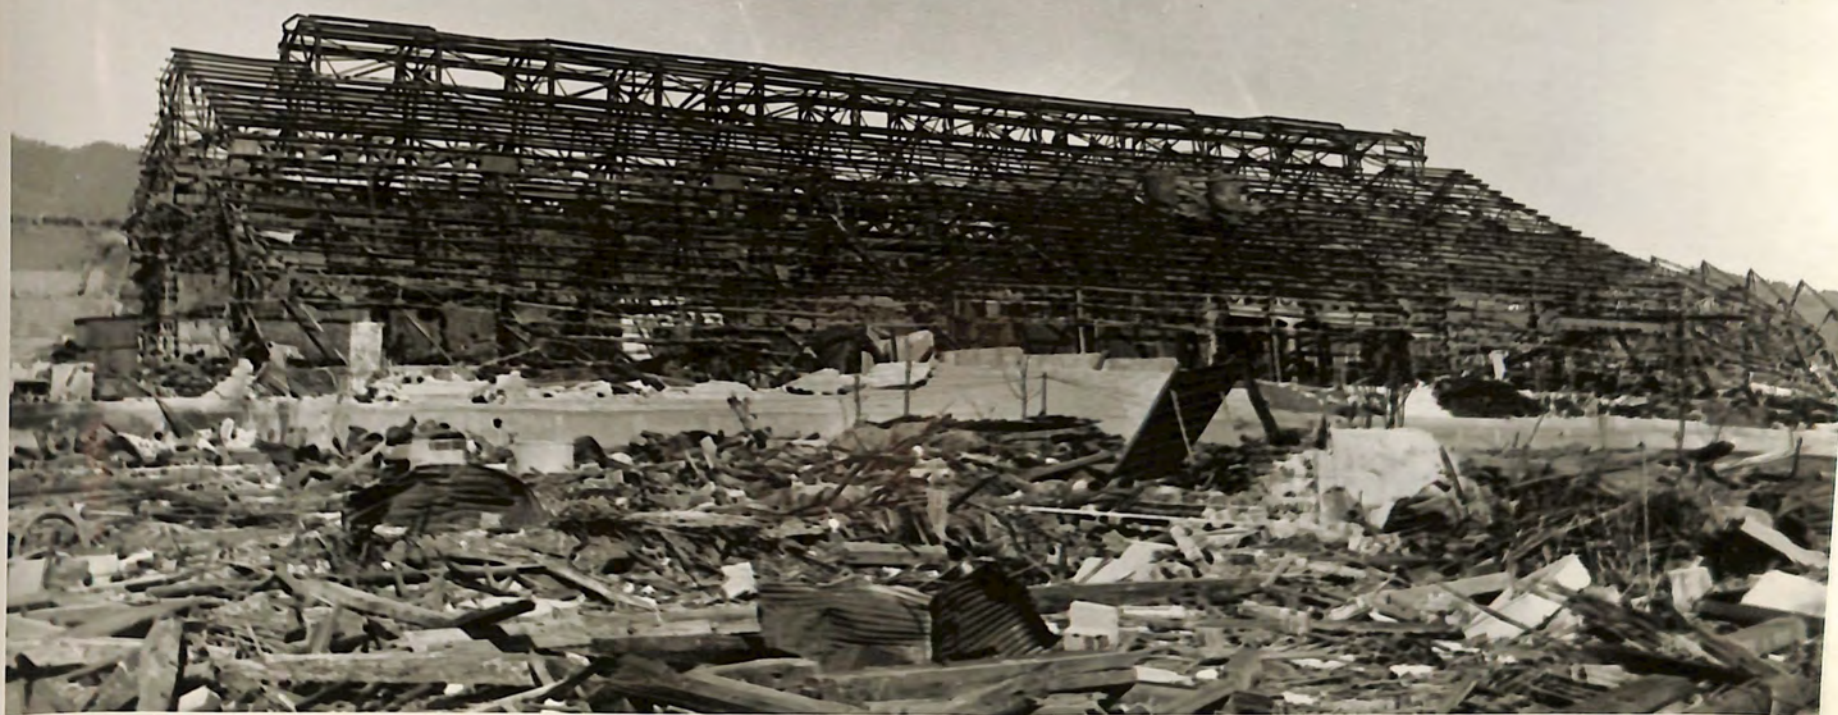
This is a view of one of the foundry buildings approximately 0.3 of a mile from zero point. It shows the damaged steel frame, stripped of roof and siding. Note that both chimneys have been broken off by the blast shortly above the roof level.

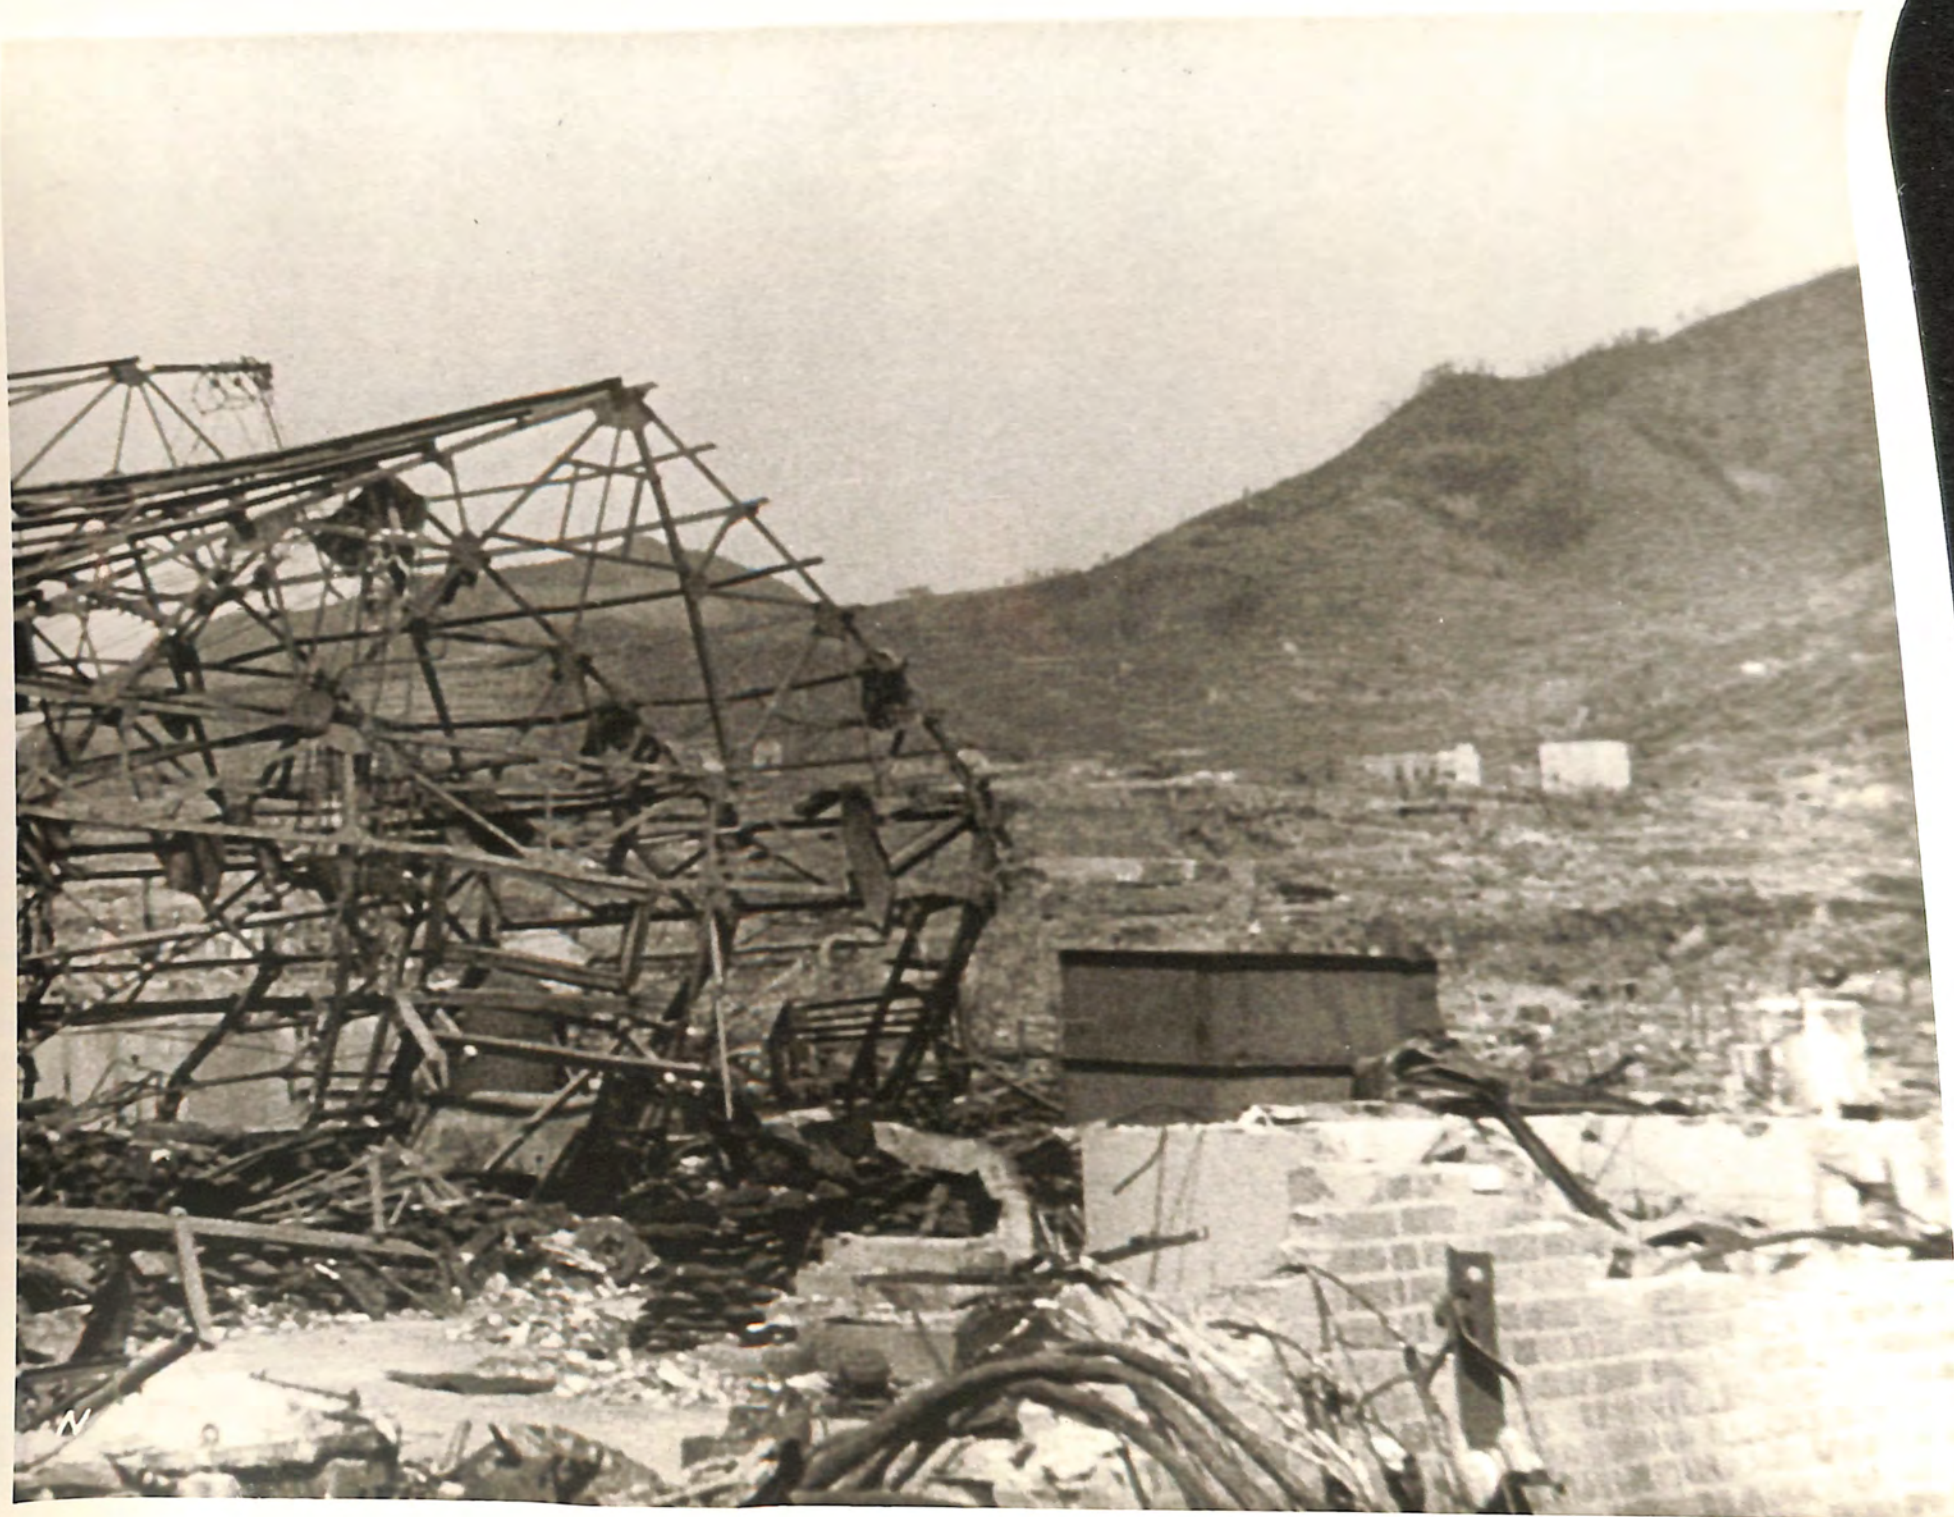
View showing damage to light steel frame approximately 0.3 miles from zero point. Roof and siding were stripped by the blast.

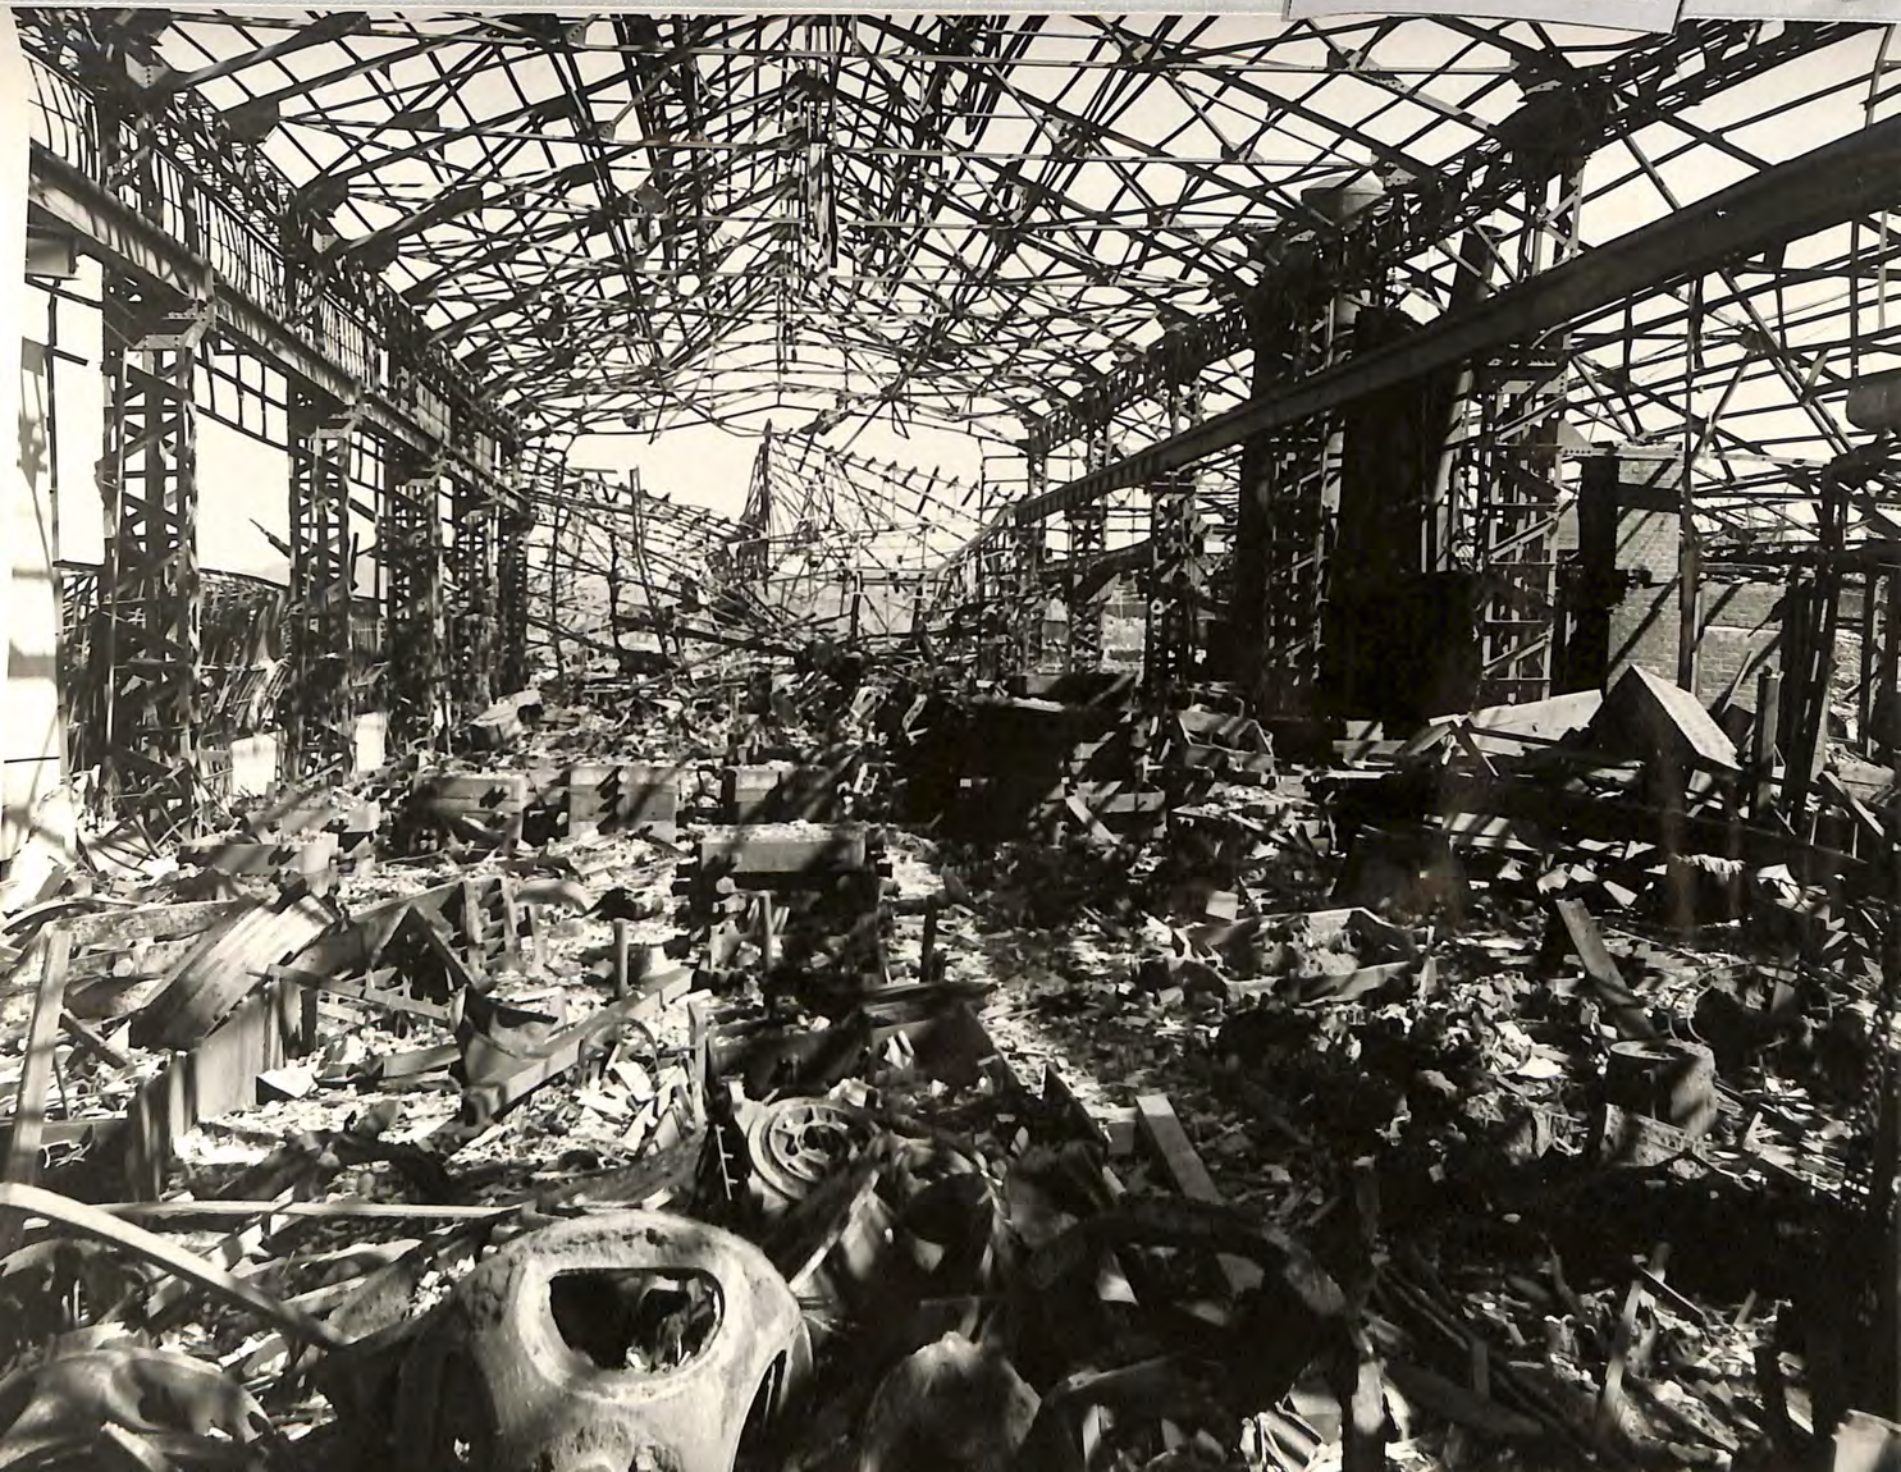
A foundry building approximately 0.3 of a mile from zero point. This is an interior view looking North toward zero point, showing how castings, moulds, and building contents in general were tumbled by the blast. The North end of the building, of light angle iron construction, was caved in by the blast wave. The tops of the columns were shoved in the direction of the blast from 18 to 25-inches, causing buckling of the tops of the columns and failure of their concrete foundations. Note, also, the small pieces of corrugated asbestos roofing and siding broken up by the blast.

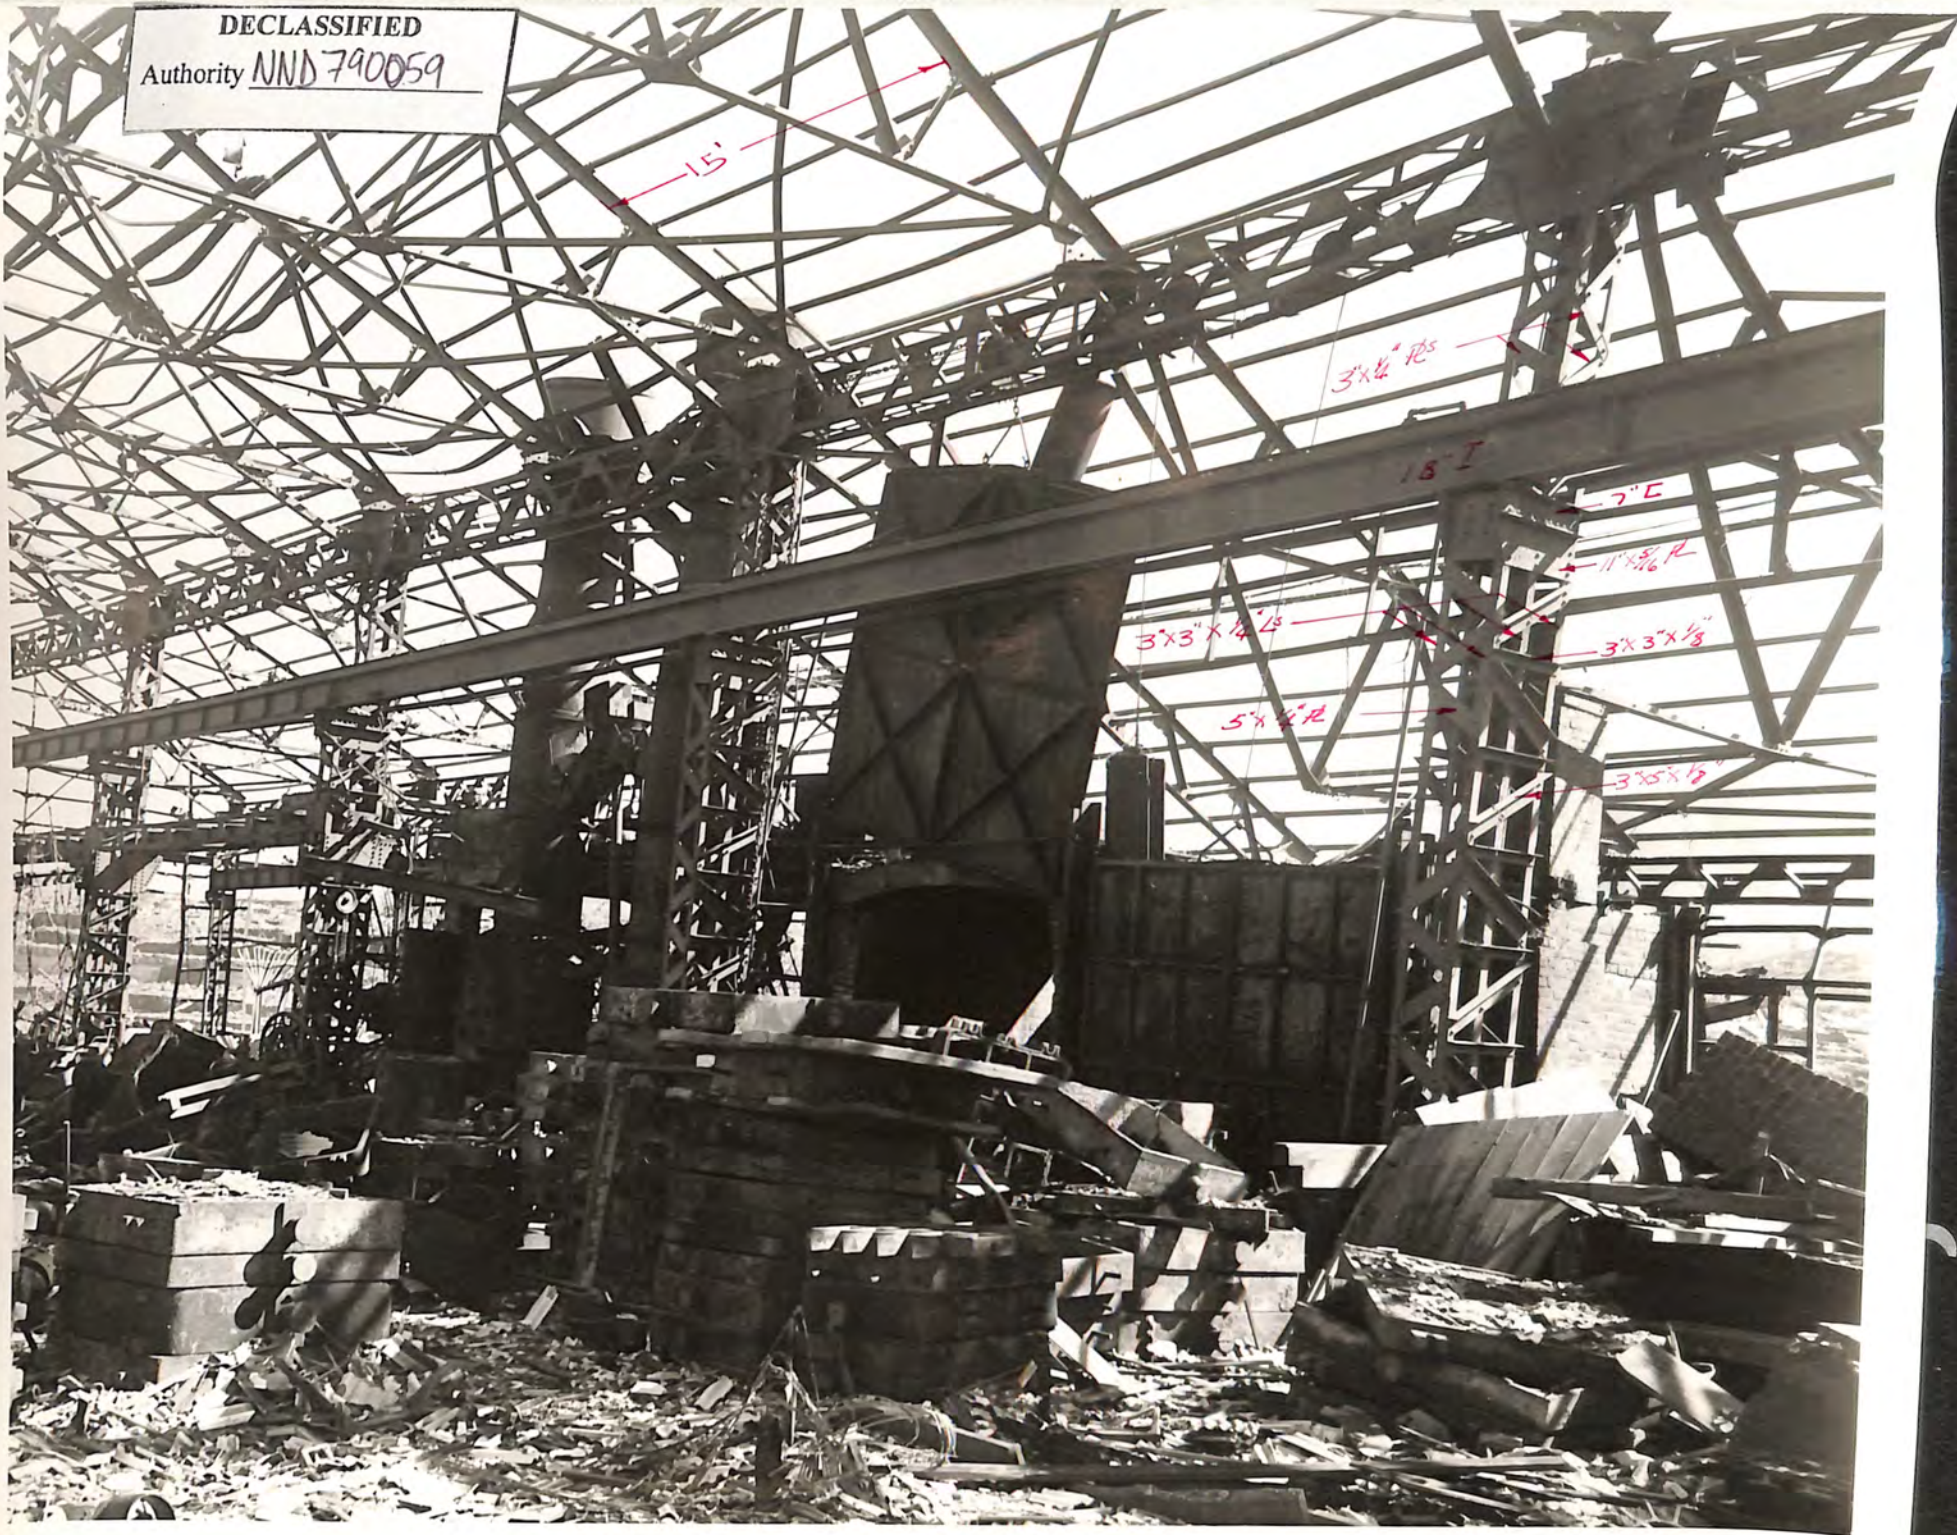
A foundry building approximately 0.3 of a mile from zero point. Interior view looking toward zero point showing molds for castings and furnaces. Two light steel chimneys were toppled by the force of the blast onto the roof purlins and roof trusses and caused damage where they fell. The force of the blast shoved the top of the building 18-inches to 25-inches to the South (right, in this picture), buckling the top portion of the columns and either cracking or rotating the concrete foundations for the columns. No fires occurred in this building, although the heat of the blast was, undoubtedly, severe at this distance.

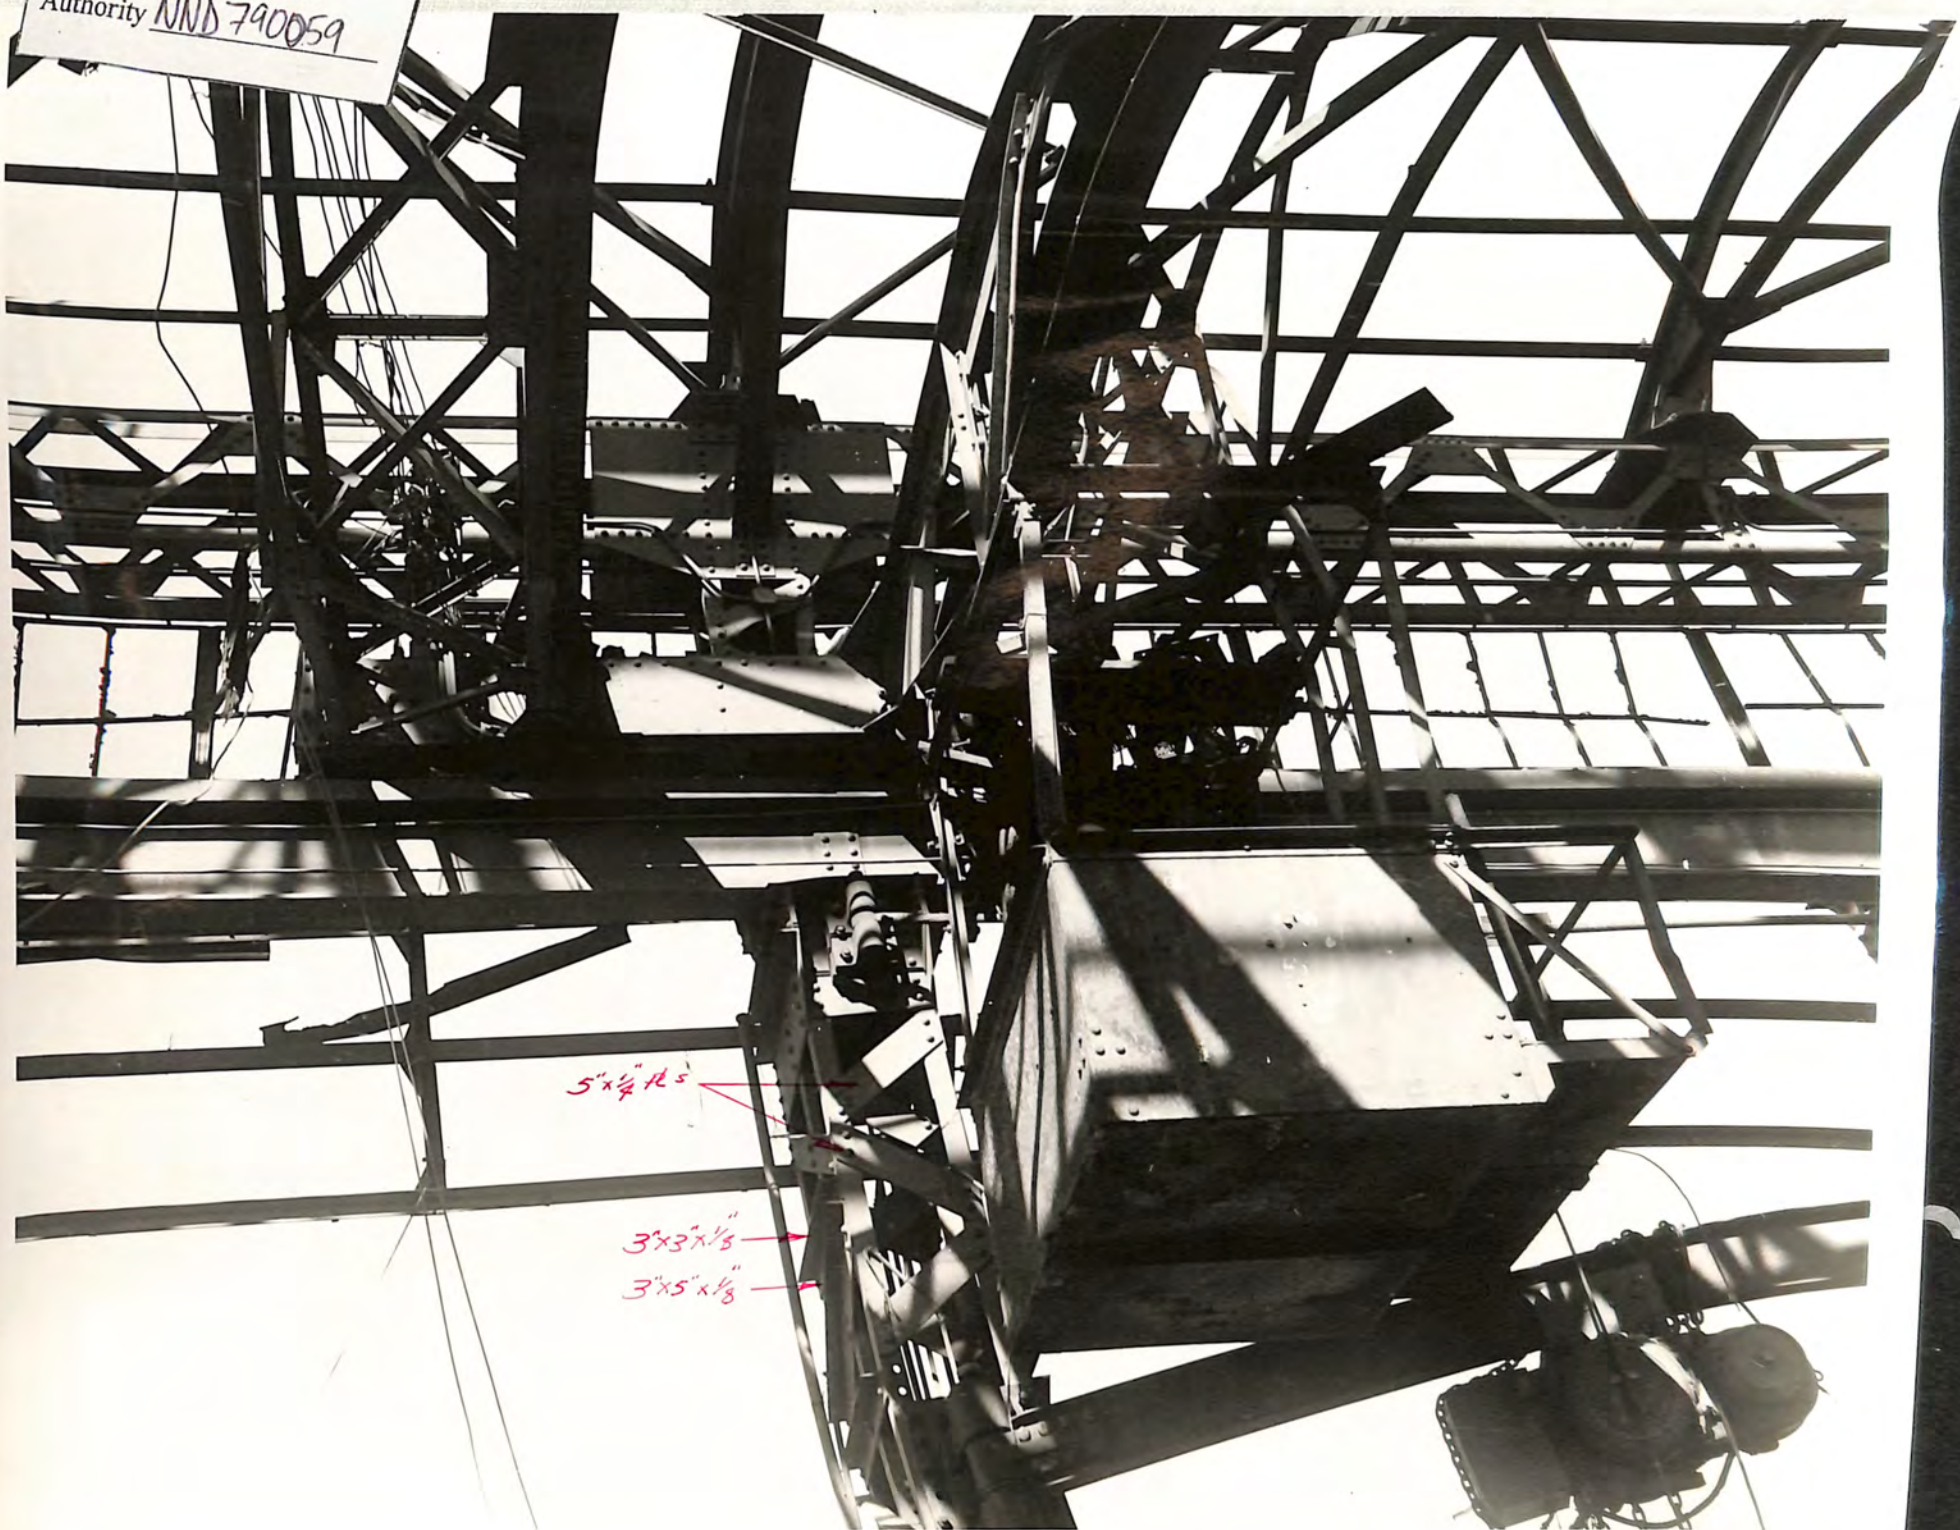
FIGURE 75

A foundry building approximately 0.3 miles from zero point. This is a side view of a typical column taken from the ground looking up to the roof truss. Note that the column is connected to the roof truss and to the truss beams connecting the columns by means of heavy gusset plates 5/16" in thickness. Also, note that the portion of the column between the roof truss and the rail for the crane has been buckled by the force of the blast, acting from the right (in this picture). This view also shows the crane and operator's cab.

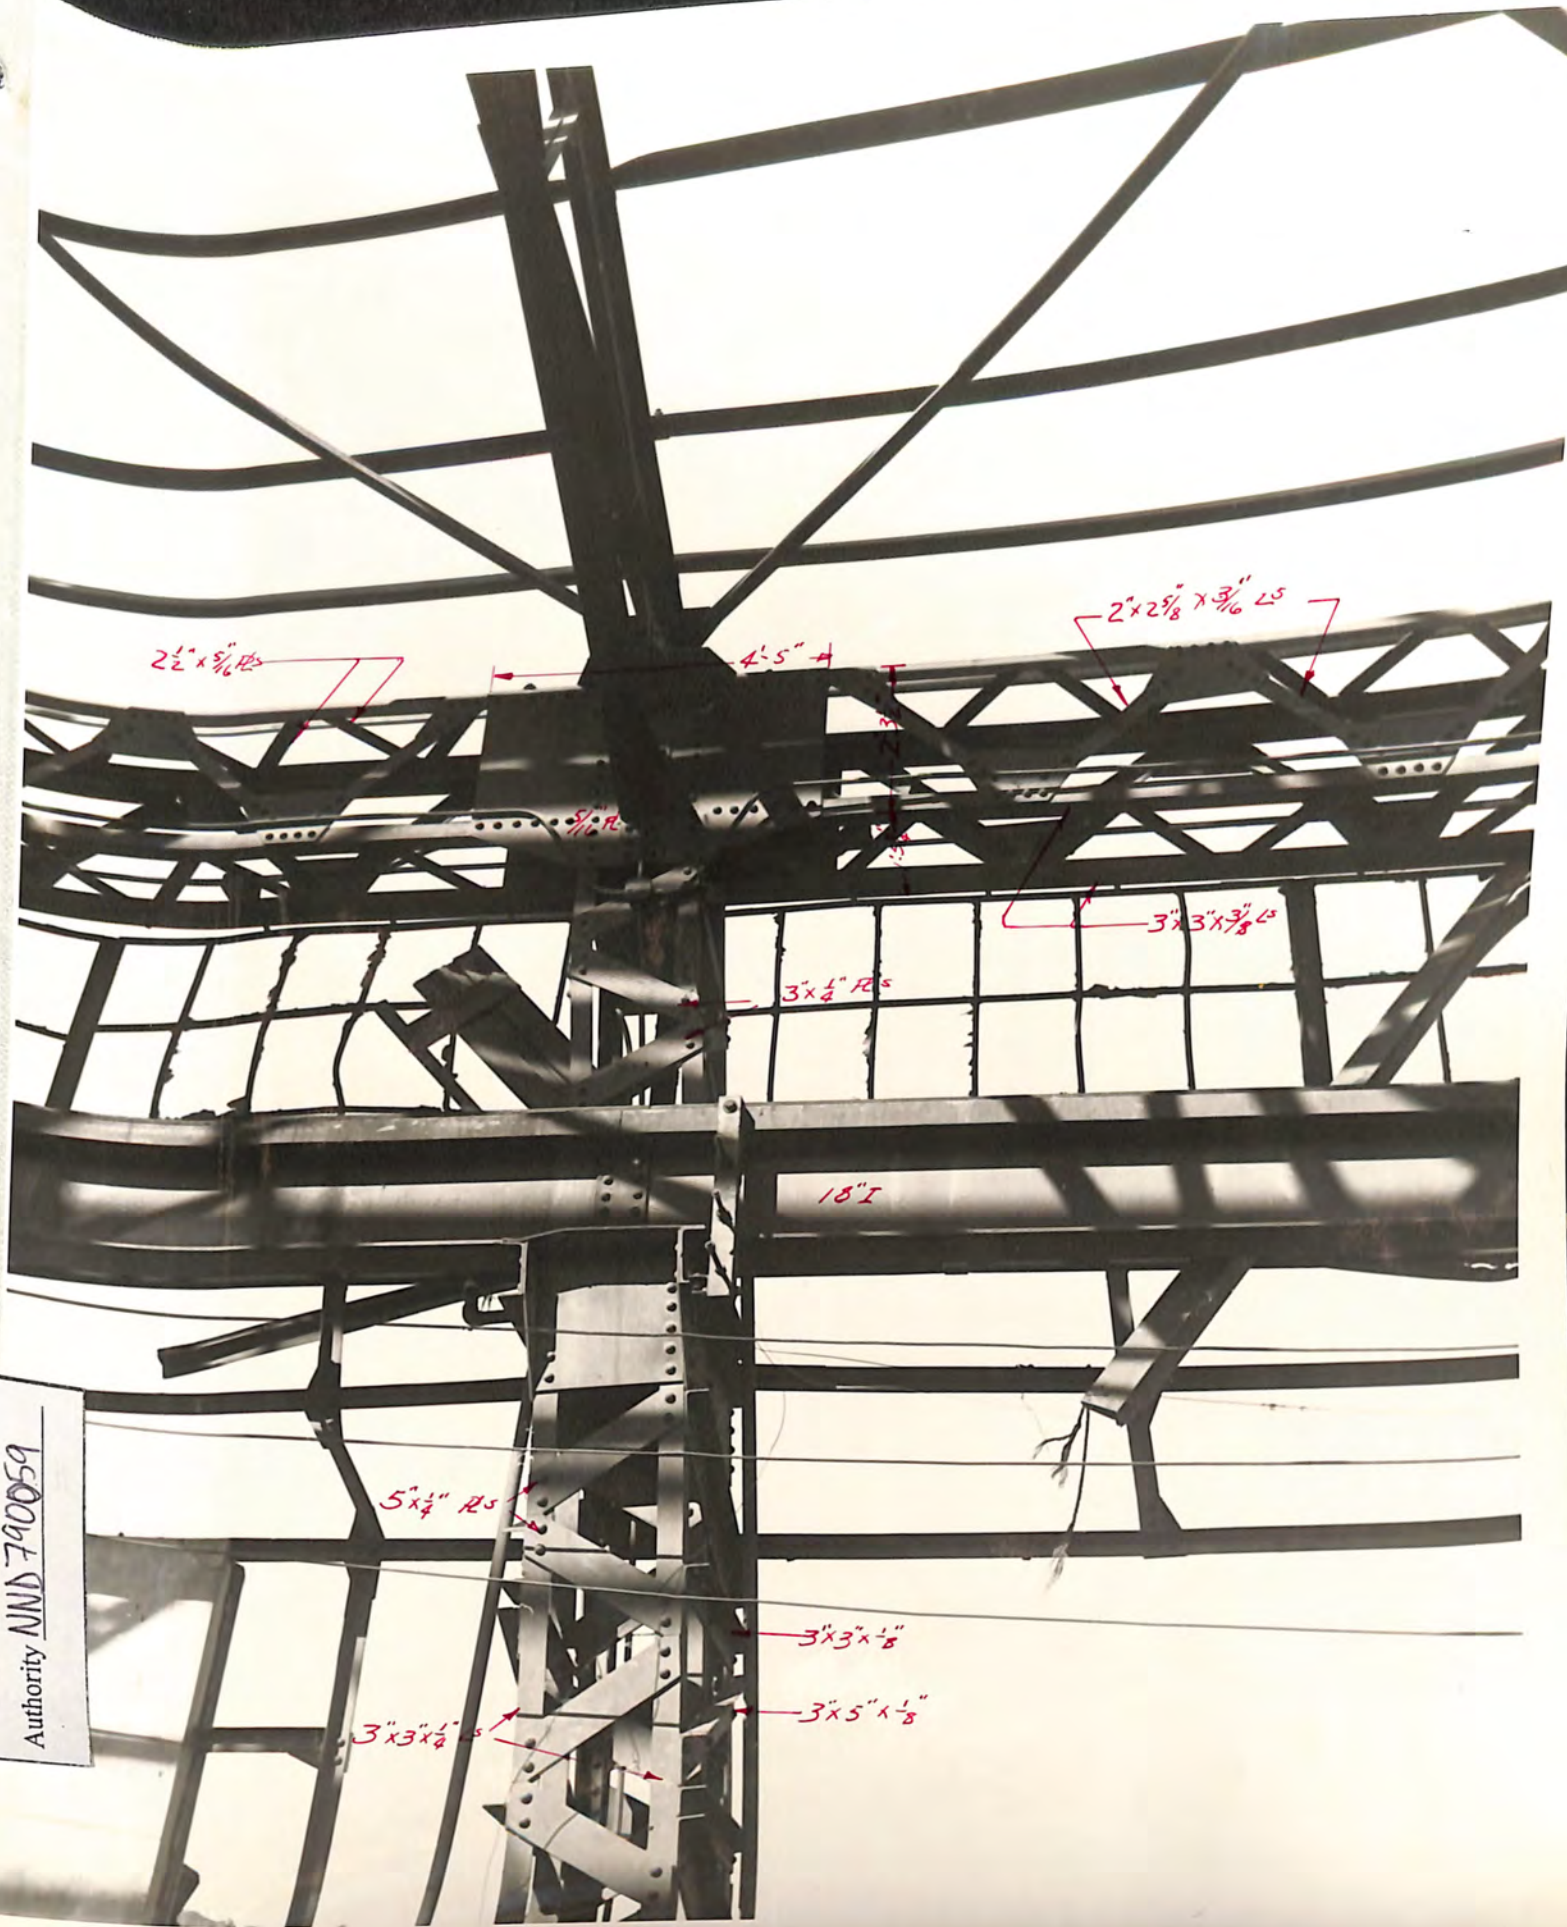
FIGURE 96

Foundry building approximately 0.3 of a mile South of zero point. This view shows a typical column and connections. Note that column consists of six angles laced together with steel straps from the base up to the point where the rail for the overhead crane is supported and that from this point to the roof truss the column is reduced to four angles laced together. The connection to the double truss beam supporting the roof trusses is made secure by the use of heavy gusset plates. It will be noted that the column is buckled at the section consisting of only four angles. This was caused by induced moment as the blast struck the building from the right (in this picture).
