NAGASAKI ATOMIC BOMB DAMAGE  
Nagasaki, Japan

9 August 1945 (Japanese Time)

UNITED STATES  
ATOMIC ENERGY COMMISSION  
OAK RIDGE, TENNESSEE

NAGASAKI ATOMIC BOMB DAMAGE

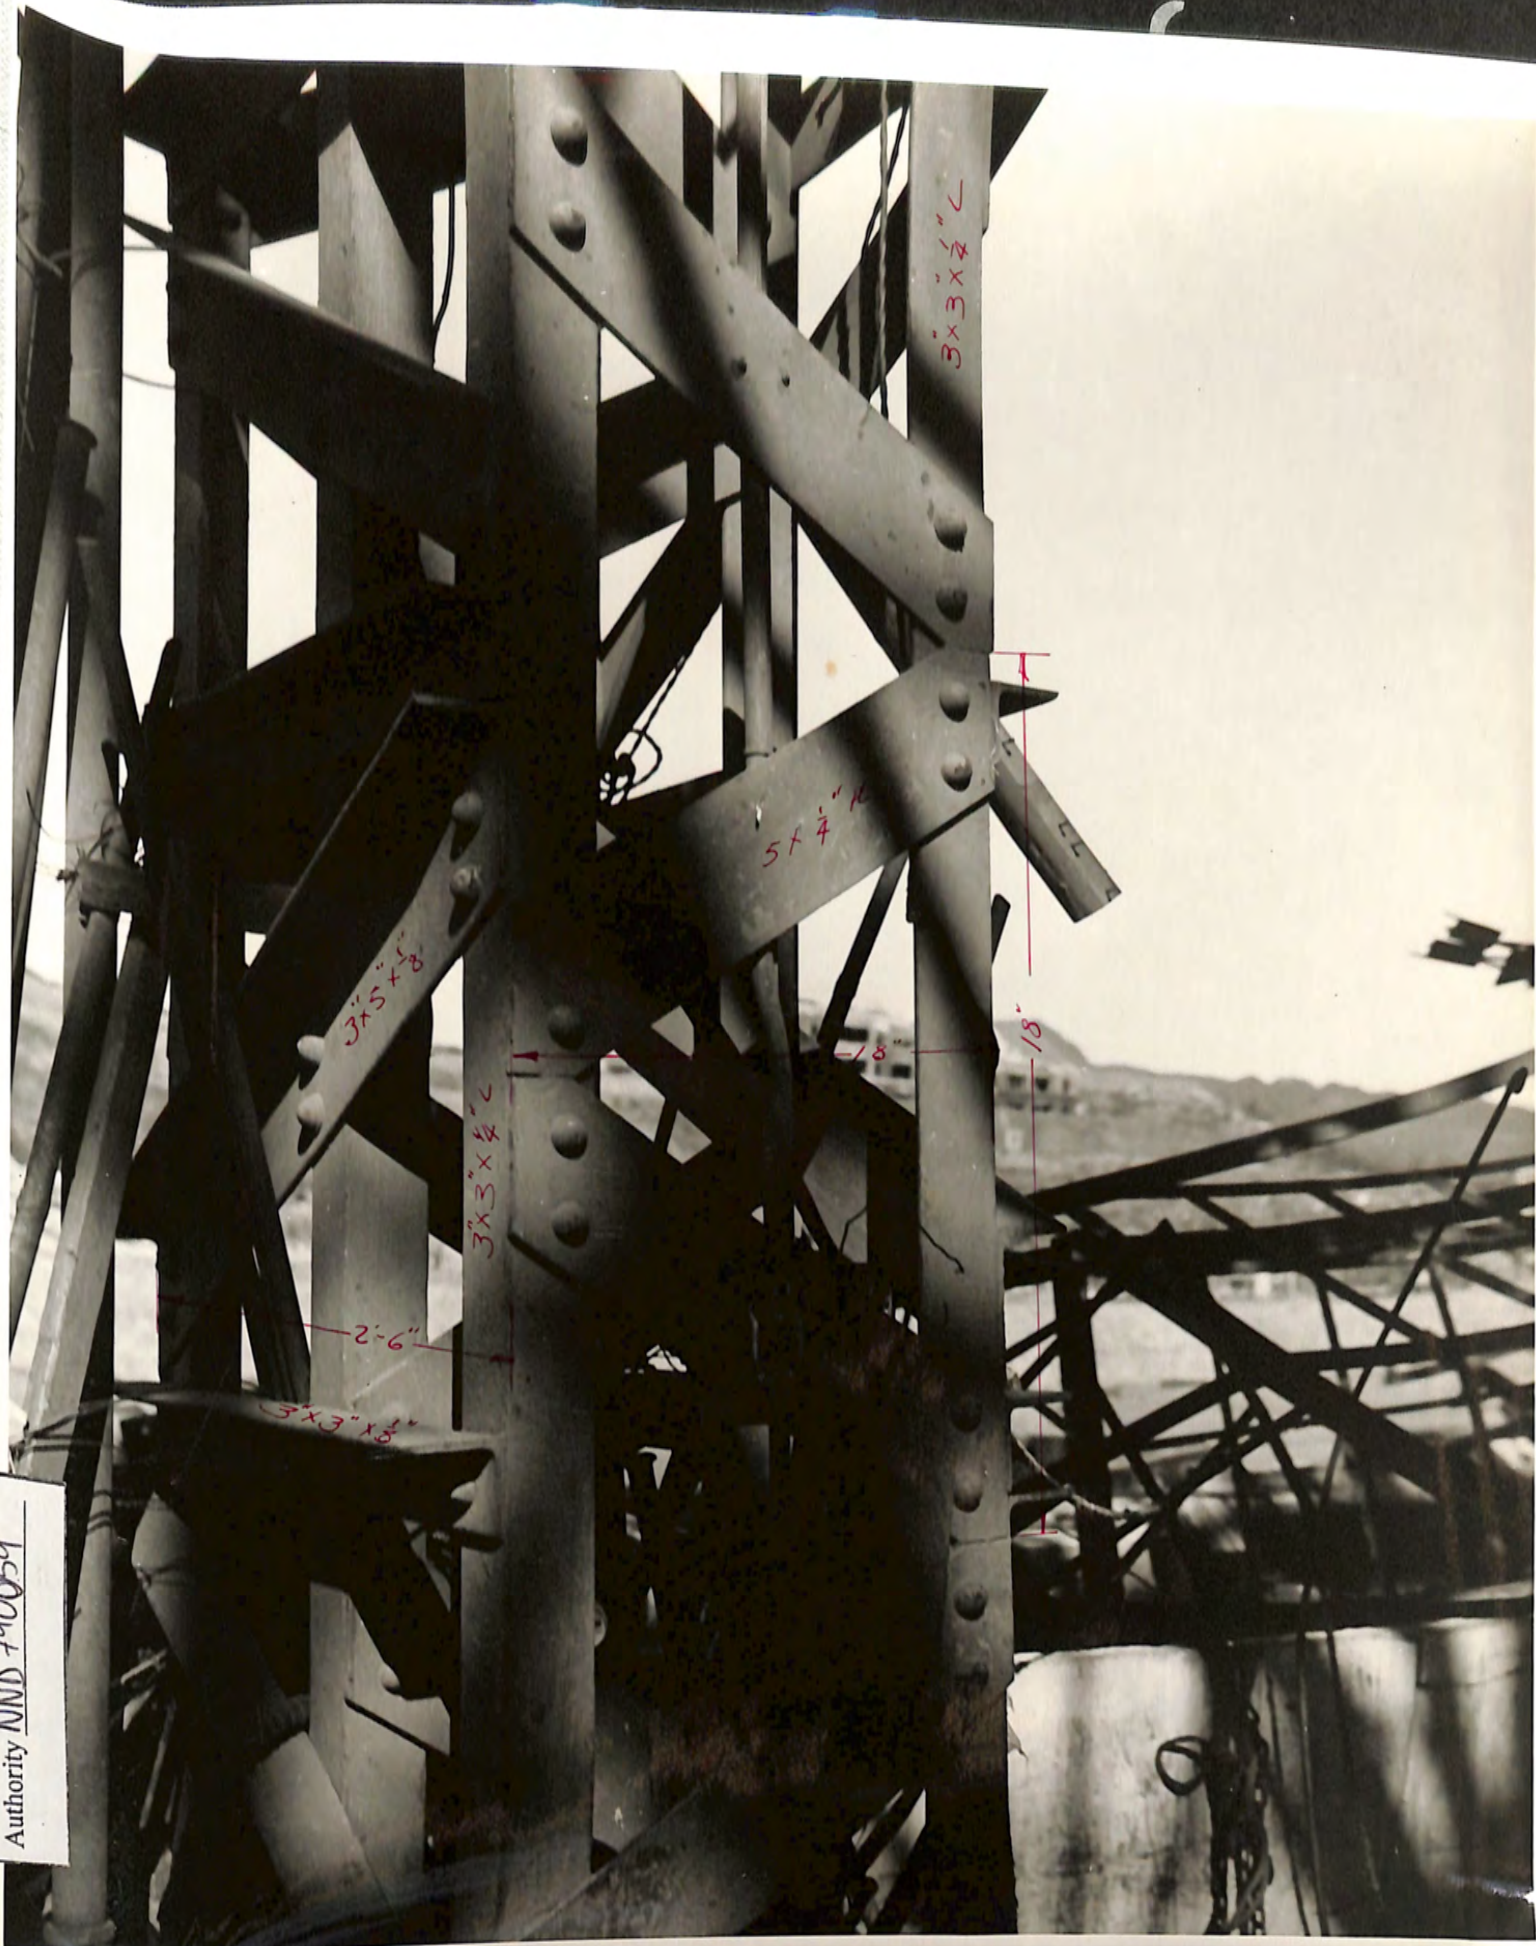
A foundry building approximately 0.3 of a mile from zero point at the North end of the Mitsubishi group. This picture shows a close-up of a typical column. The column is composed of six angles, each 3" x 3" x 1/4", stiffened and laced with 3" x 5" x 1/8" angles and 5" x 1/4" plates. This type of built-up column requires a great deal of time and labor for fabrication, but the Japanese were very short of steel and they probably used this type of construction since it requires less material than other types.

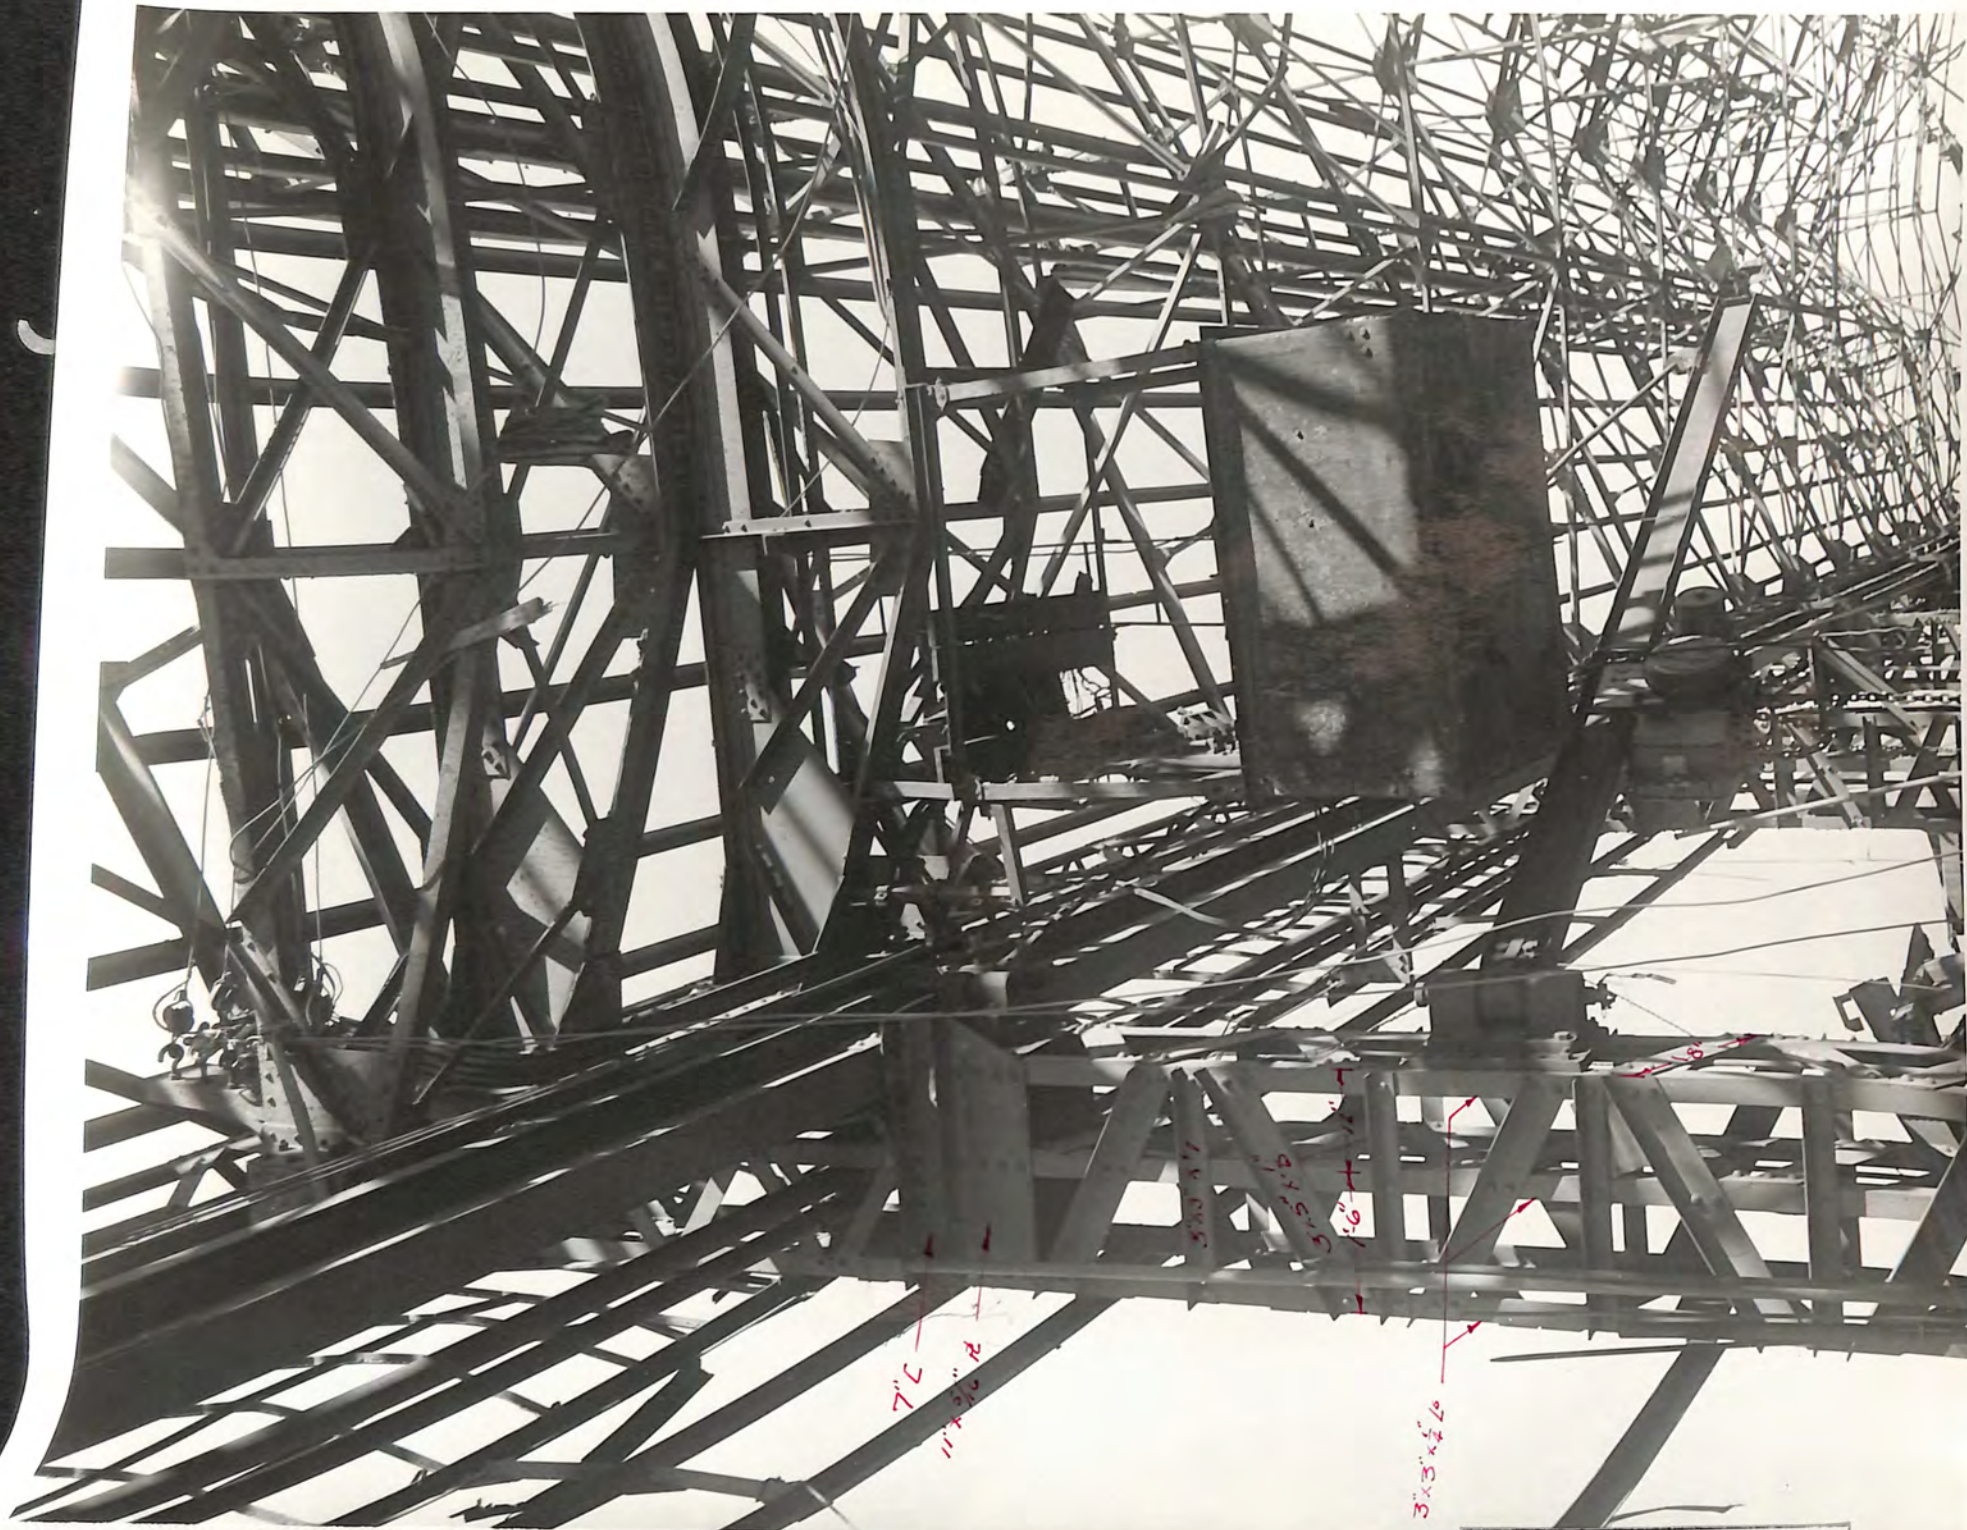
FIGURE 98

A foundry building approximately 0.3 of a mile from zero point. This view shows typical columns along the West side of the building. Note that the rail for the overhead crane is carried by the columns and that from the rail to the roof truss, the column is reduced in size from six angles laced together to four angles laced together. Also, note that corrugated asbestos roof and siding have been stripped by the force of the Atomic blast and that all windows have been knocked out.

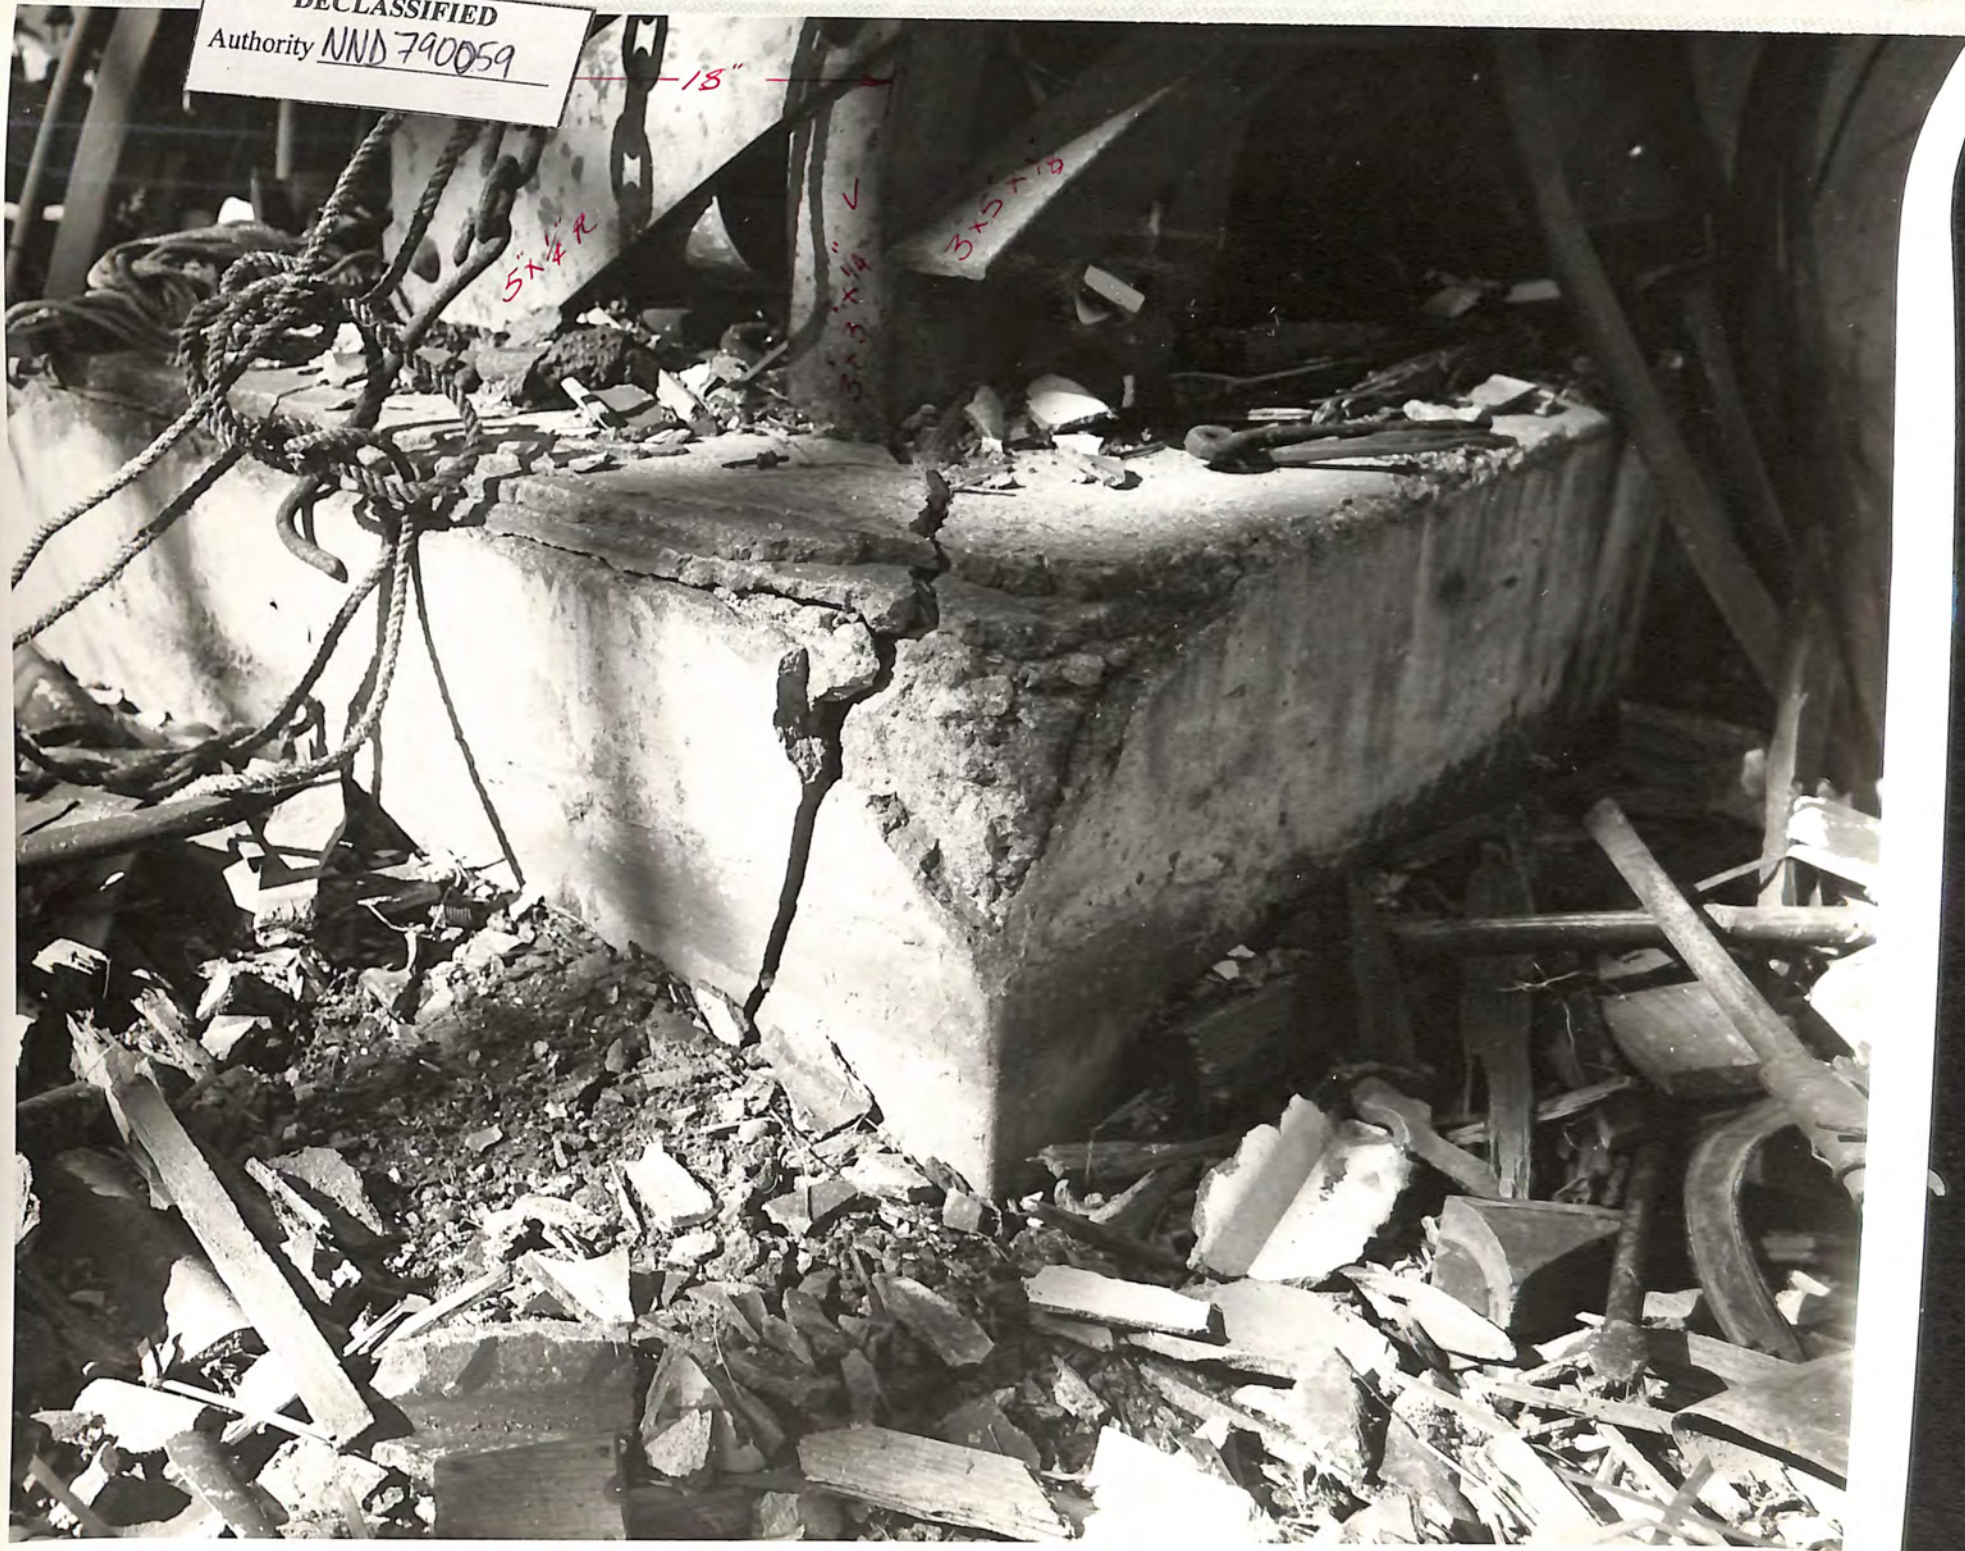
A foundry building approximately 0.3 of a mile from zero point. This is a close-up of the concrete foundation for a typical structural steel column, showing crack caused by induced moment which resulted from the blast, acting from the right (in this picture). In those instances where the foundation did not crack as shown here, the concrete foundation was rotated; that is, it was caused to rise on one side and to lower on the other side. Note the small pieces of corrugated asbestos roofing and siding broken by the blast. Also, note the large amount of combustible matter and tinder which did not burn or char even though relatively close to zero point.

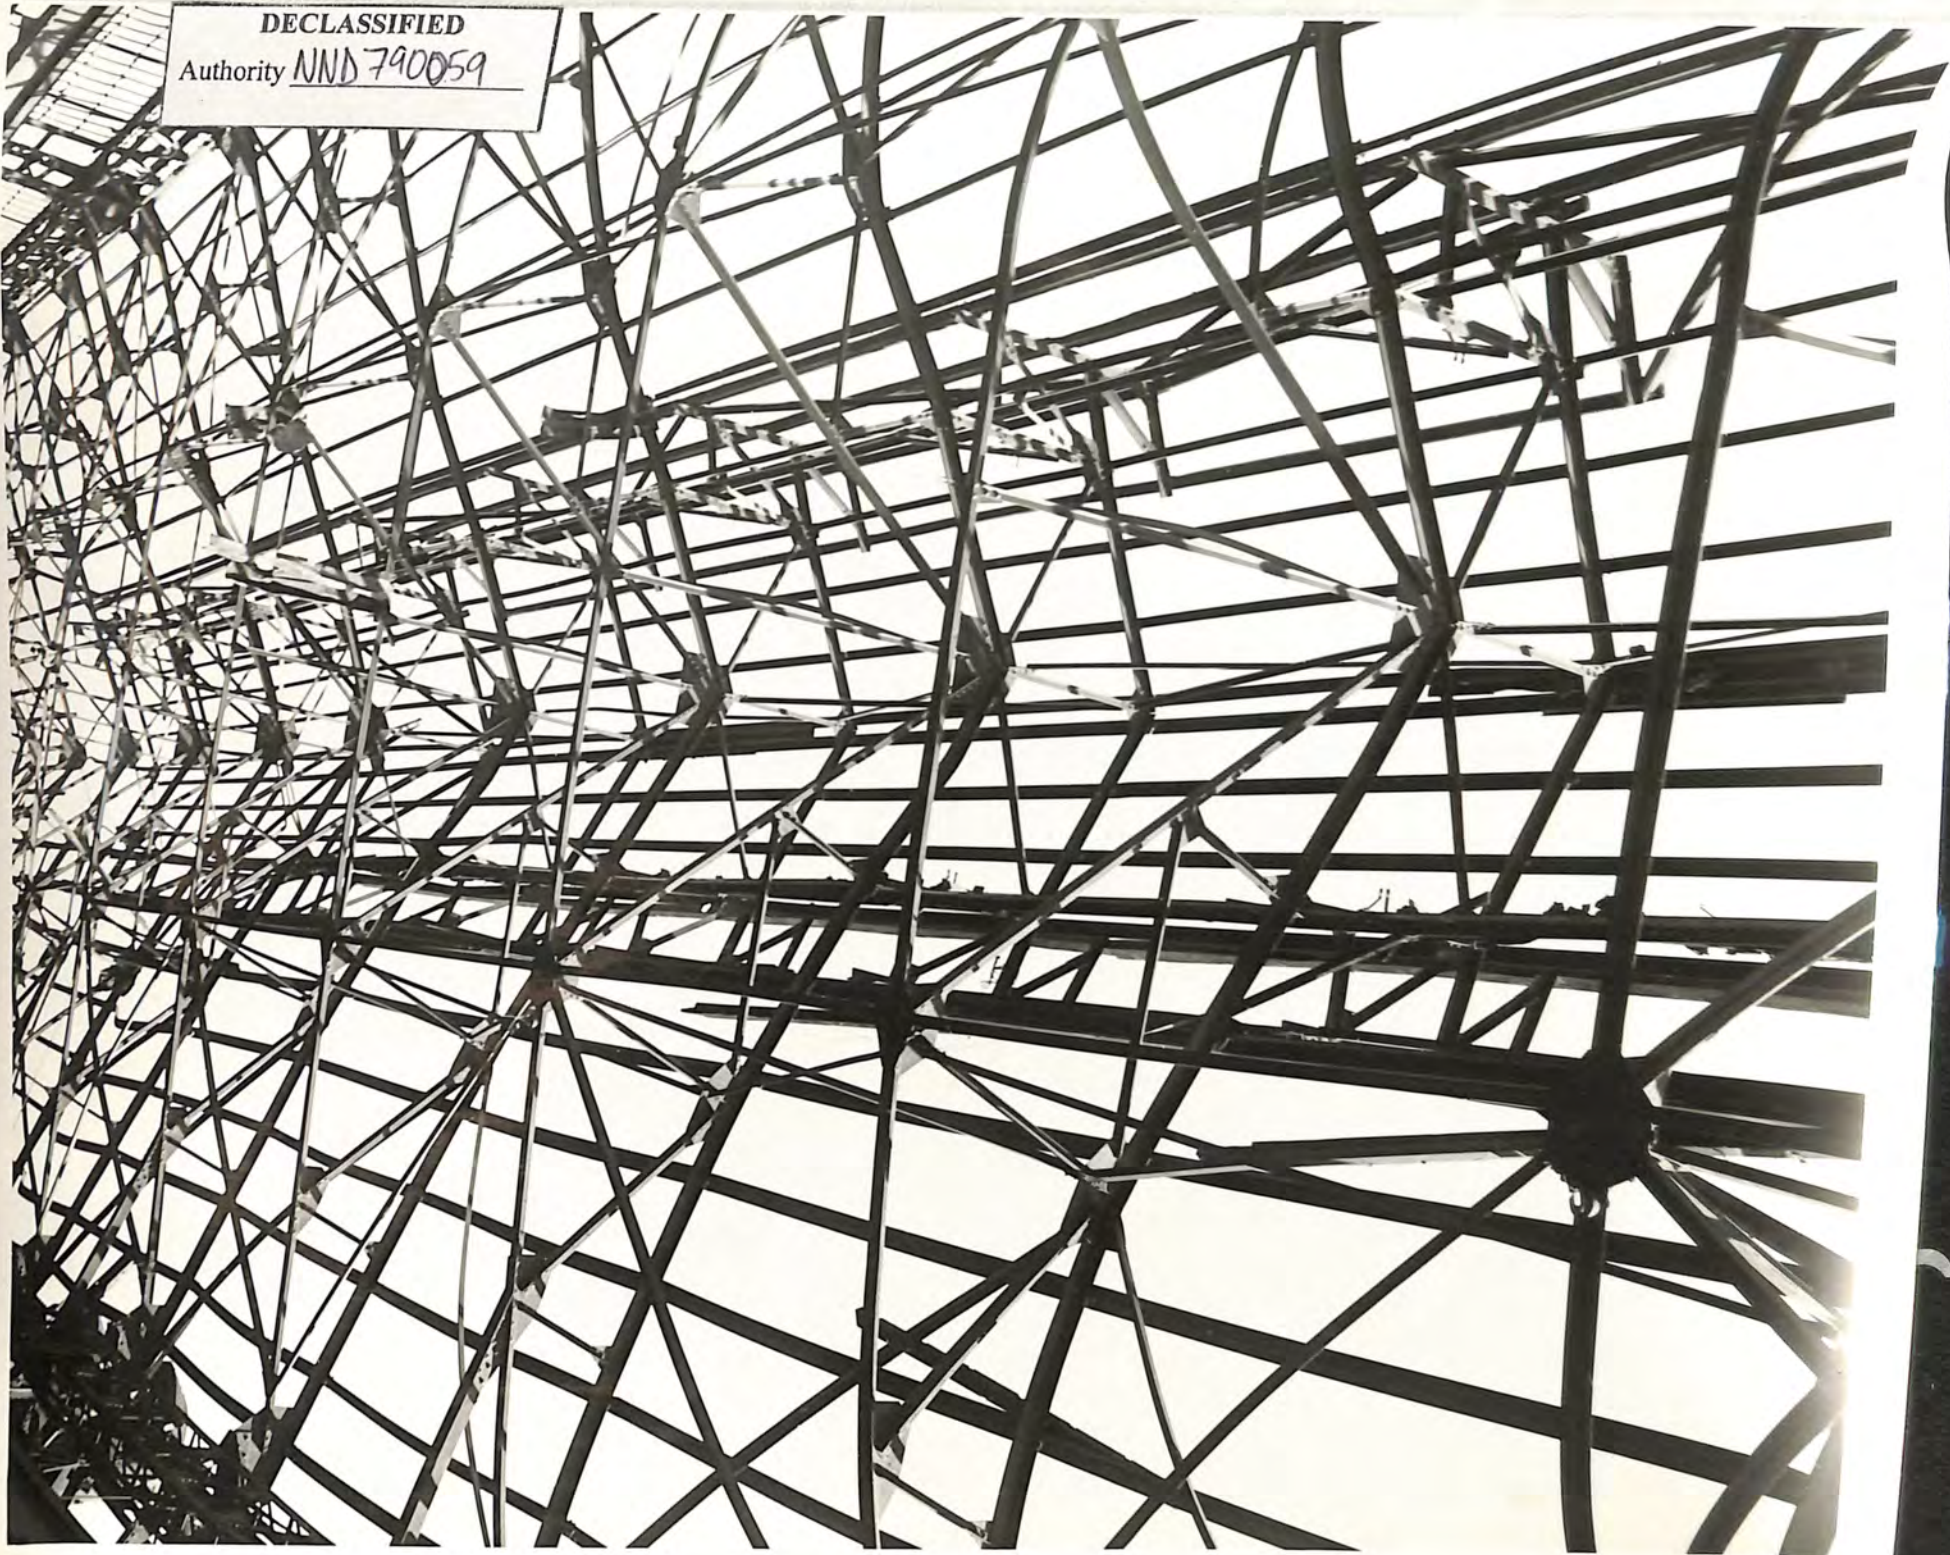
A foundry building approximately 0.3 miles from zero point. This is a general view looking up to the steel roof trusses. Note that while the corrugated asbestos roofing has been stripped by the blast and some of the steel purlins have been bent, the roof trusses themselves suffered only minor damage.

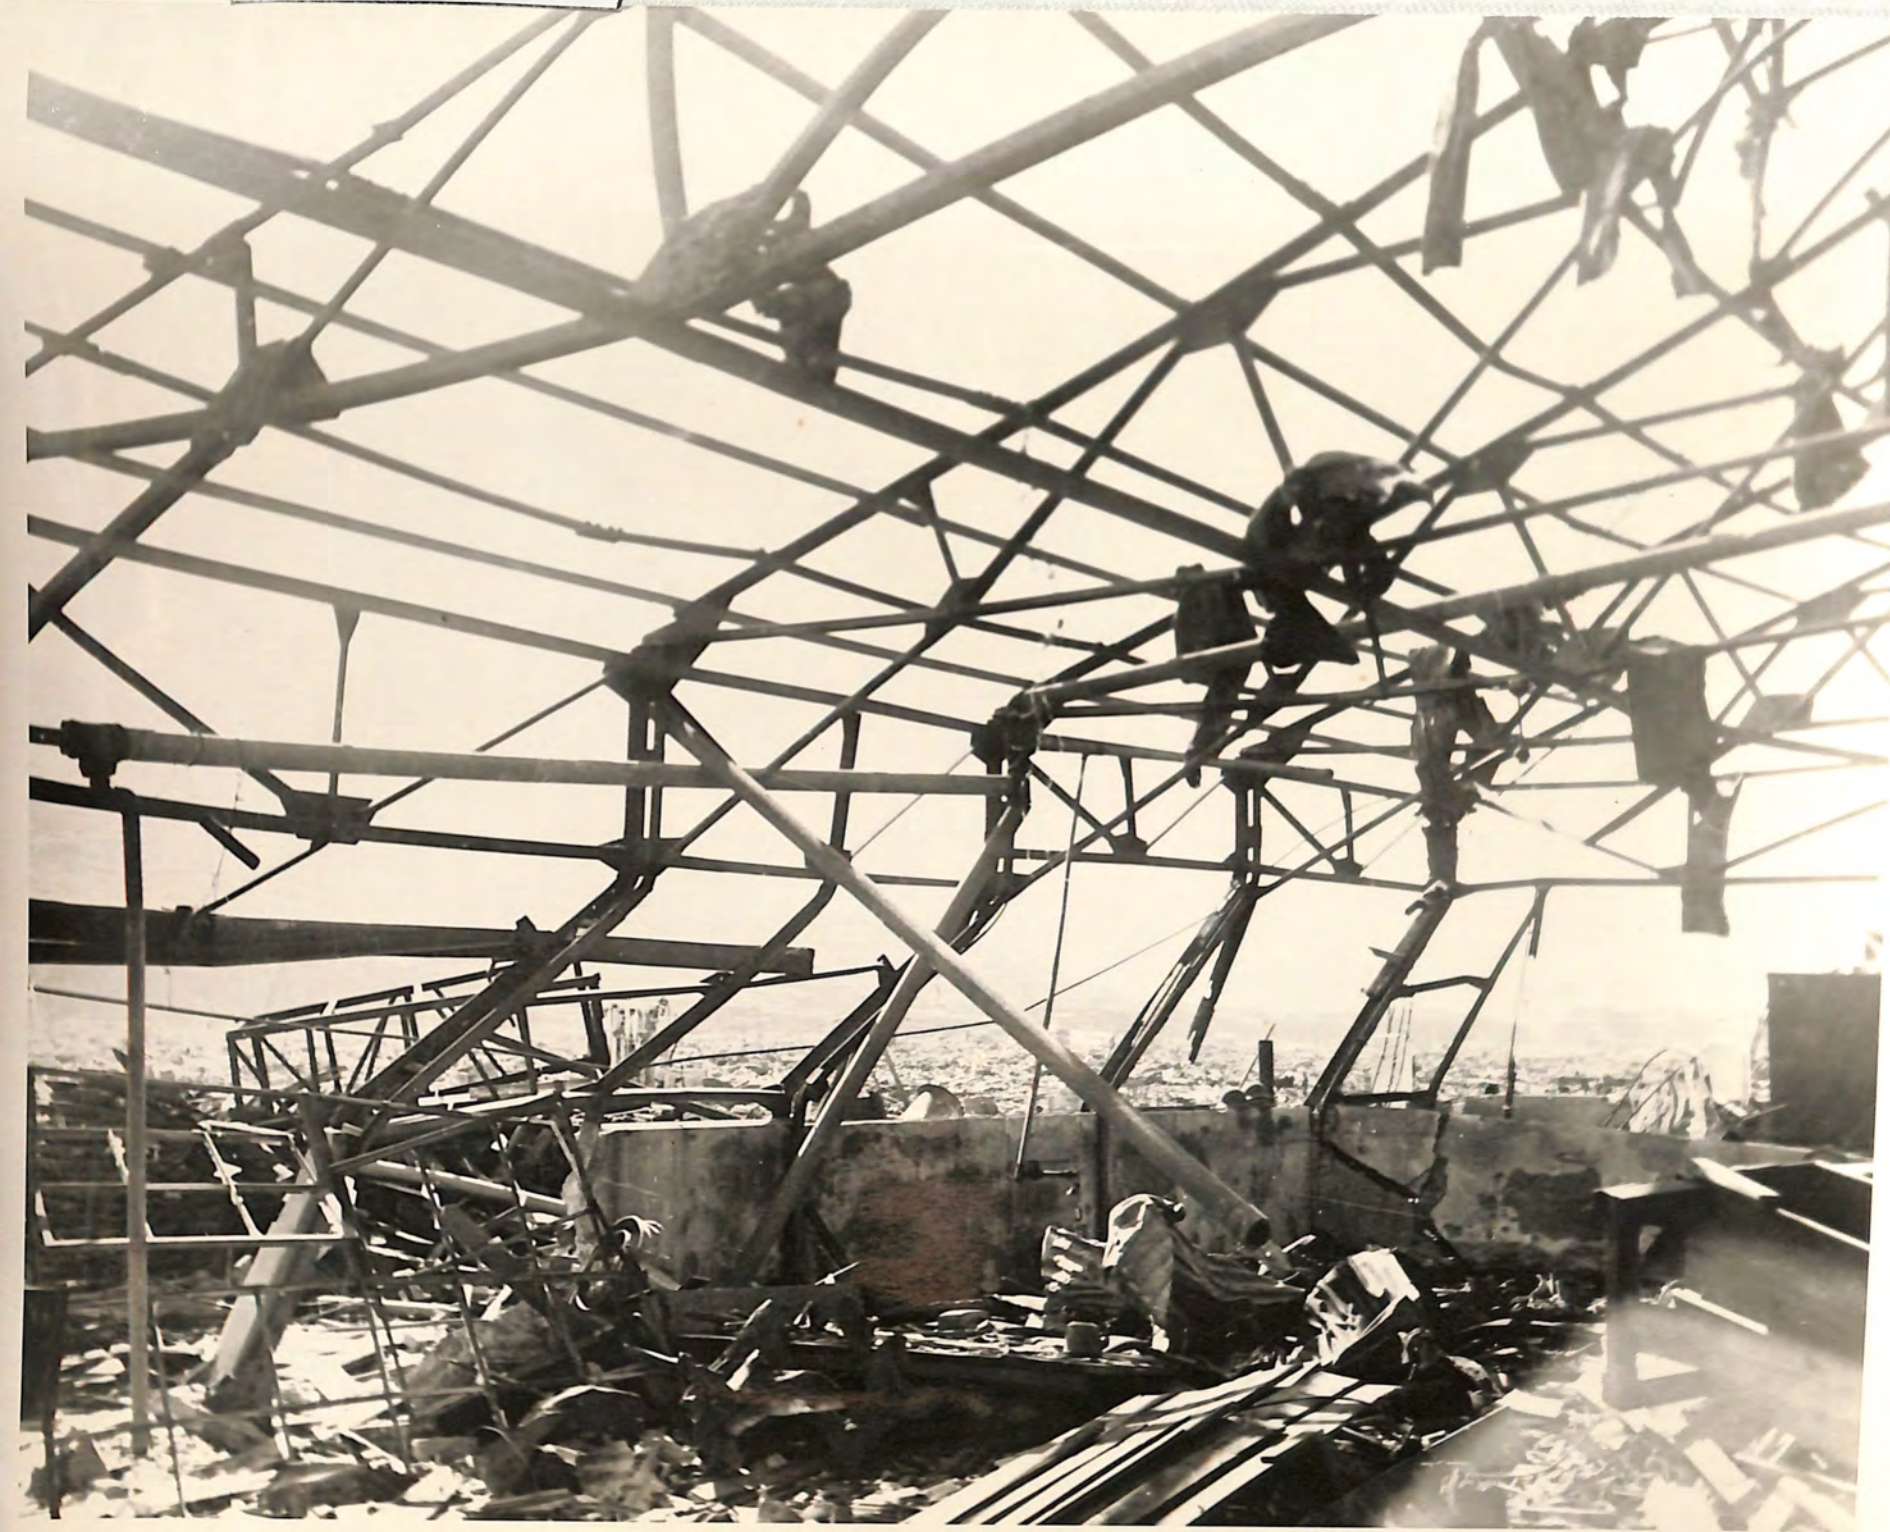
Foundry building approximately 0.3 of a mile from zero point.  
This view shows the light steel construction in the furnace room.  
Note how the wall columns failed at the tops and bottoms from  
negative moment induced by the blast.

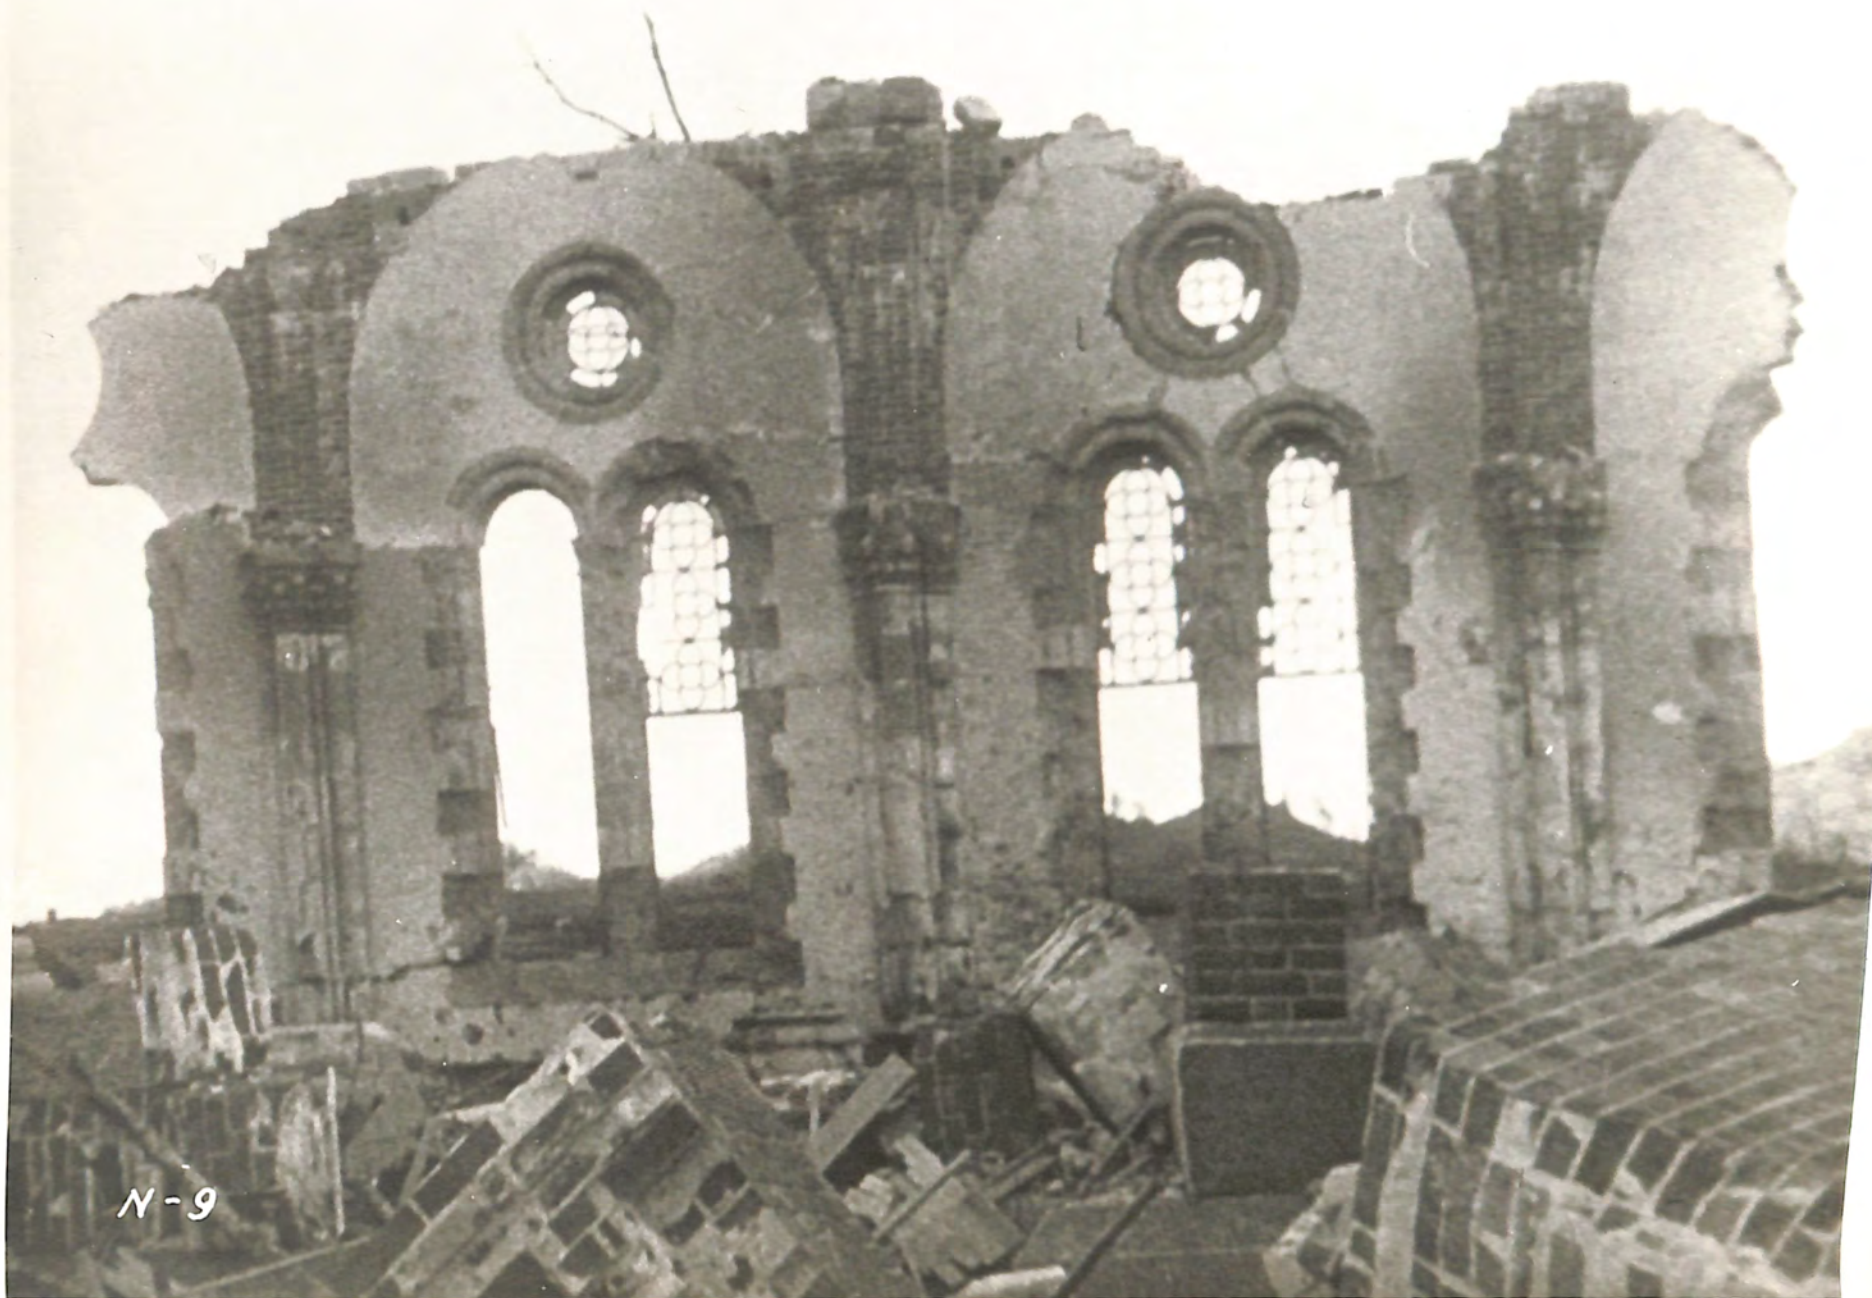
FIGURE 104

General view of wreckage. The large expanse of walls with few openings offered great resistance to the blast wave and contributed to the failure even though the walls were massive brick.

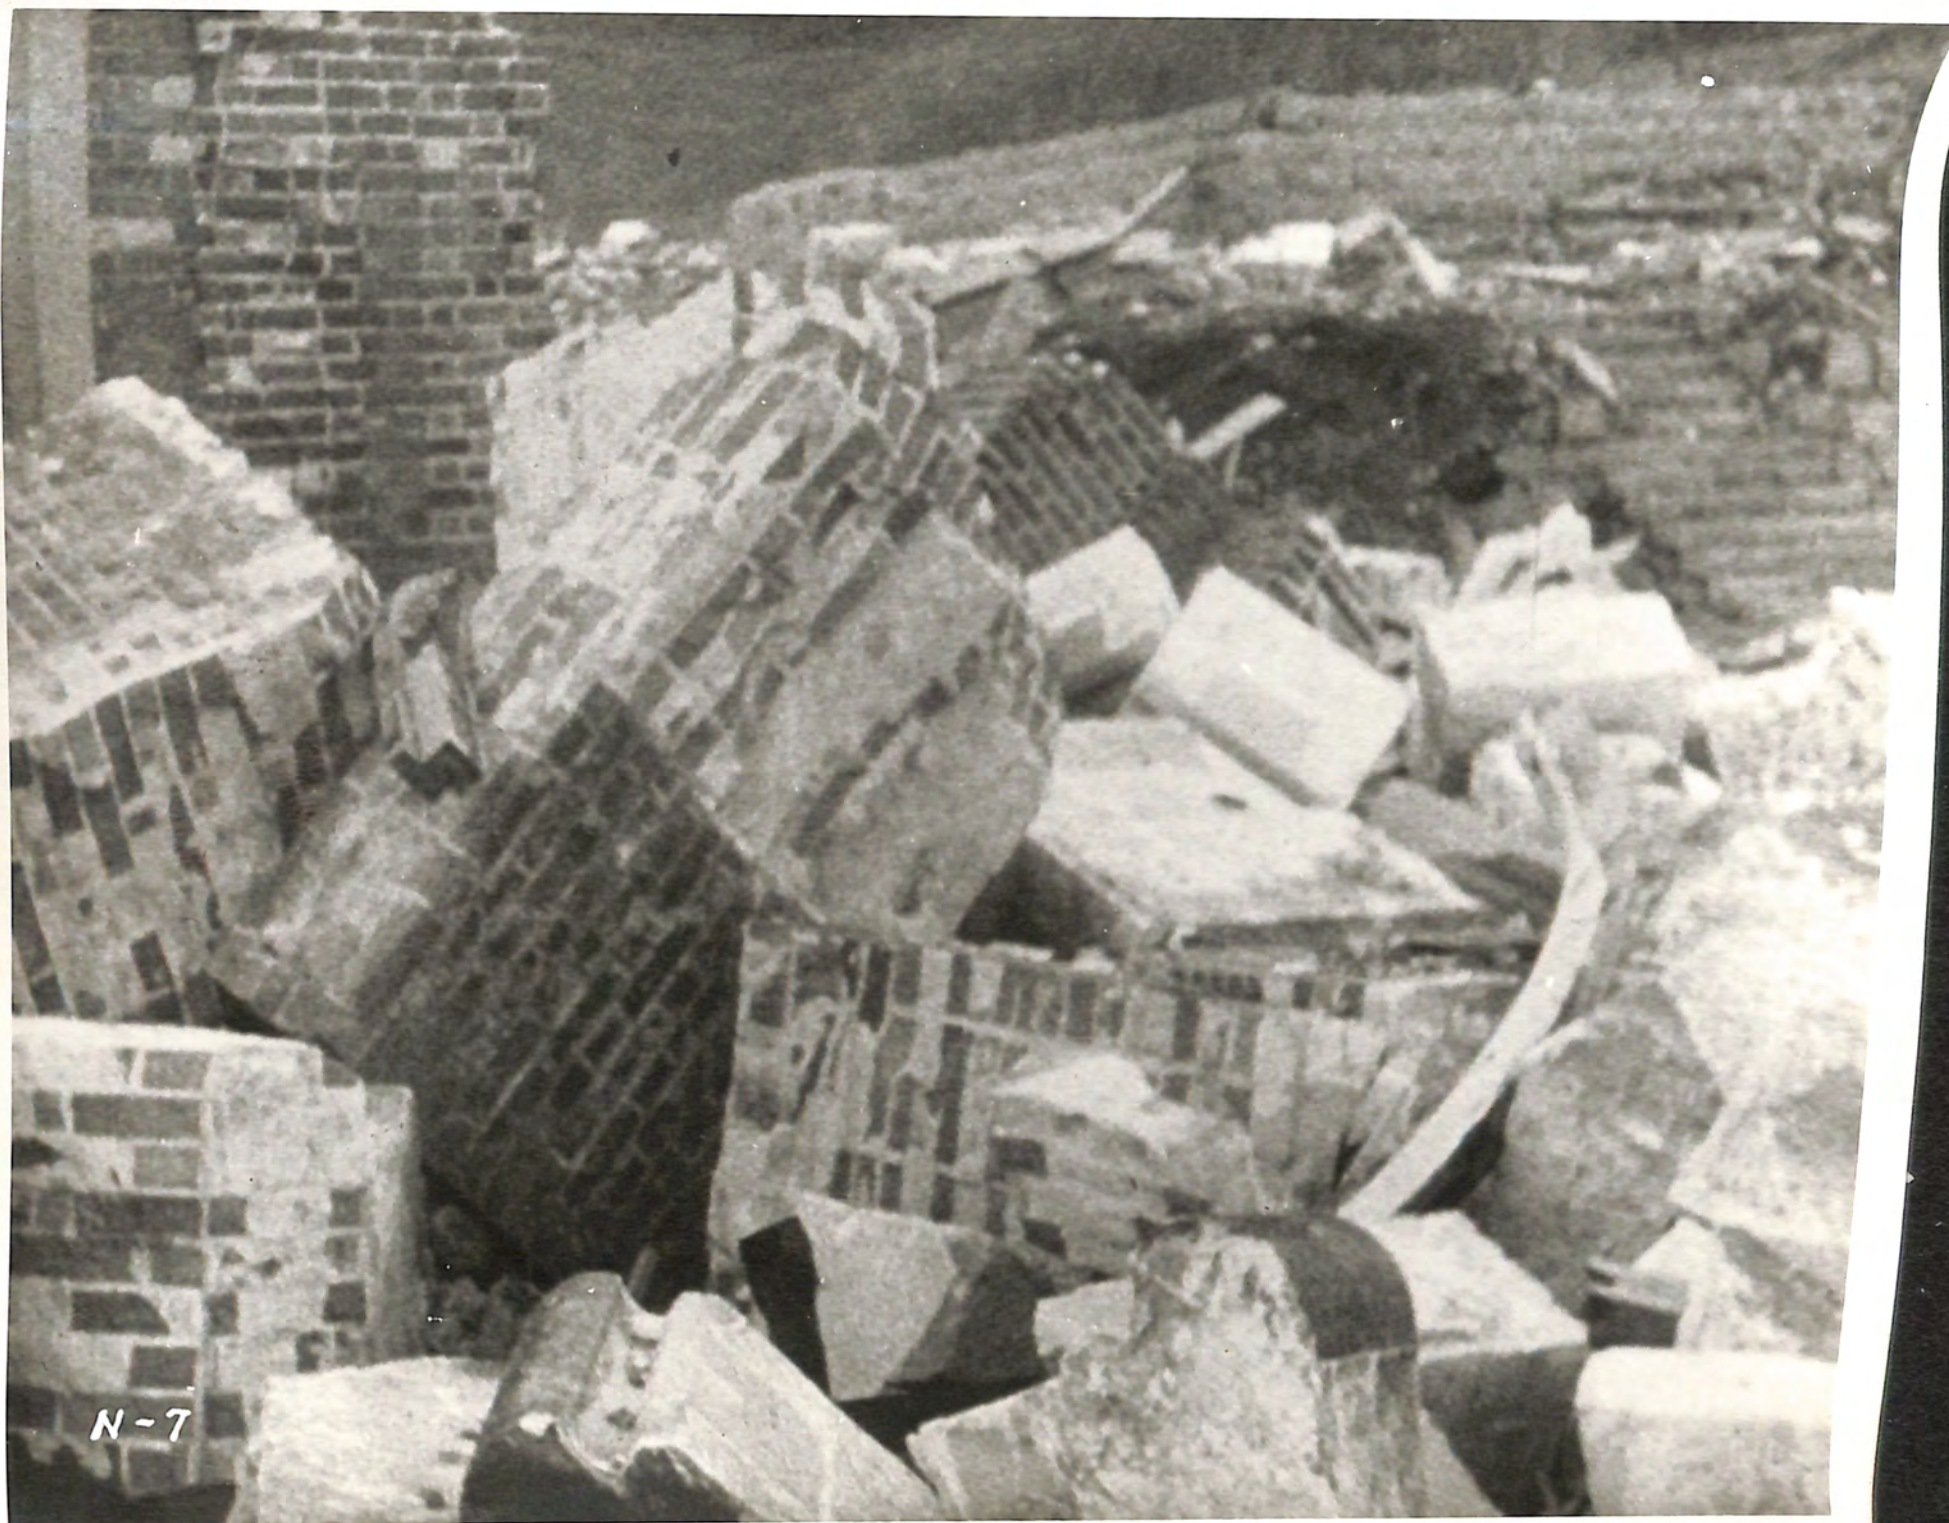
FIGURE 105

Close-up of a wall left standing, showing failure of heavy masonry (brick) construction.
