NAGASAKI ATOMIC BOMB DAMAGE  
Nagasaki, Japan

9 August 1945 (Japanese Time)

UNITED STATES  
ATOMIC ENERGY COMMISSION  
OAK RIDGE, TENNESSEE

NAGASAKI ATOMIC BOMB DAMAGE

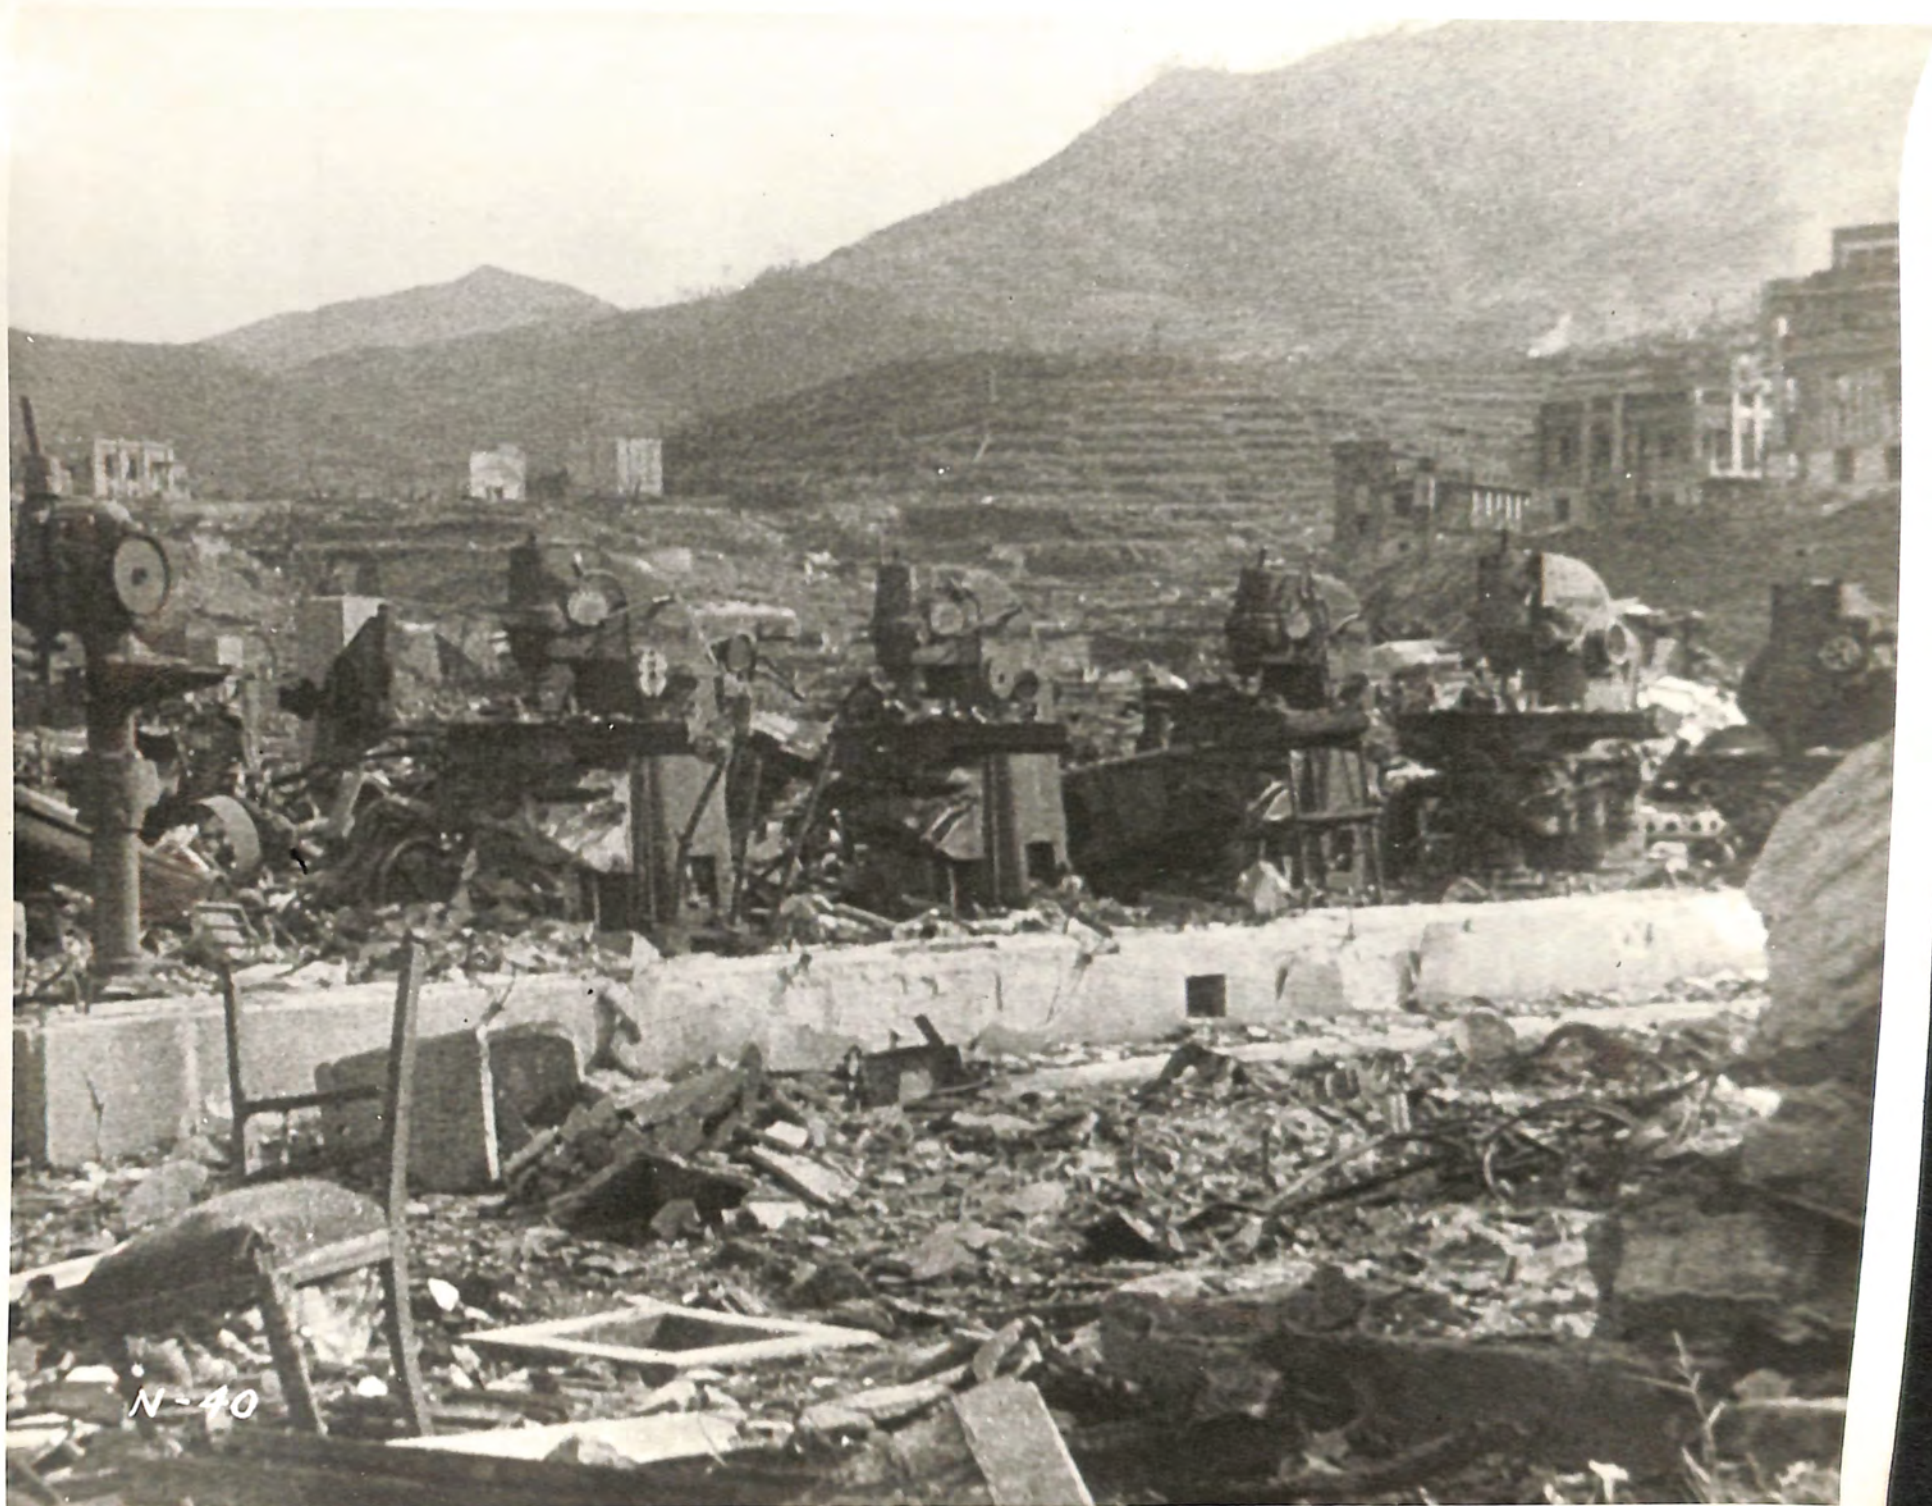
FIGURE 108

The remains of a small factory, probably of masonry construction. Masonry buildings were completely wrecked or seriously damaged by the blast.

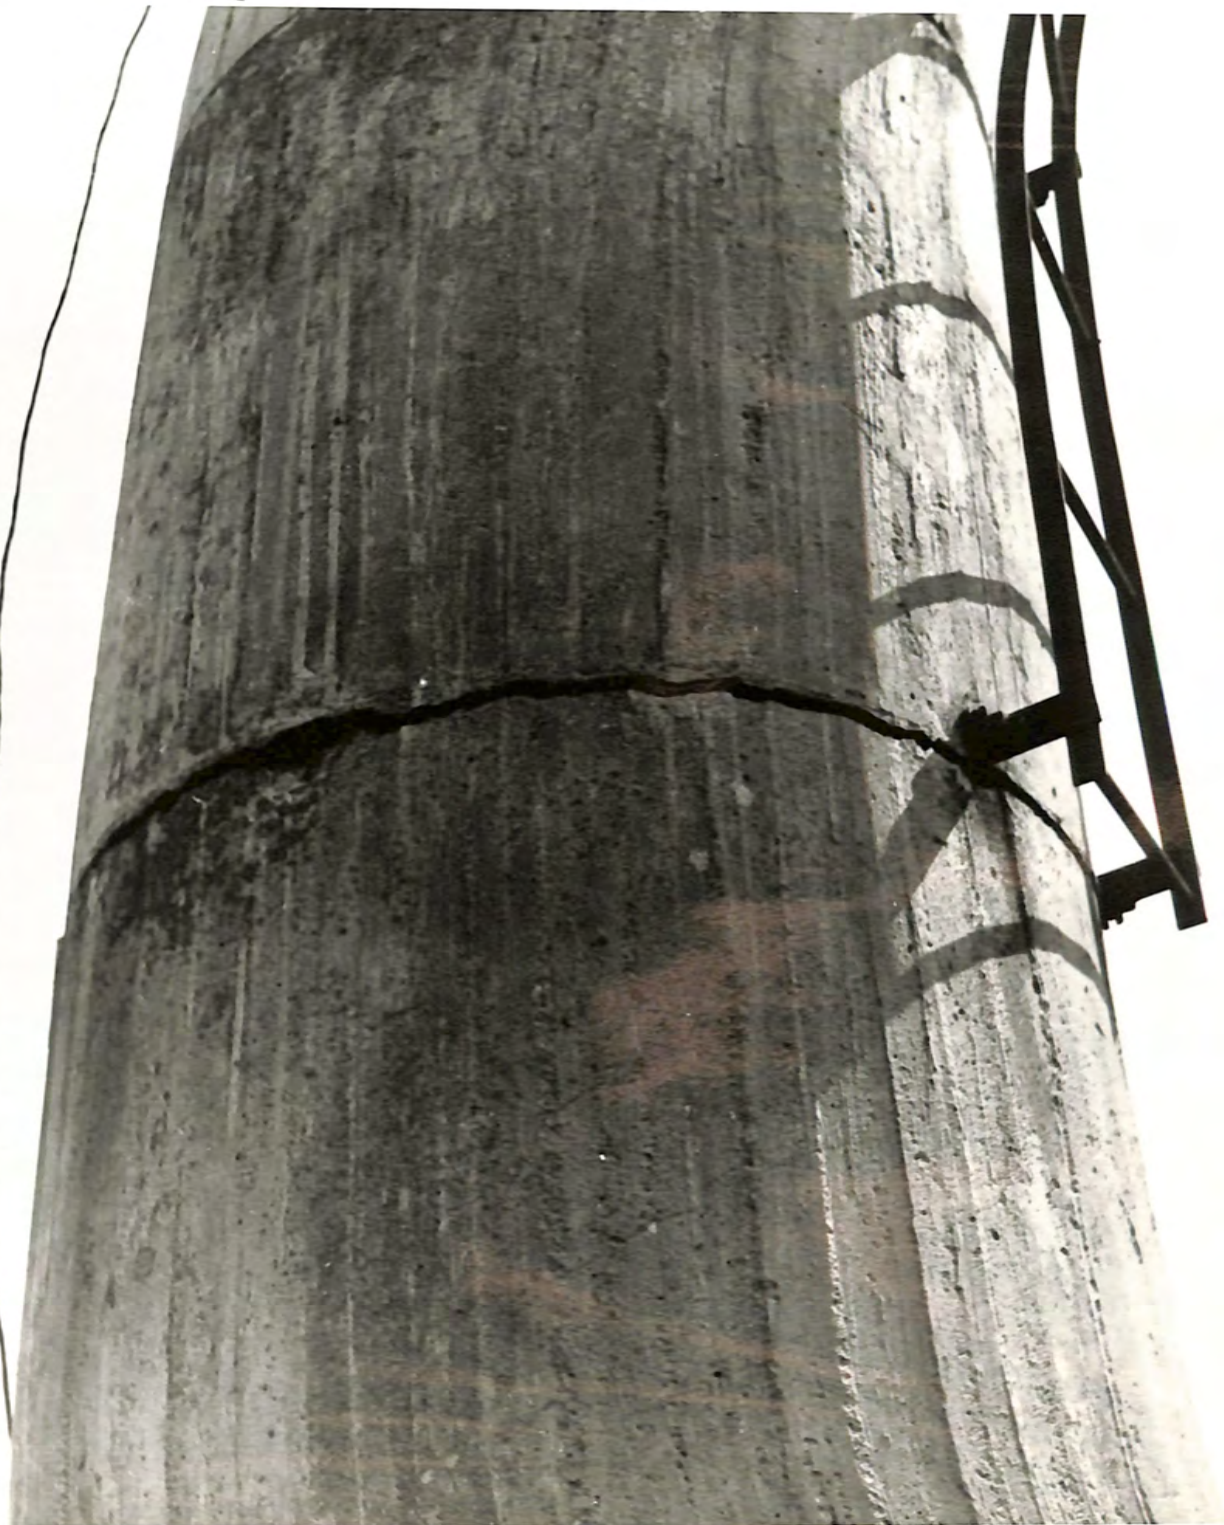
Close-up of reinforced concrete chimney showing horizontal crack caused by the blast. Also, note spalling (chipping out) of concrete.

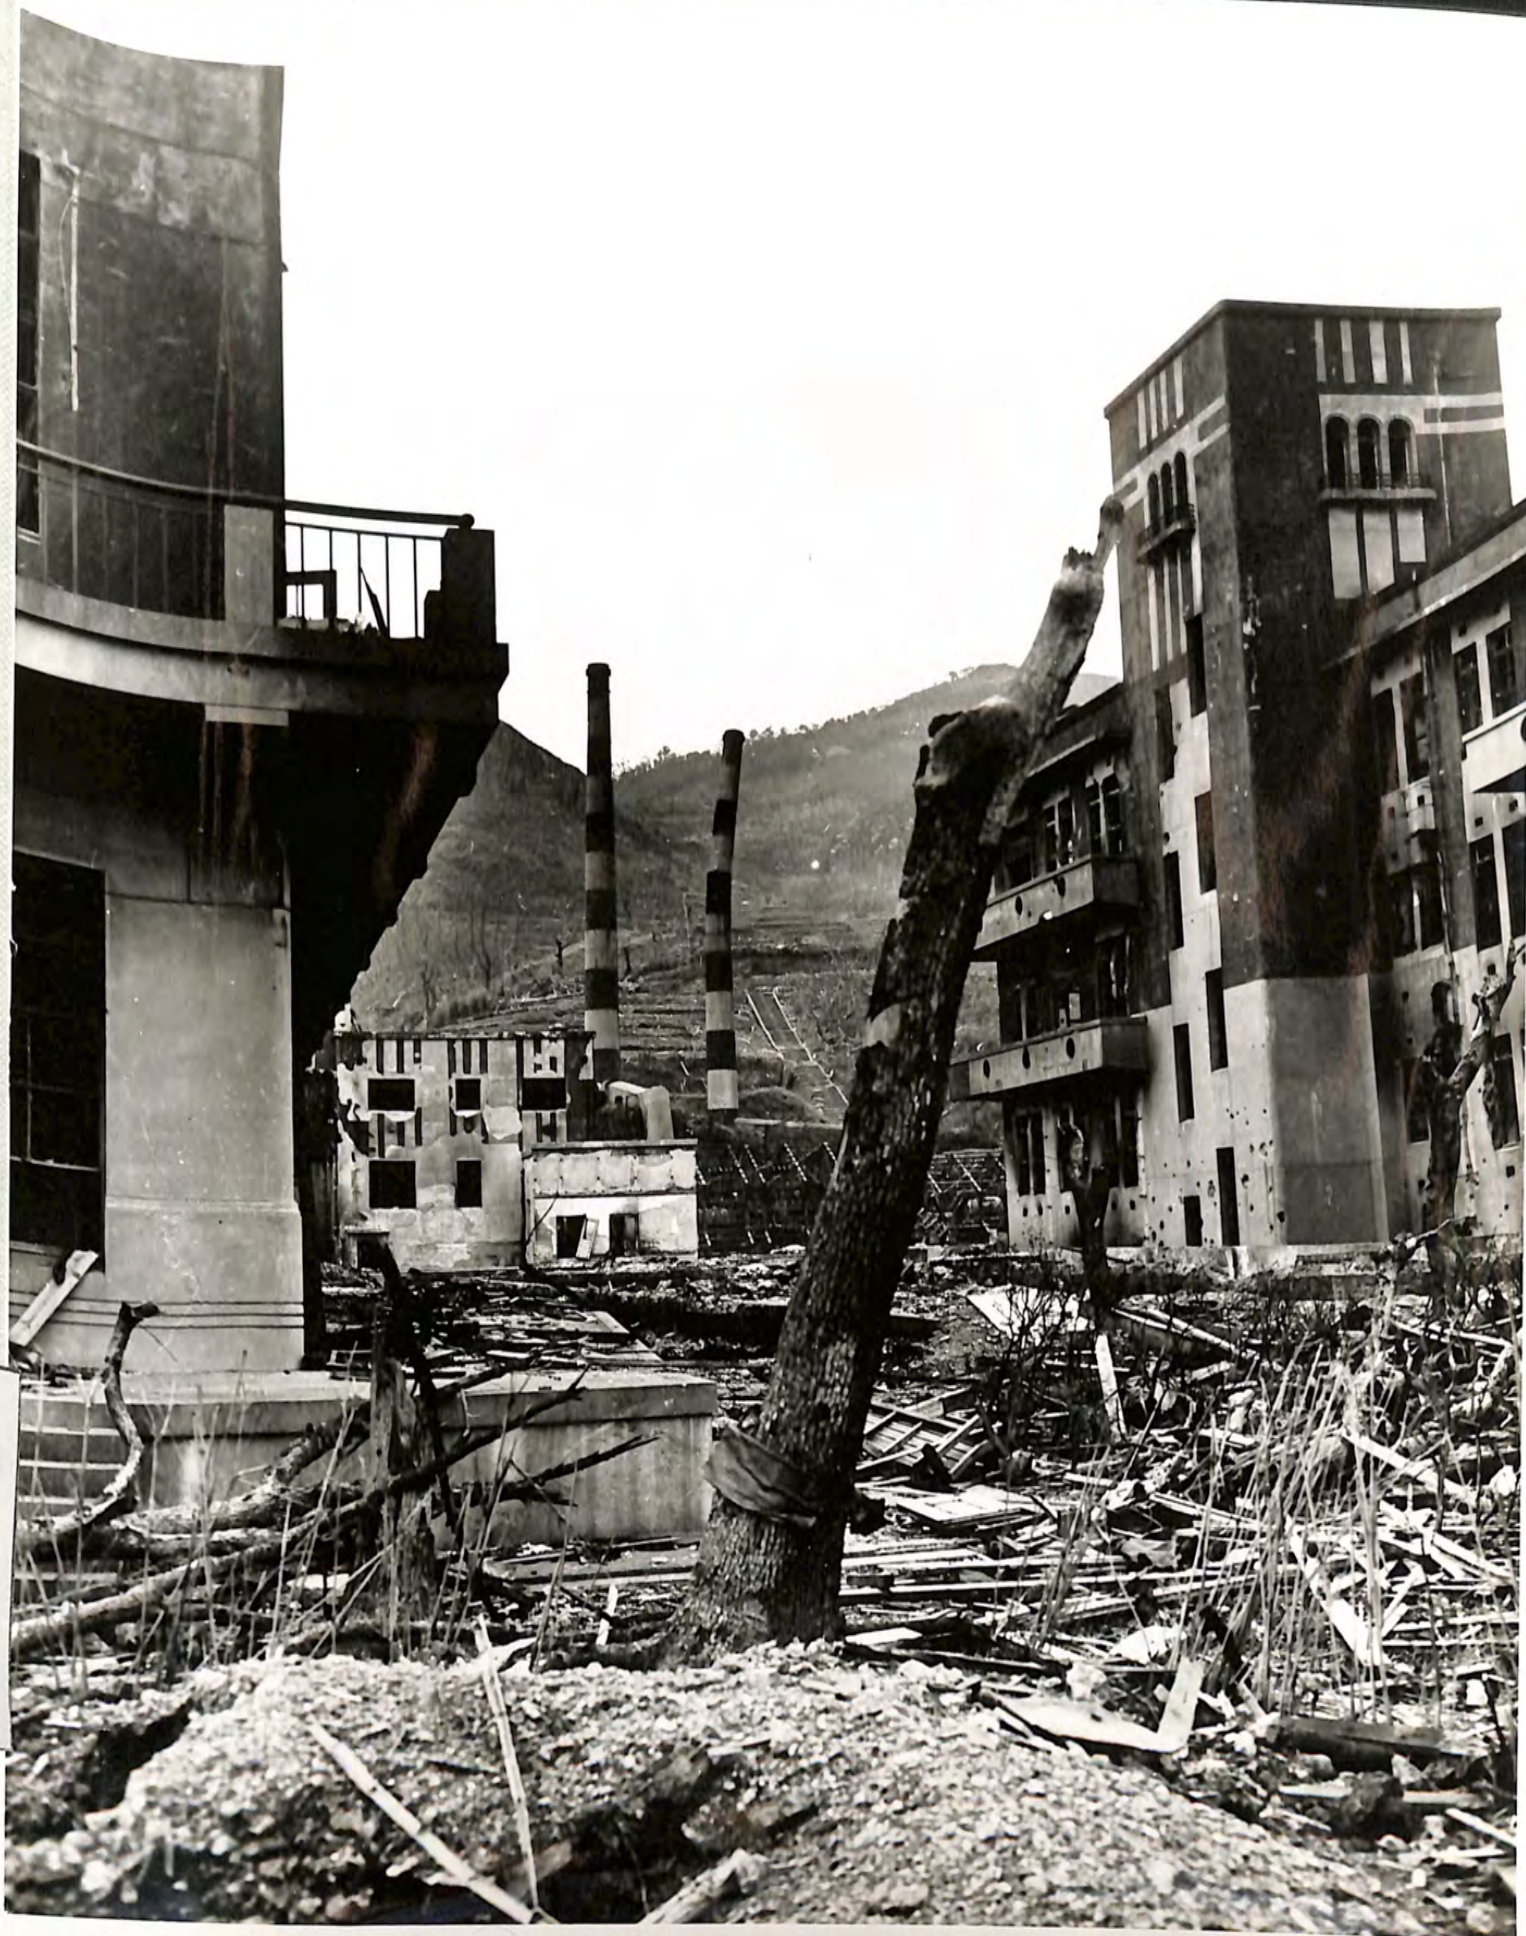
Reinforced concrete chimney broken off by the Atomic blast. Note foundations of wooden building destroyed by blast and fire.

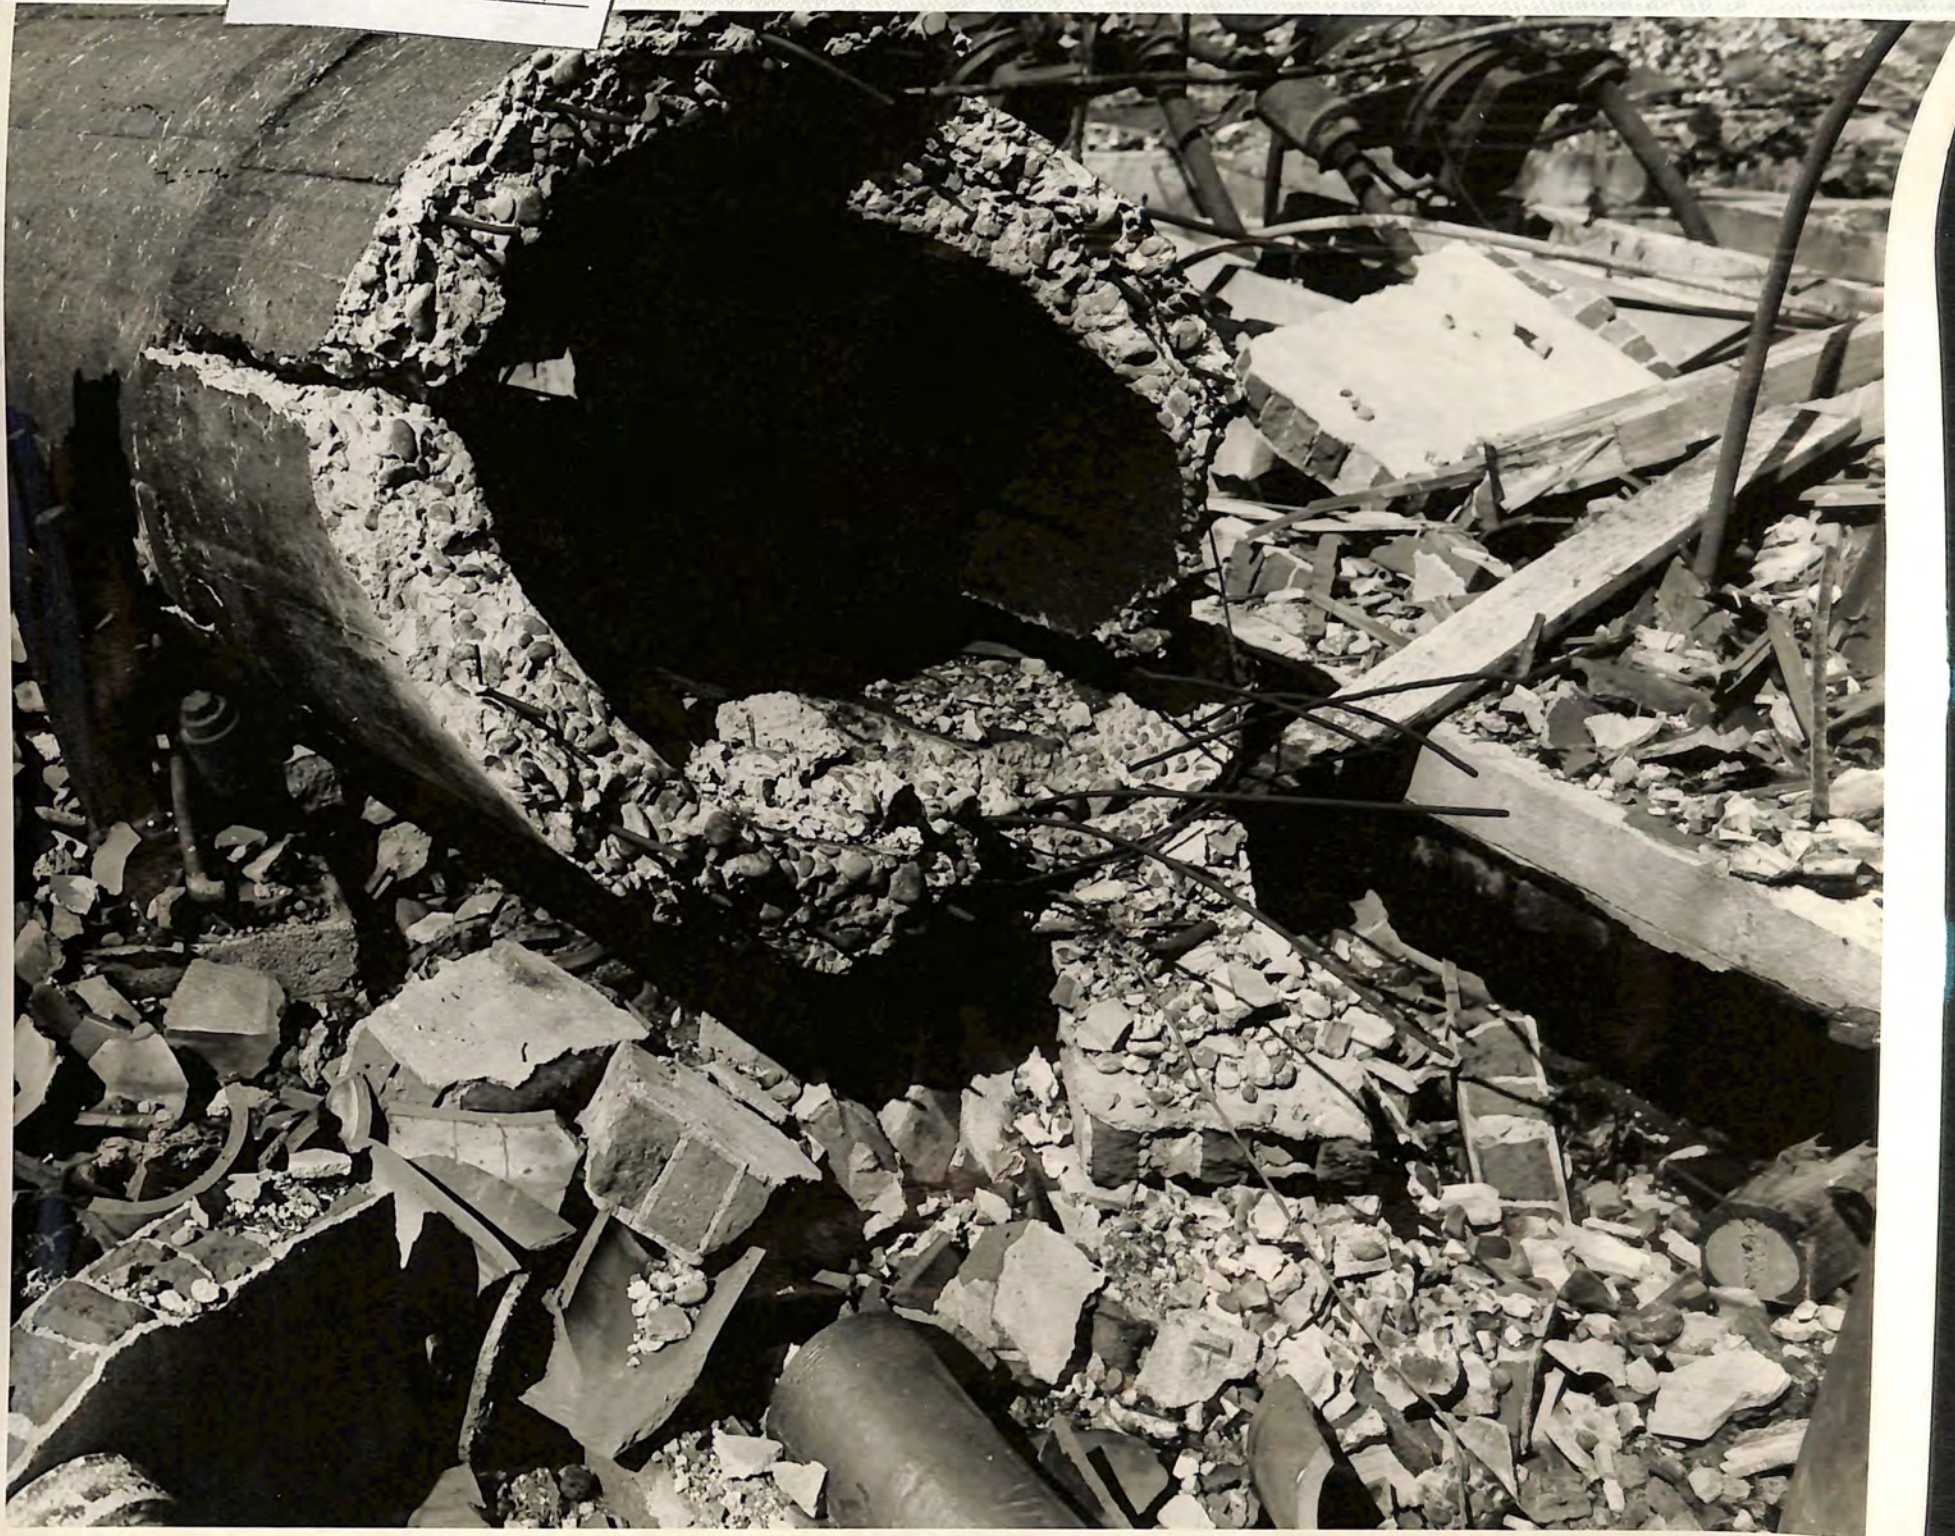
Another courtyard, showing steam plant and severely damaged reinforced concrete chimneys in background. Note how chimney on right is inclined off of vertical. Also, note combustible material that did not burn.

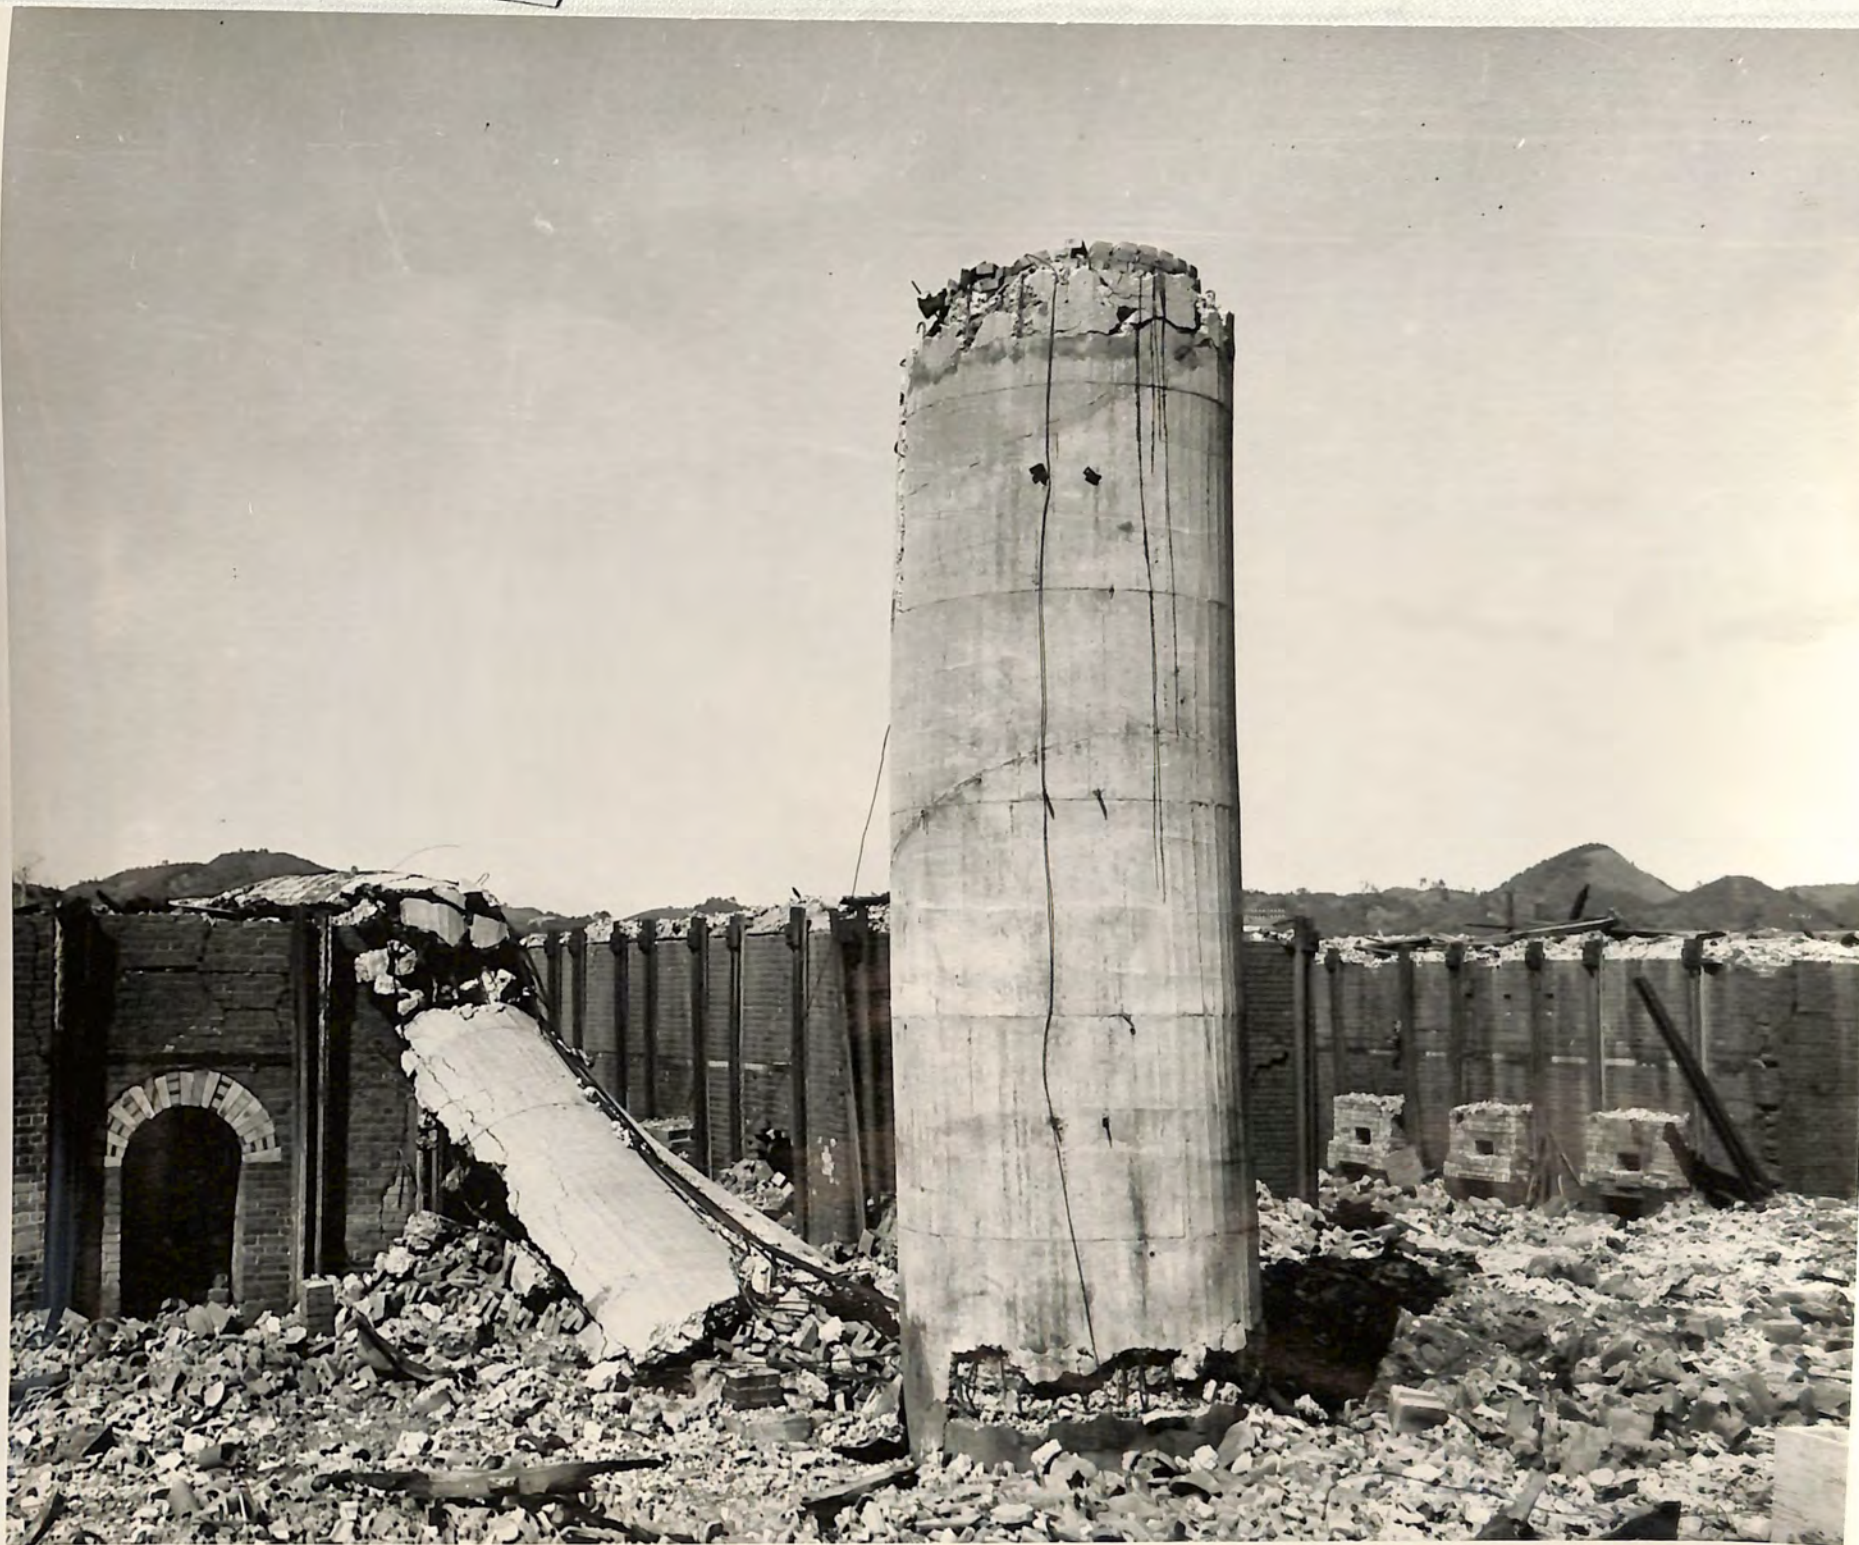
FIGURE 118

This is a close-up of a small reinforced concrete chimney, part of an industrial plant, which was knocked over by the force of the blast. Diameter at the break was approximately 4.3 feet and the wall thickness was 6-inches. The reinforcing consisted of 5/16-inch round bars, spaced on 6-1/2 inch centers. The horizontal reinforcing consisted of 1/8-inch round bars with 8-inch spacing. The chimney, about 65-feet high, was broken off approximately 15-feet above the base. The quality of the concrete appeared poor. The percentage of reinforcing was only 0.2. American designs generally have 0.8 to 1.0 percent.

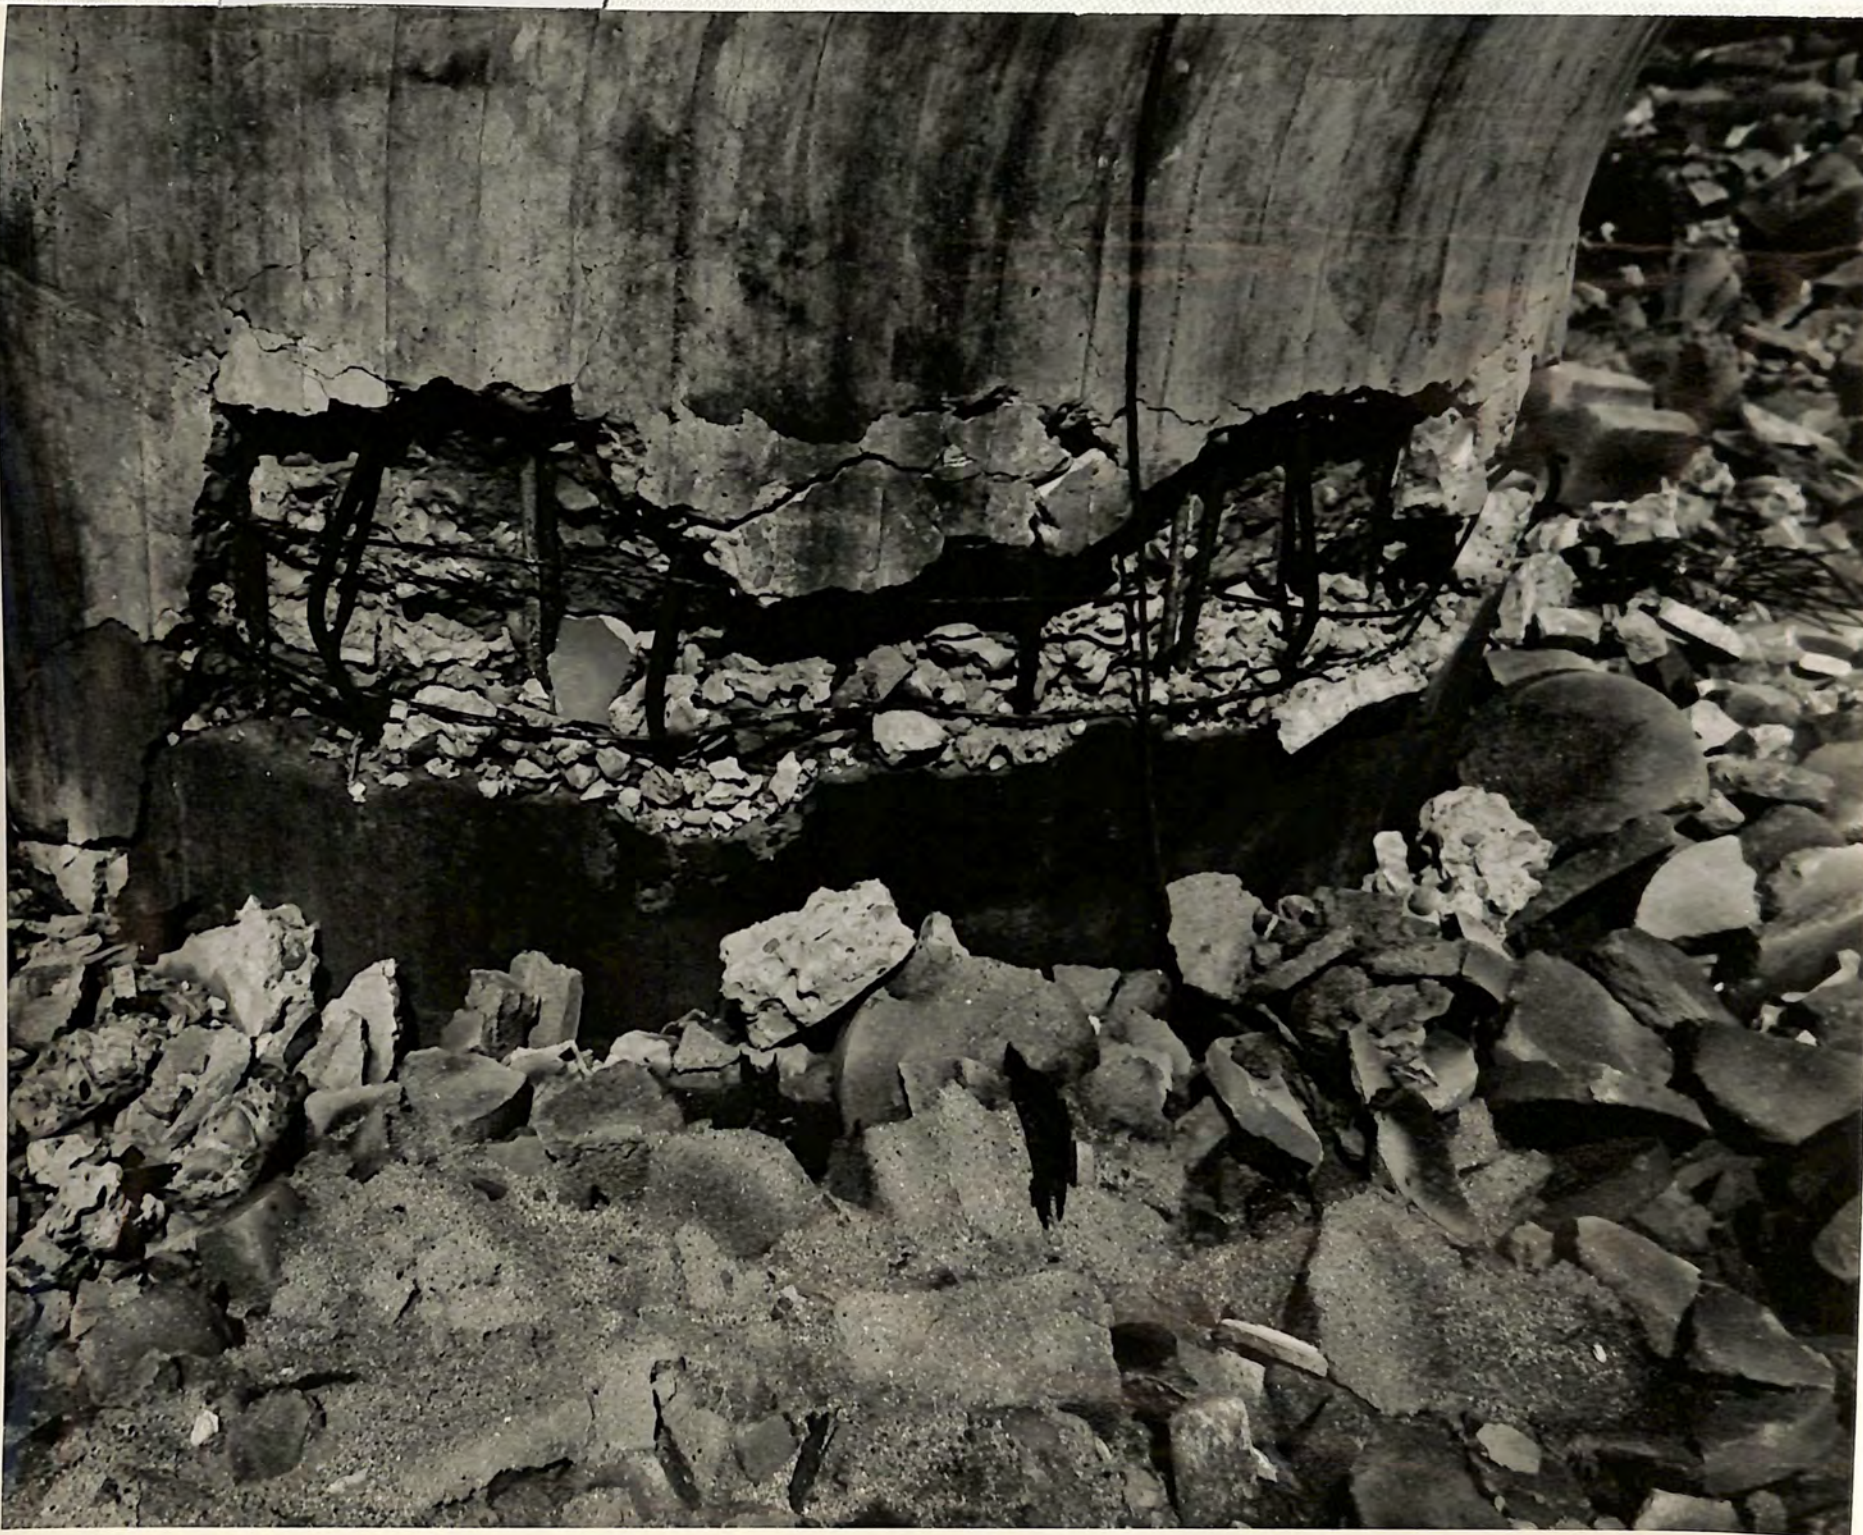
FIGURE 120

A close-up of chimney, close to the base, on the side facing the blast. Note that concrete has spalled, exposing the reinforcing. The vertical reinforcing consisted of 1/2-inch round bars on 8-inch centers and 1/2-inch round bars on 16-inch centers. Horizontal reinforcing consisted of 3/16-inch round bars with a spacing of 18-inches.

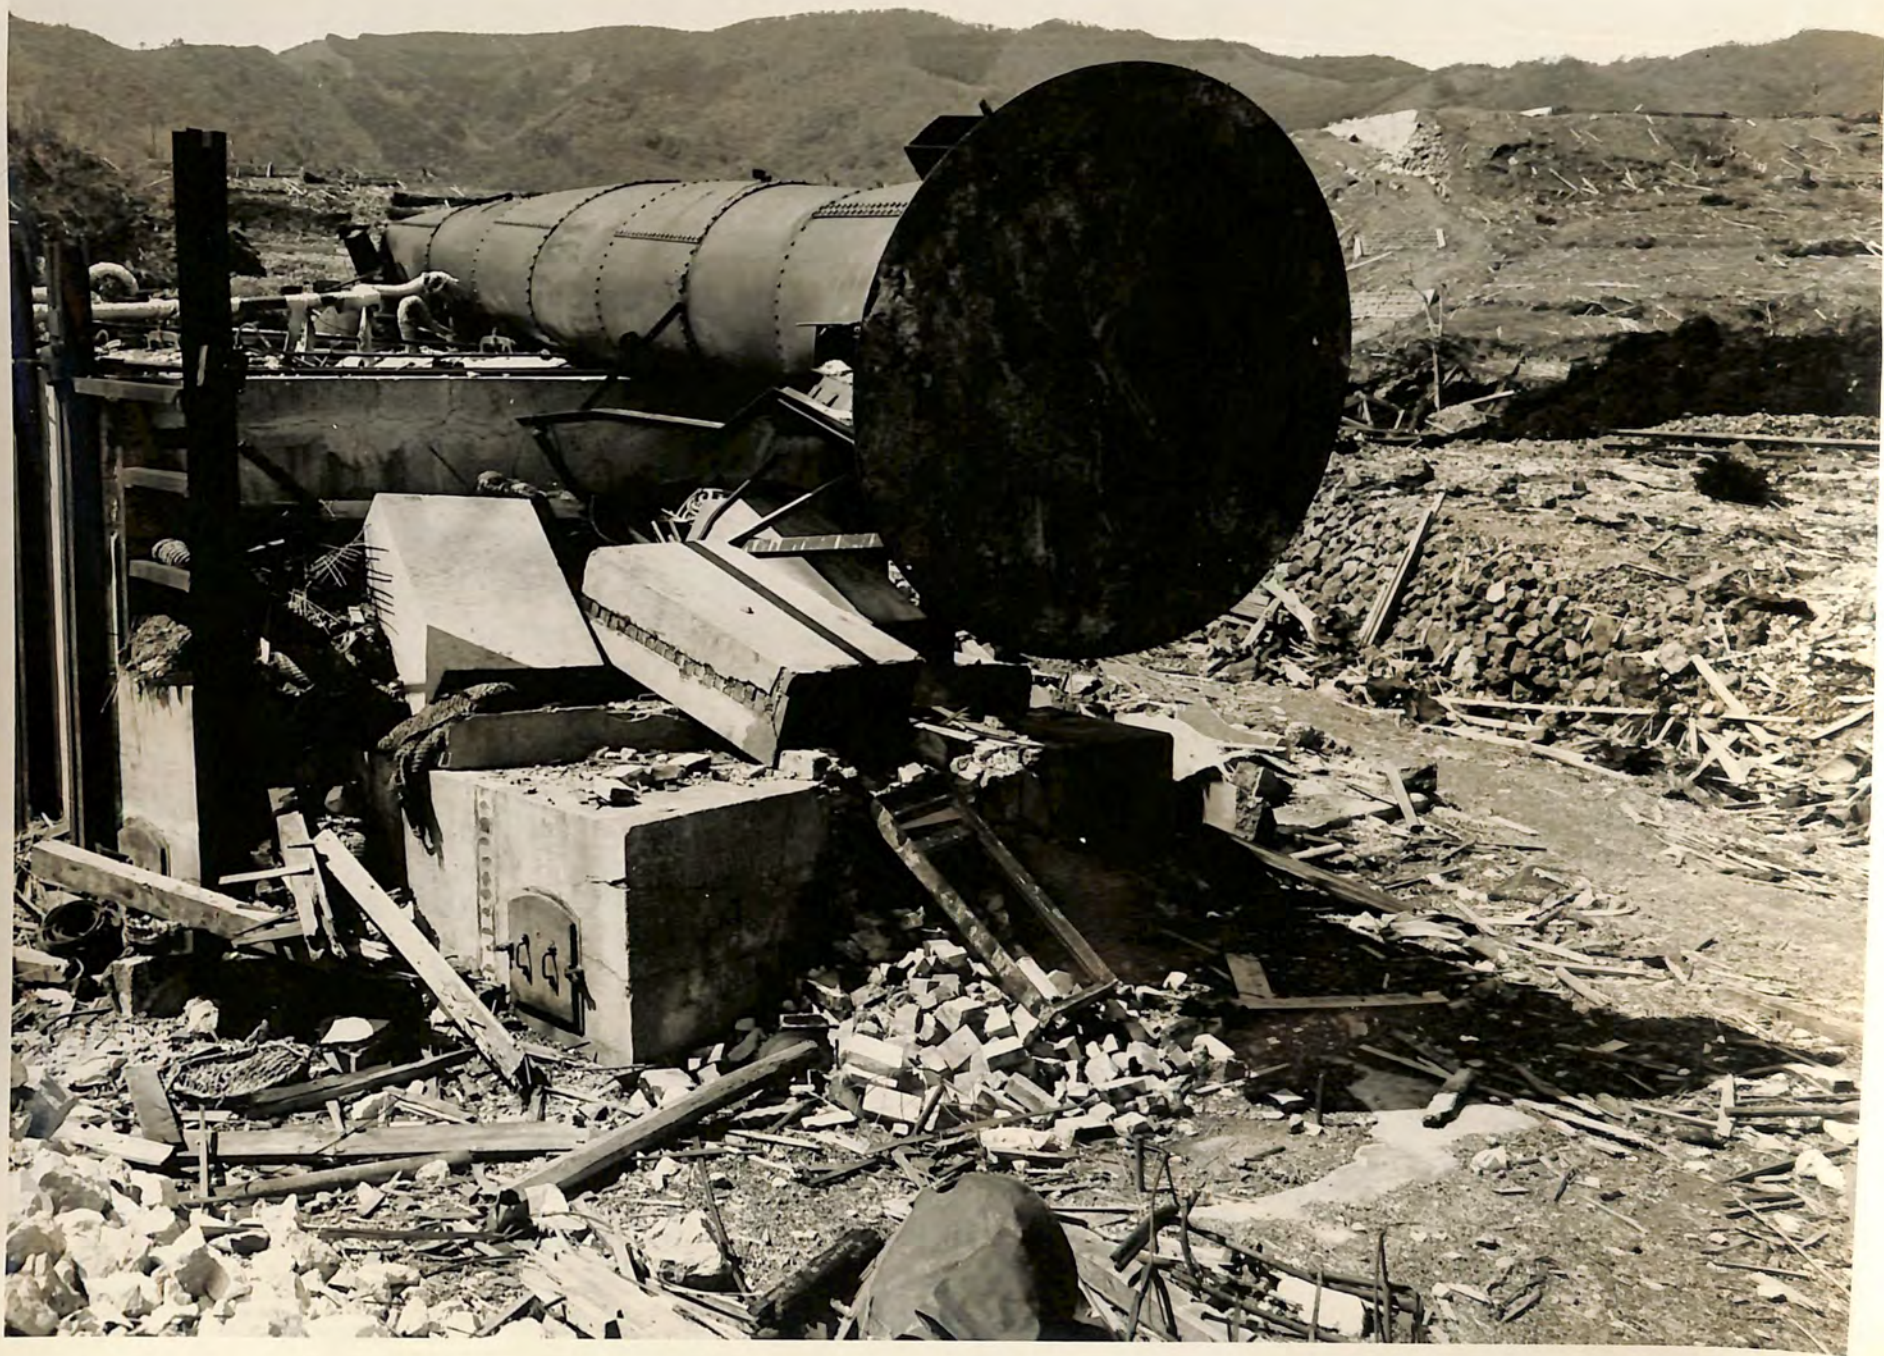
FIGURE 121

A view of a riveted steel chimney (stack) toppled by the blast. This was the site of a small factory on the West bank of the Urakami River. The chimney was supported on a concrete base and was held in place by six anchor bolts, 1-1/4-inches in diameter. The chimney was approximately 80-feet high and approximately 6-feet in diameter, except for the bottom 4-foot length, which was approximately 8-feet in diameter. The chimney capsized when the anchor bolts failed in tension.

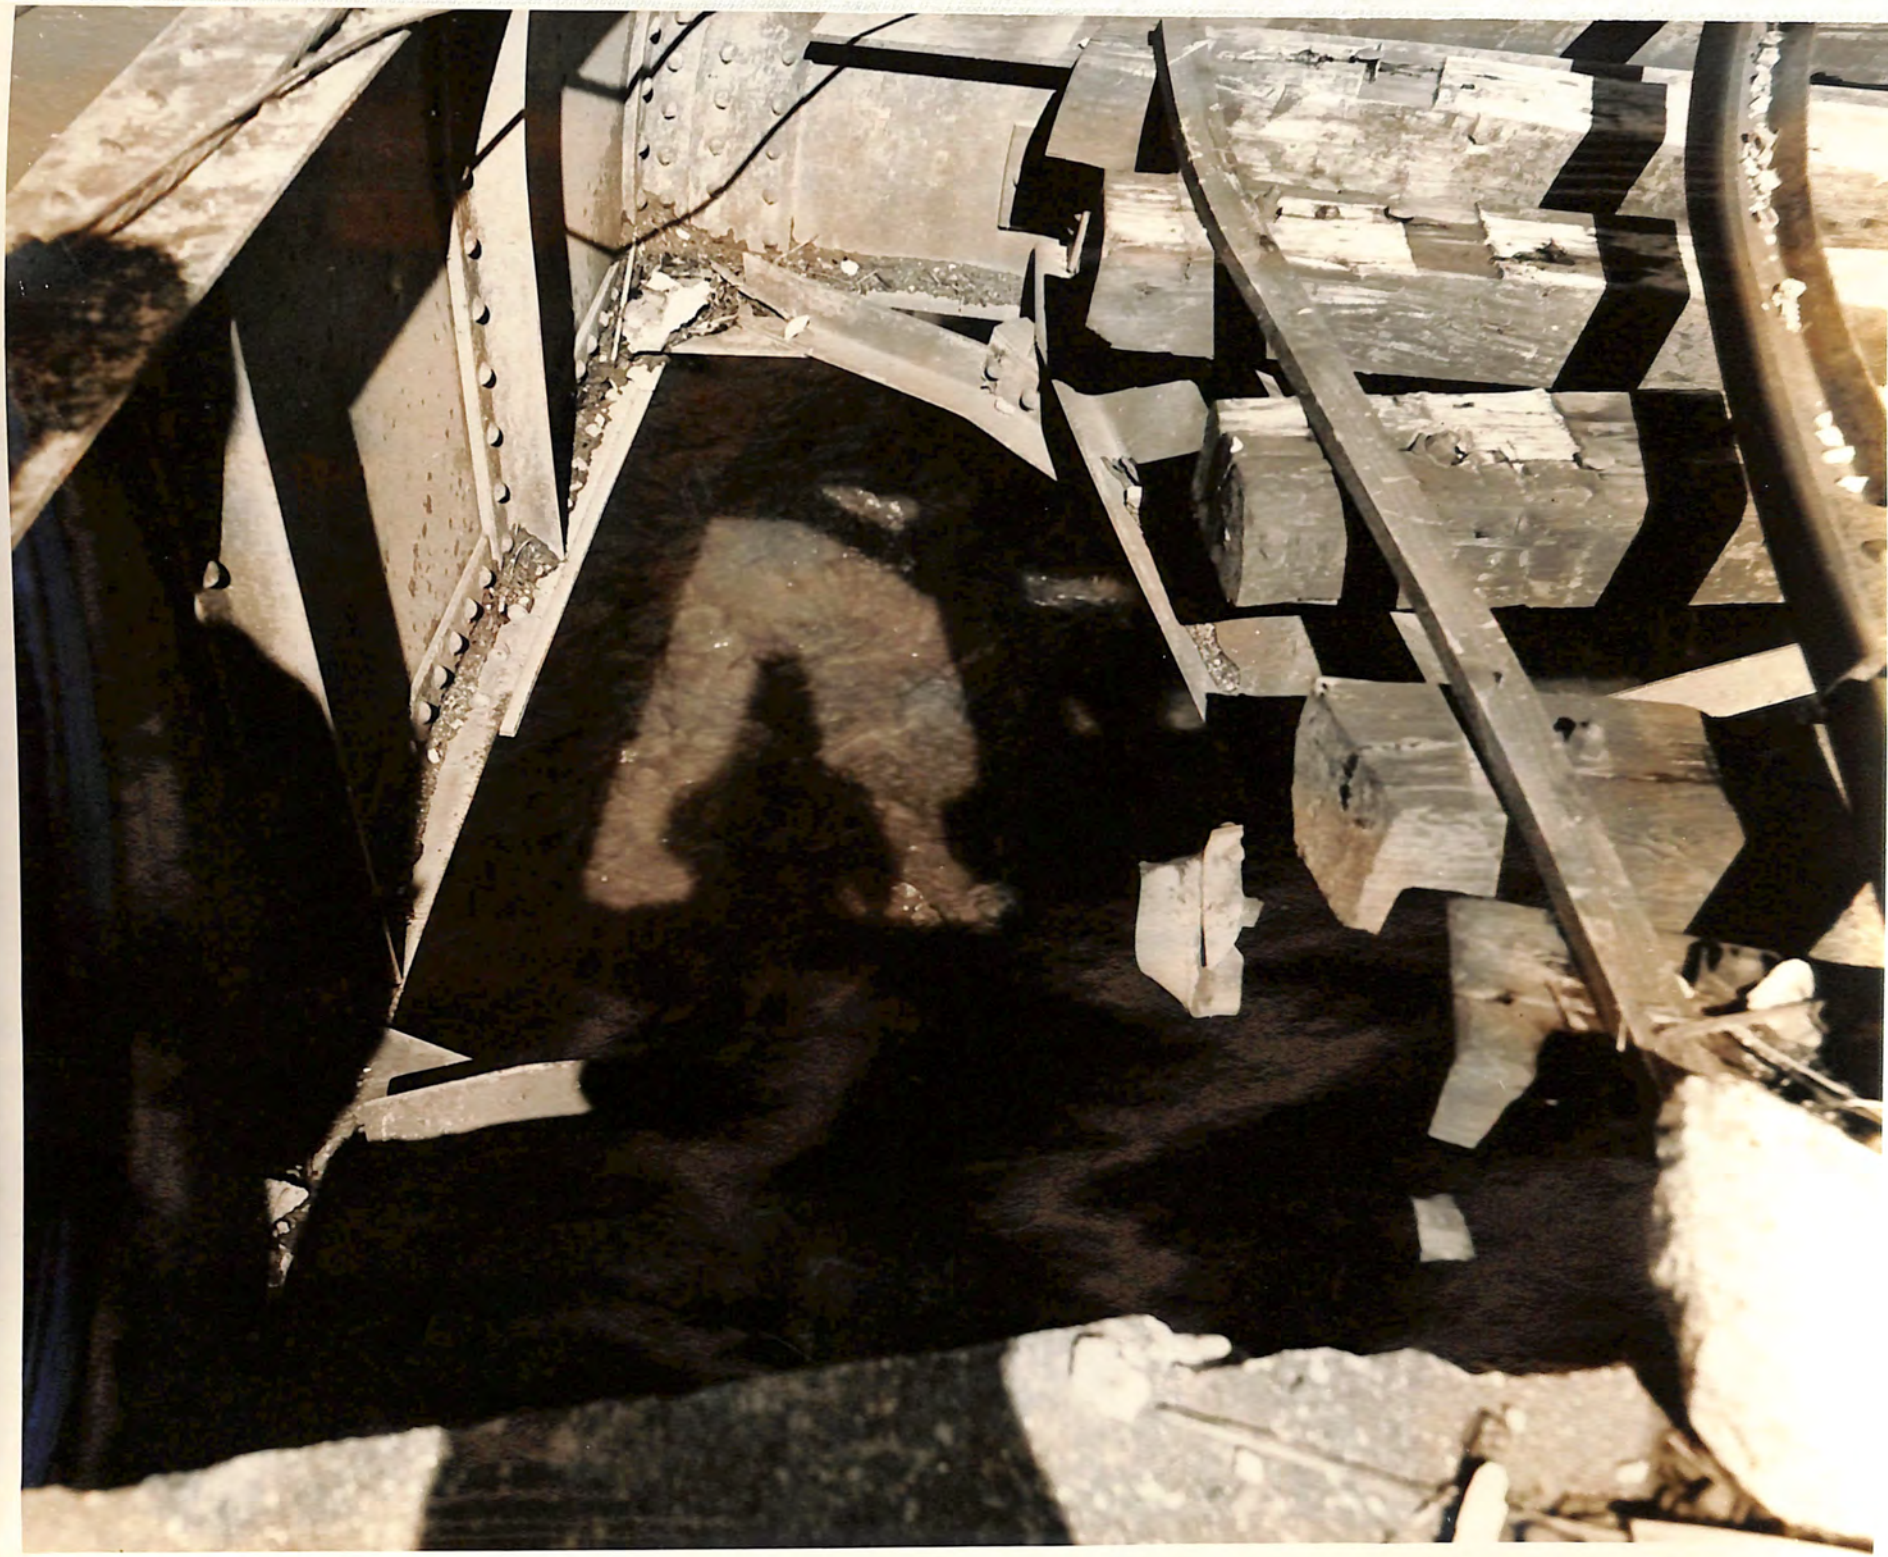
FIGURE 130

This is a close-up of the Northeast corner showing how girder was knocked loose from the metal bridge seat and buckled by the blast. Note the large amount of wood splinters and other combustible material which did not burn.
