NAGASAKI ATOMIC BOMB DAMAGE  
Nagasaki, Japan

9 August 1945 (Japanese Time)

UNITED STATES  
ATOMIC ENERGY COMMISSION  
OAK RIDGE, TENNESSEE

NAGASAKI ATOMIC BOMB DAMAGE

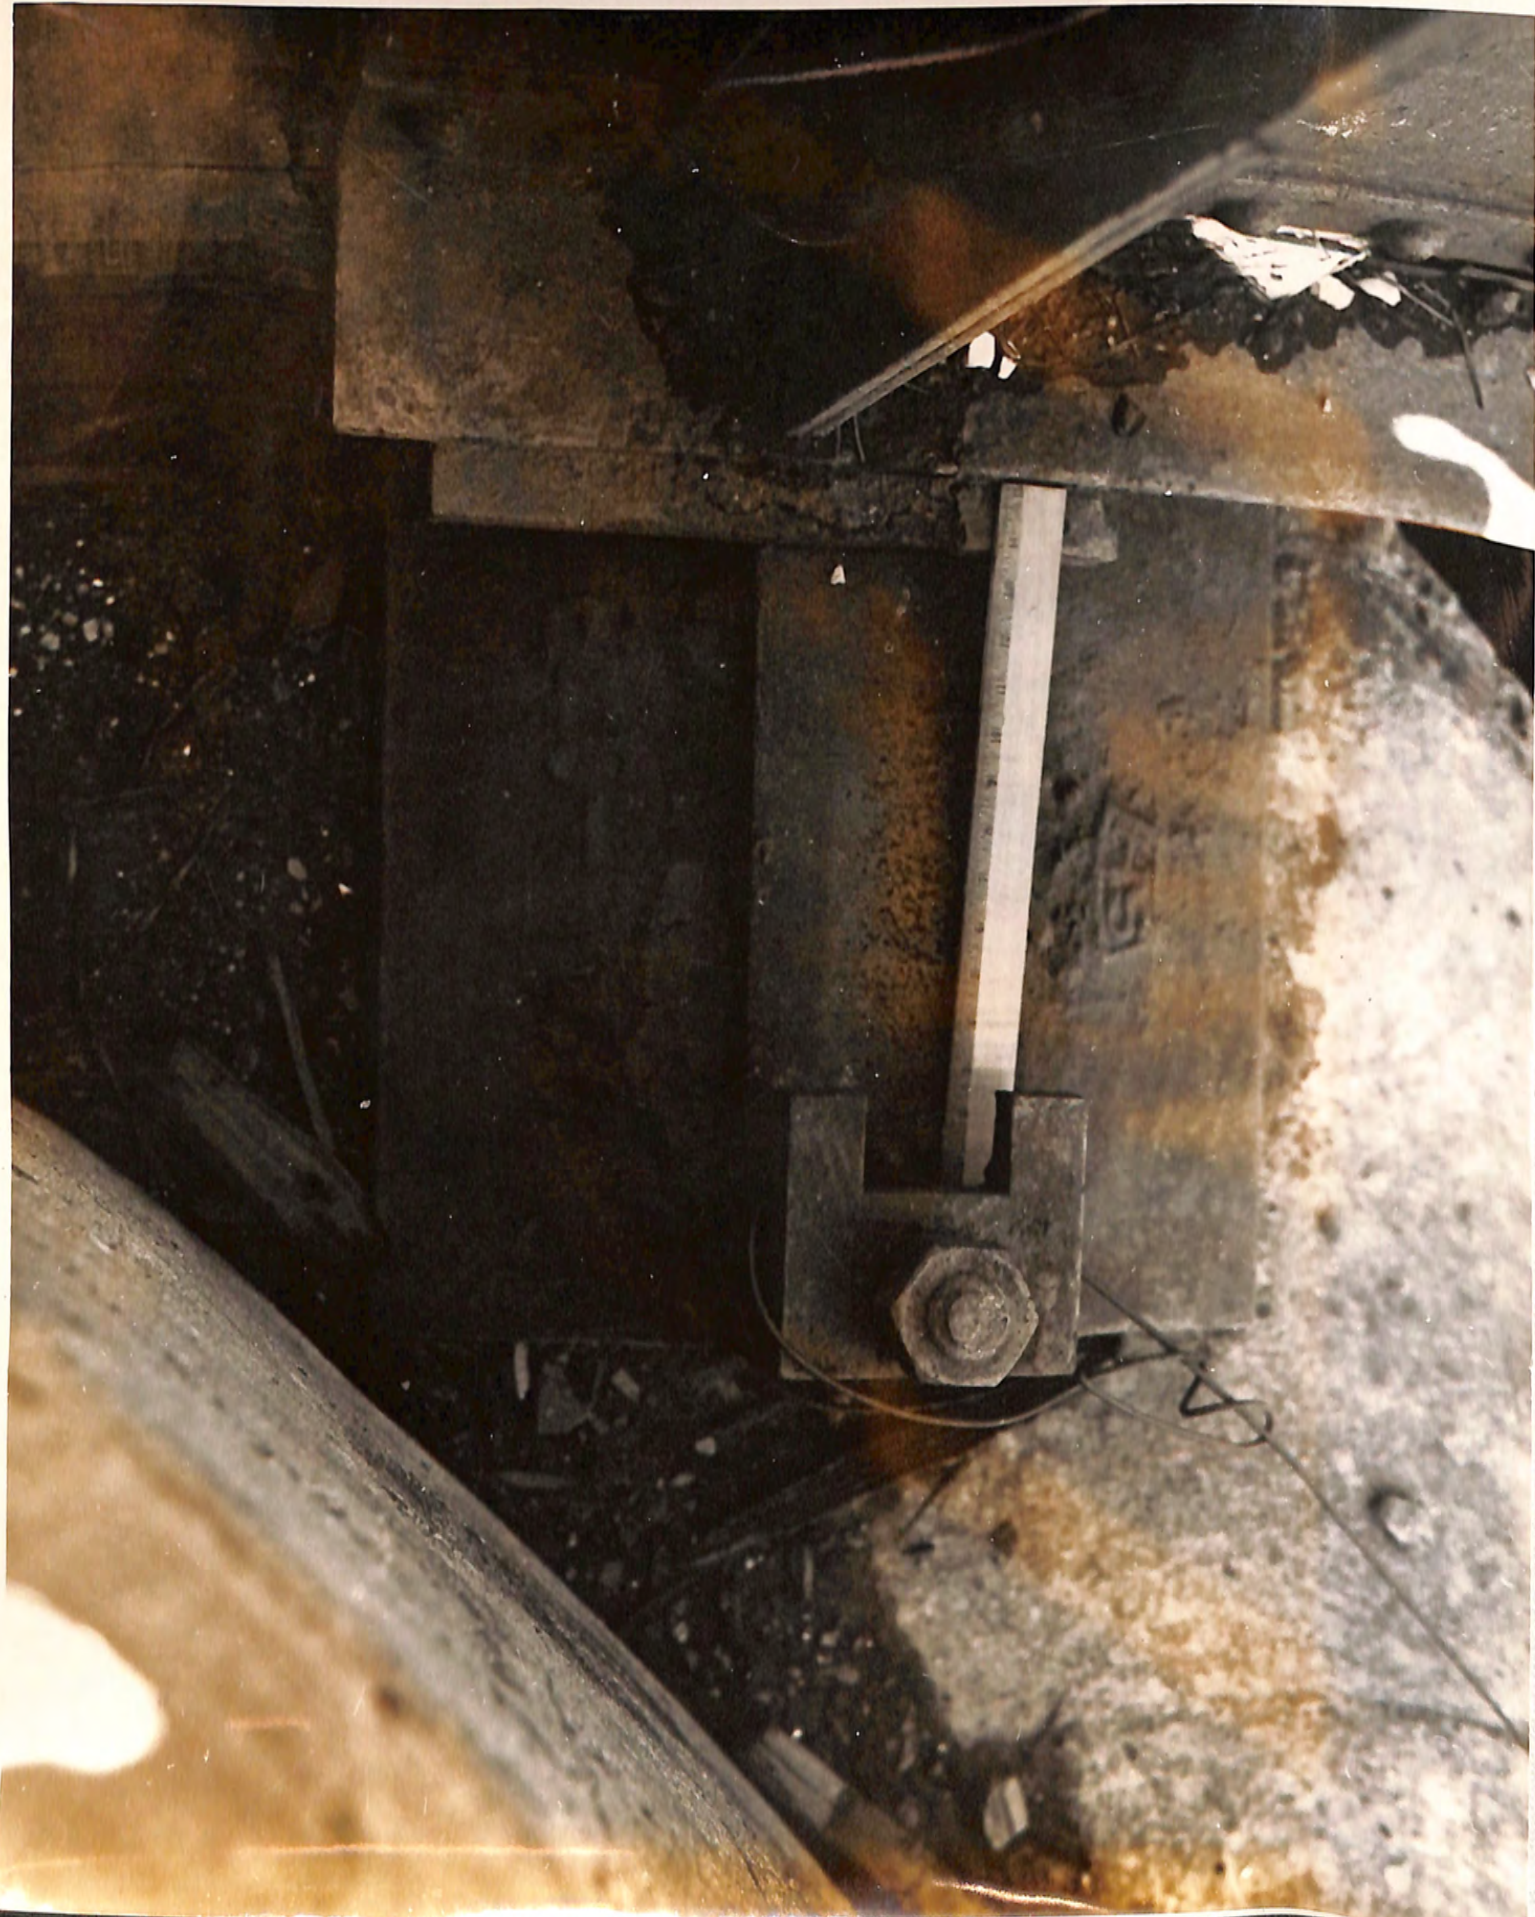
FIGURE 136

Close-up at the Southeast corner, showing how East girder was moved a distance of approximately  $14\frac{1}{2}$  inches. The opposite end (North end) was moved a distance of approximately  $3\frac{1}{2}$  inches.
