SCL-DR-65-5

REPORT OF MINUTEMAN ACCIDENT  
INVOLVING A MK 11 RE-ENTRY VEHICLE  
AT SITE LIMA II, DECEMBER 5, 1964 ~~(CFRD)~~

R. K. Petersen, 8141-2  
Sandia Corporation, Livermore Laboratory

January 1965

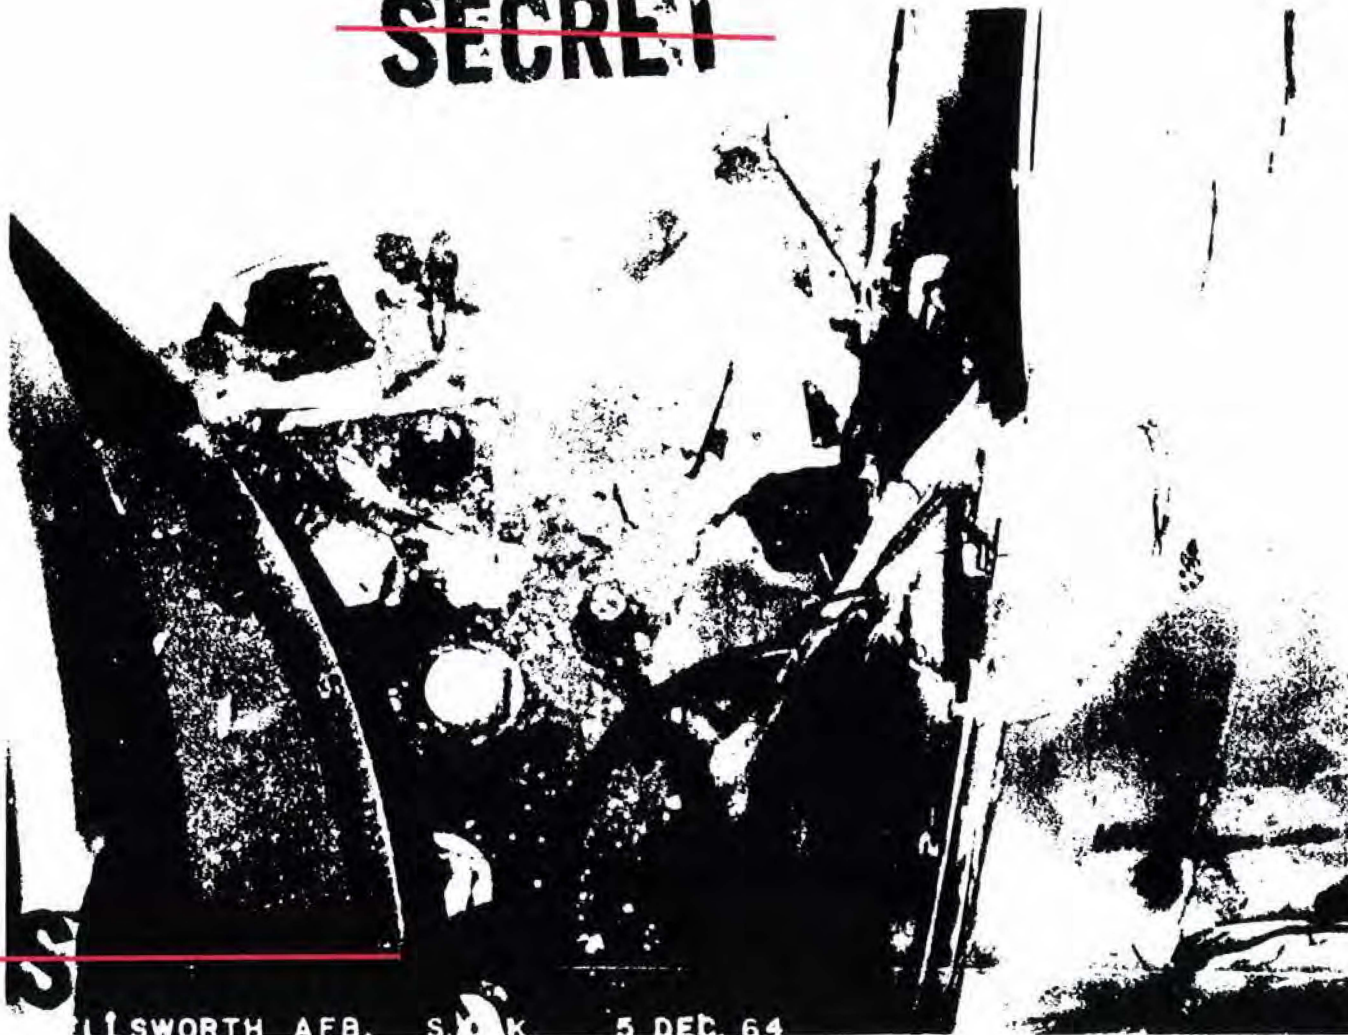
Figure 14. An Early Re-entry Vehicle

WALLSWORTH AFB, S.D. K. 5 DEC. 64
