VOLUME II
PHYSICAL DAMAGE
HIROSHIMA, JAPAN

Prepared by Major Noland Varley

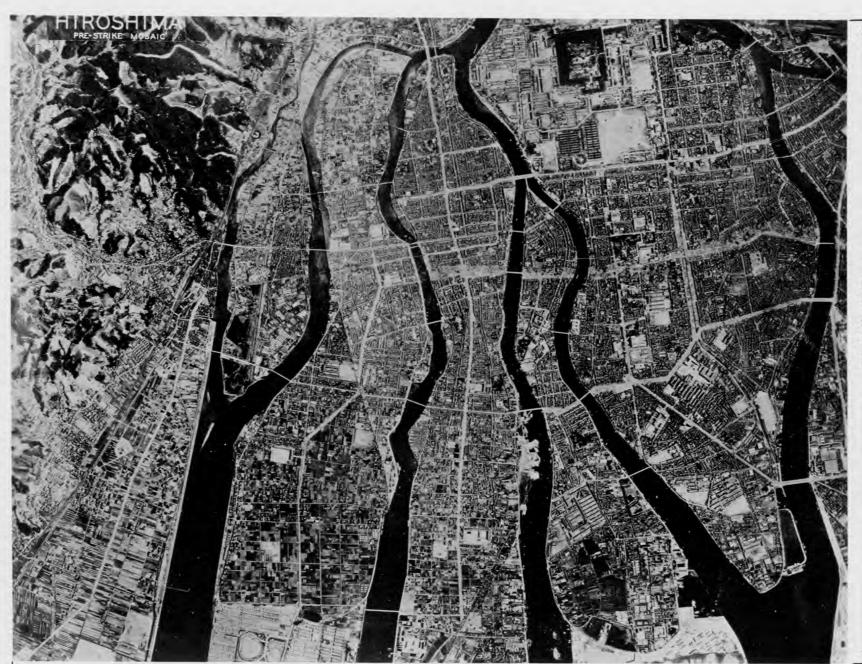
#### PRE-STRIKE AERIAL VIEW

This pre-strike aerial view of Hiroshima shows the high density of the built up area.

Fire lanes formed by razing frame buildings may be seen in this view. The Japanese were hurriedly extending these lanes in anticipation of incendiary raids.

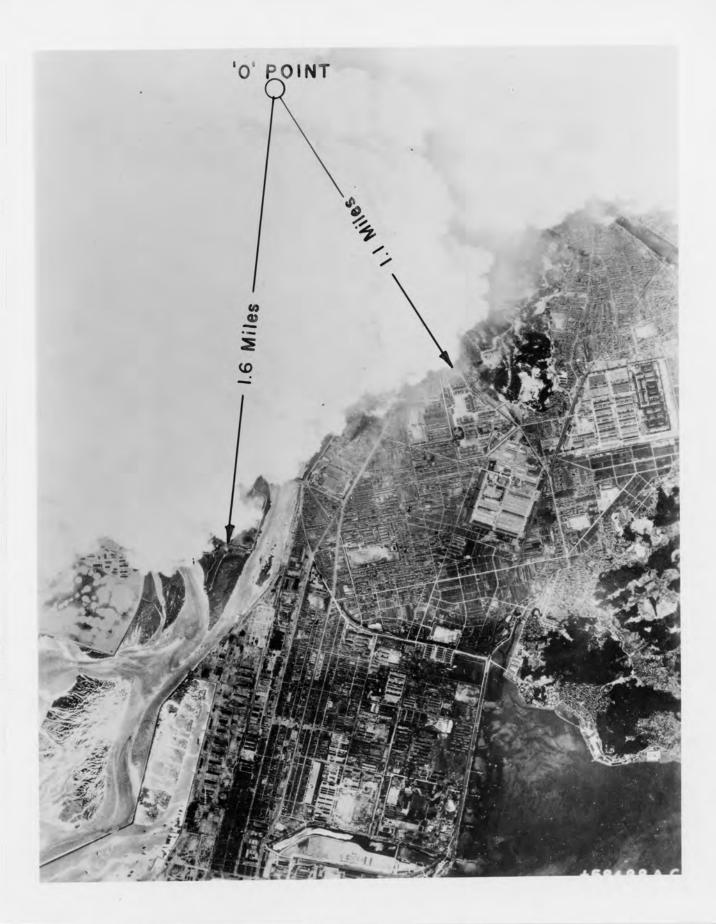
#### POST STRIKE ABRIAL VIEW

This picture taken on the day of the explosion shows dense smoke obscuring the target area.

This picture was photographed from an elevation of 25,000 feet.

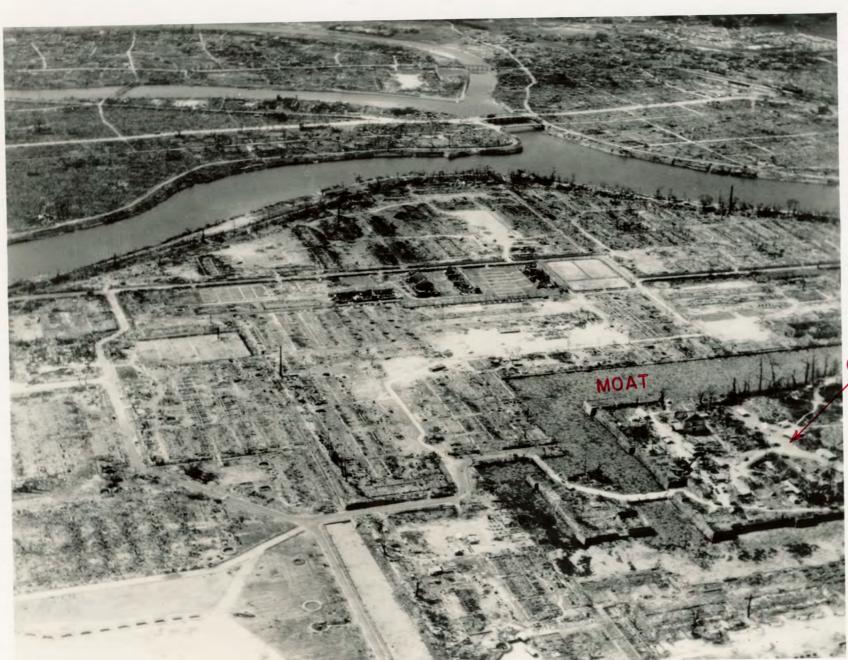
#### MILITARY AREA

(0.6 Mile North of Zero Point)

This aerial view shows almost complete destruction of ordnance, storage and administrative buildings located in the northeast section of the military area.

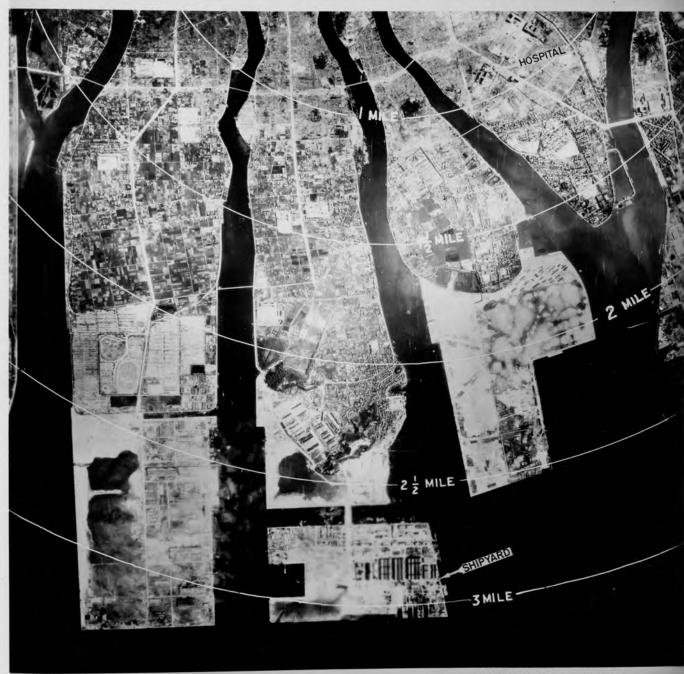
#### AERIAL VIEW

This post-strike view looking from west to east shows devastation from zero point to 0.4 mile south of zero point.

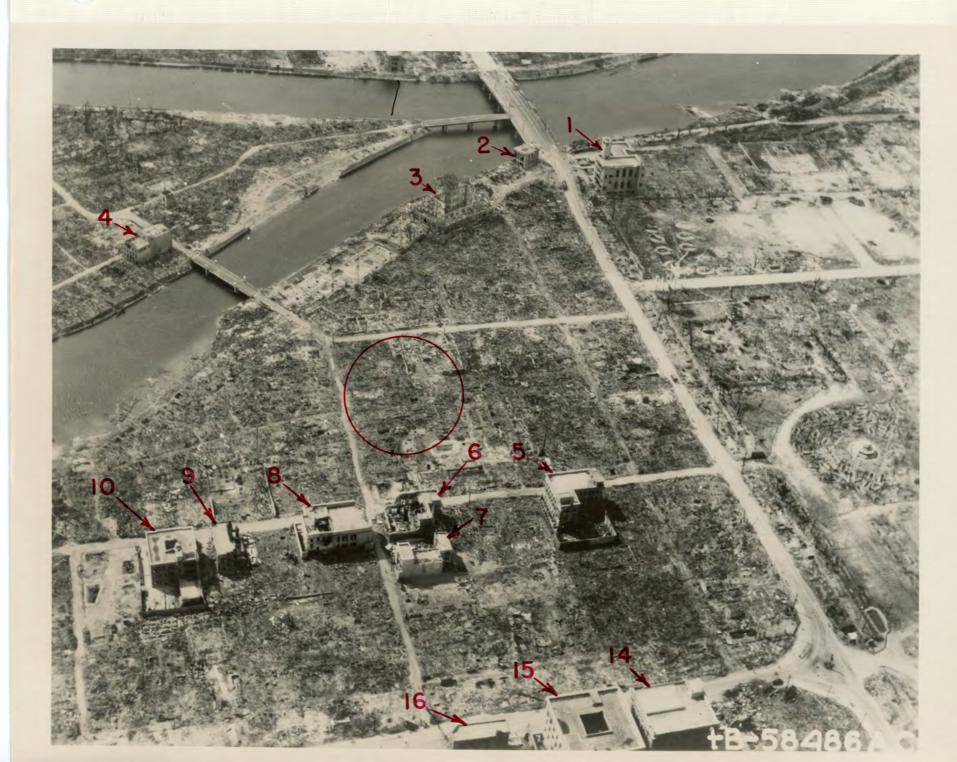
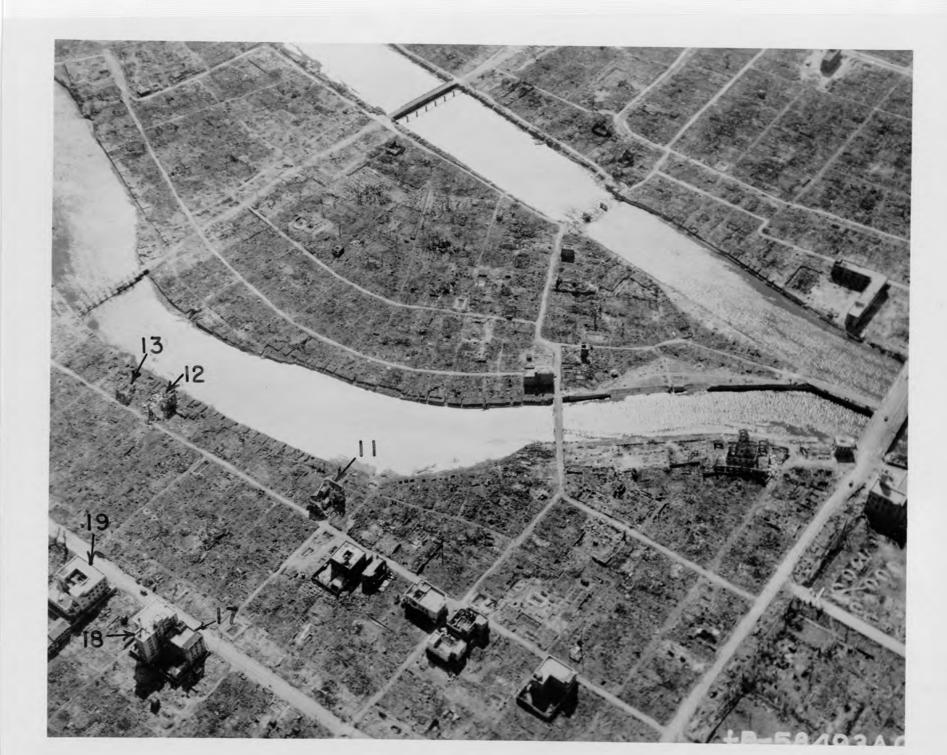
The following two aerial views show the location of "Zero Point" over which the atom bomb was exploded. The buildings remaining in this vicinity have been numbered for identification in following pictures.

Location of two bridges demolished by the blast may be seen.

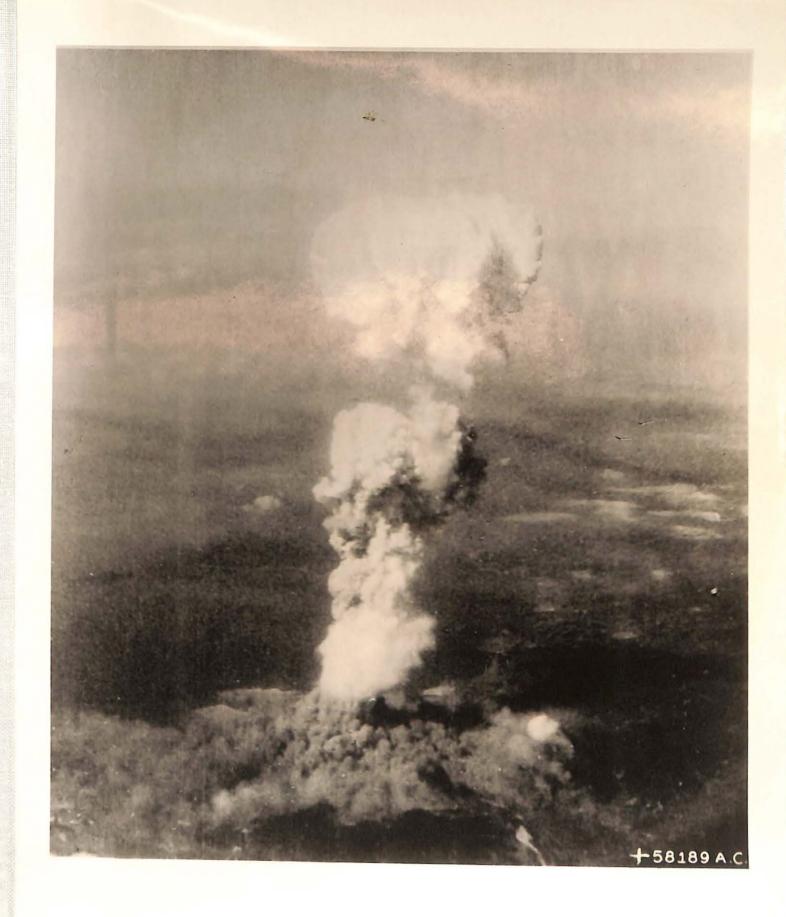
# AIR BURST OVER HIROSHIMA

This aerial view of the air burst shows smoke billowed 20,000 feet above Hiroshima. The smoke at the base of the column has spread out over 10,000 feet of the target area.

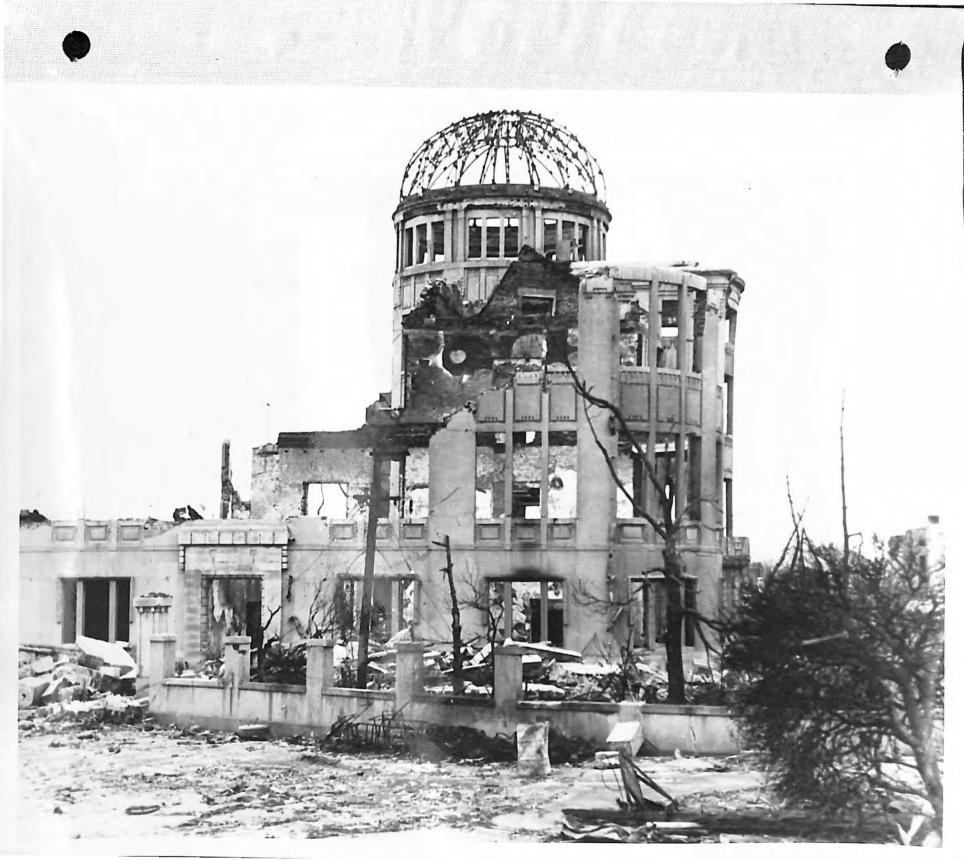
#### COMMERCIAL MUSEUM

(700 Feet West of Zero Point)

This view is similar to that in the preceding picture.

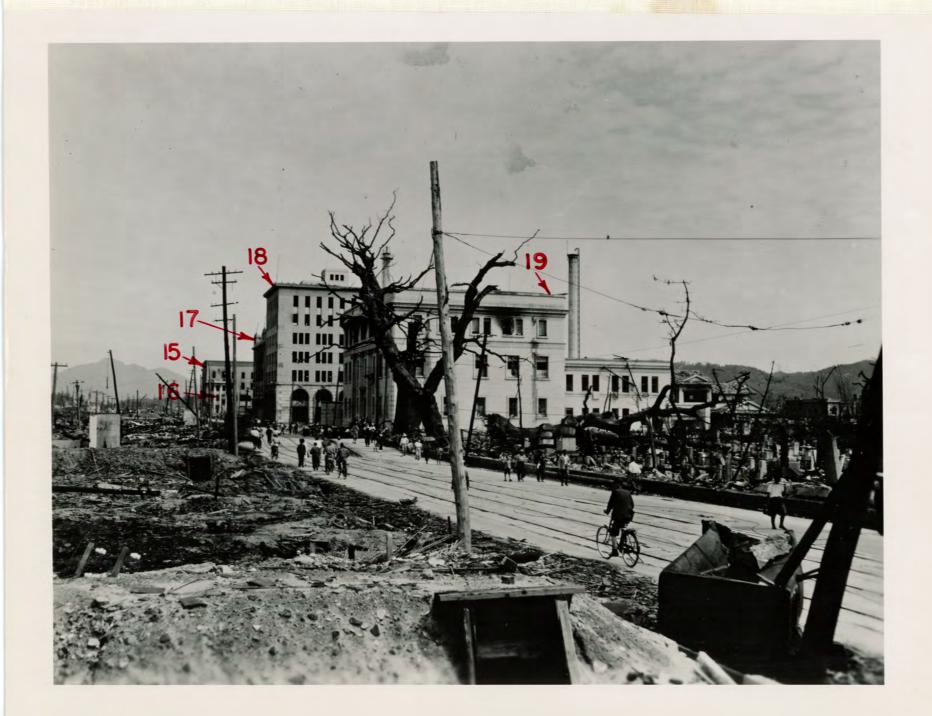
Some combustible debris still remains. The streets were undamaged. Street cars were placed back in operation after the streets were cleared of debris and overhead wiring was replaced.

Note air raid shelters in the foreground.

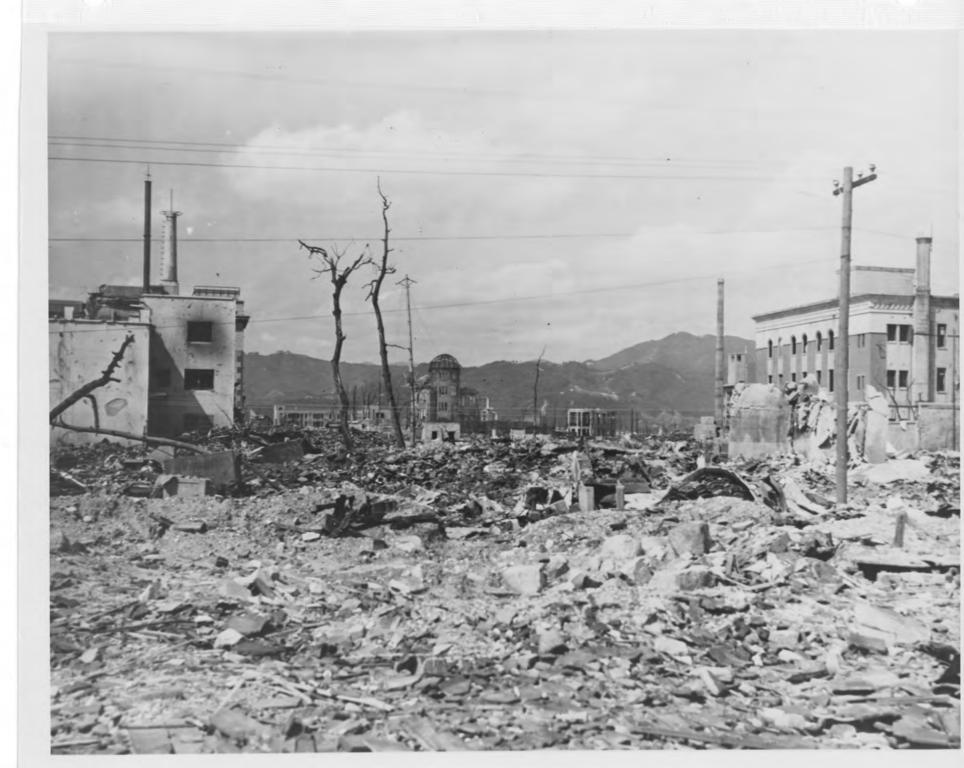
This view is looking west across "zero point" from O.l mile east of "zero point".

Building No. 7 may be seen in the left foreground and building No. 3 (Commercial Museum) 700 ft. west of "zero point" may be seen in the center background.

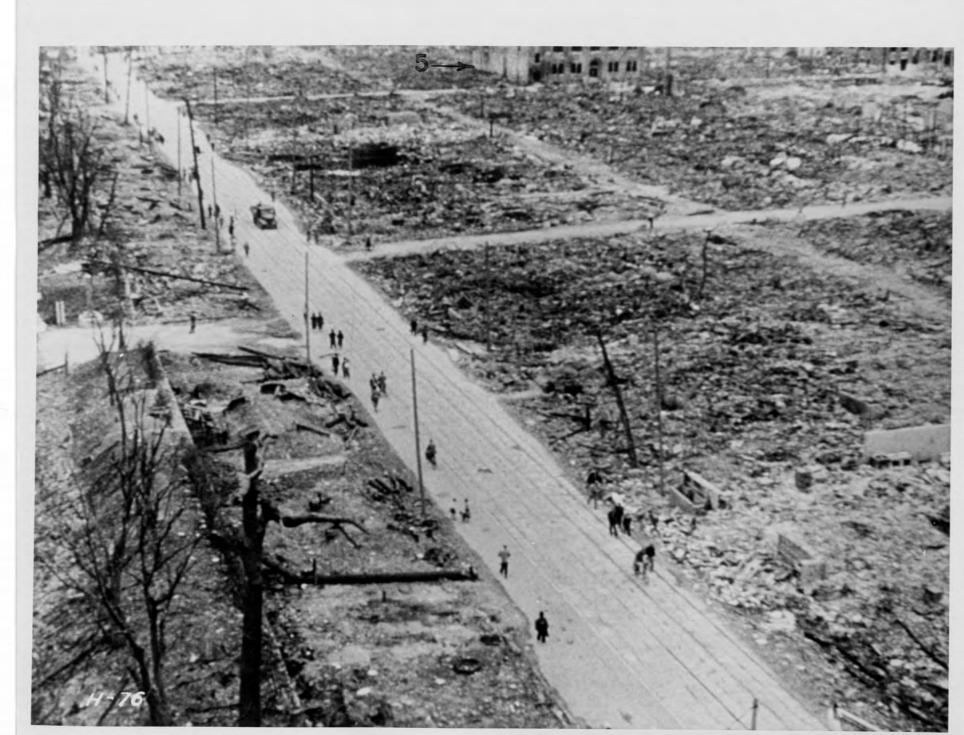
#### DEVASTATION NORTH OF "ZERO POINT"

This view shows devastation immediately north of "Zero Point". The streets in this area have been cleared of debris and new power poles set, in order to restore streetcar service.

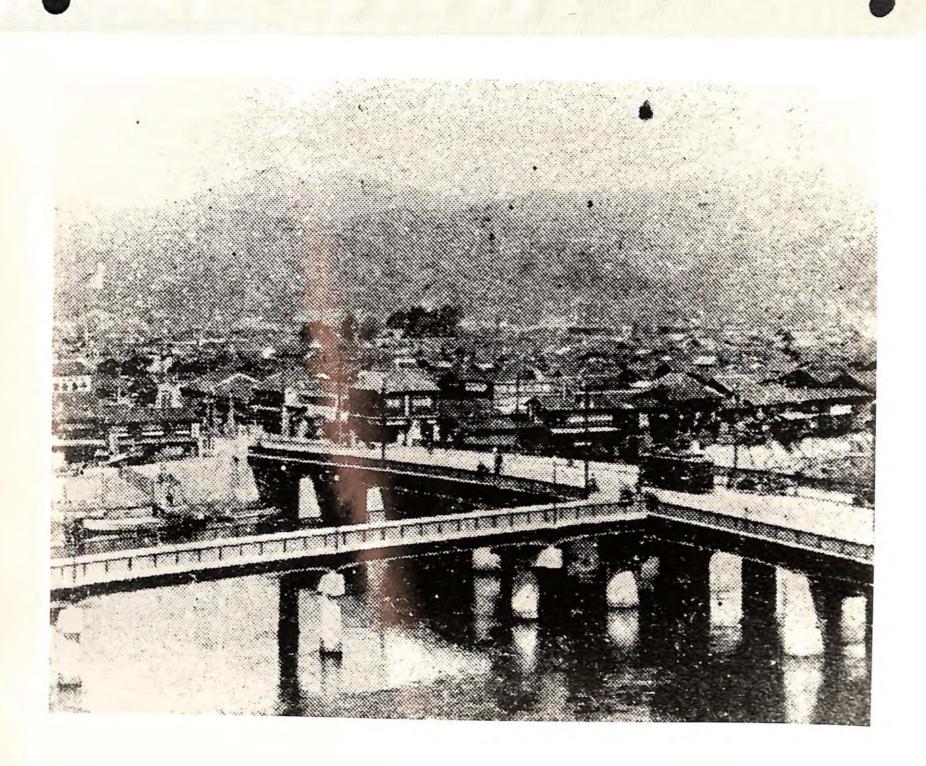
This view looking northwest shows typical 2-story frame buildings destroyed by the blast.

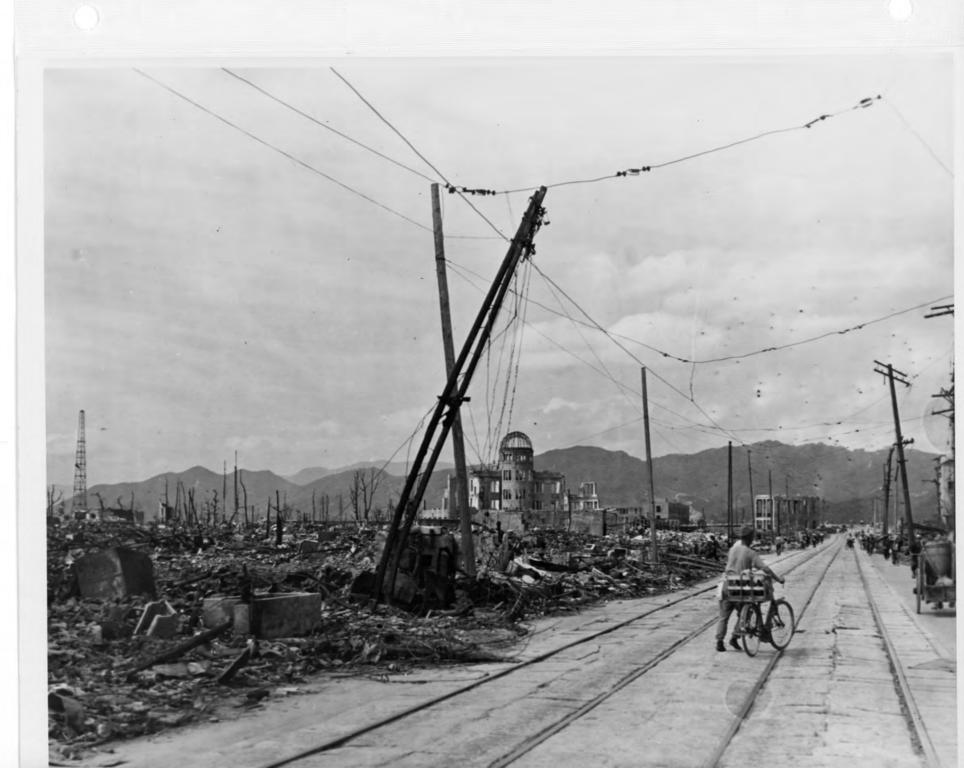
The steel pole in the foreground is leaning in the direction of the blast.

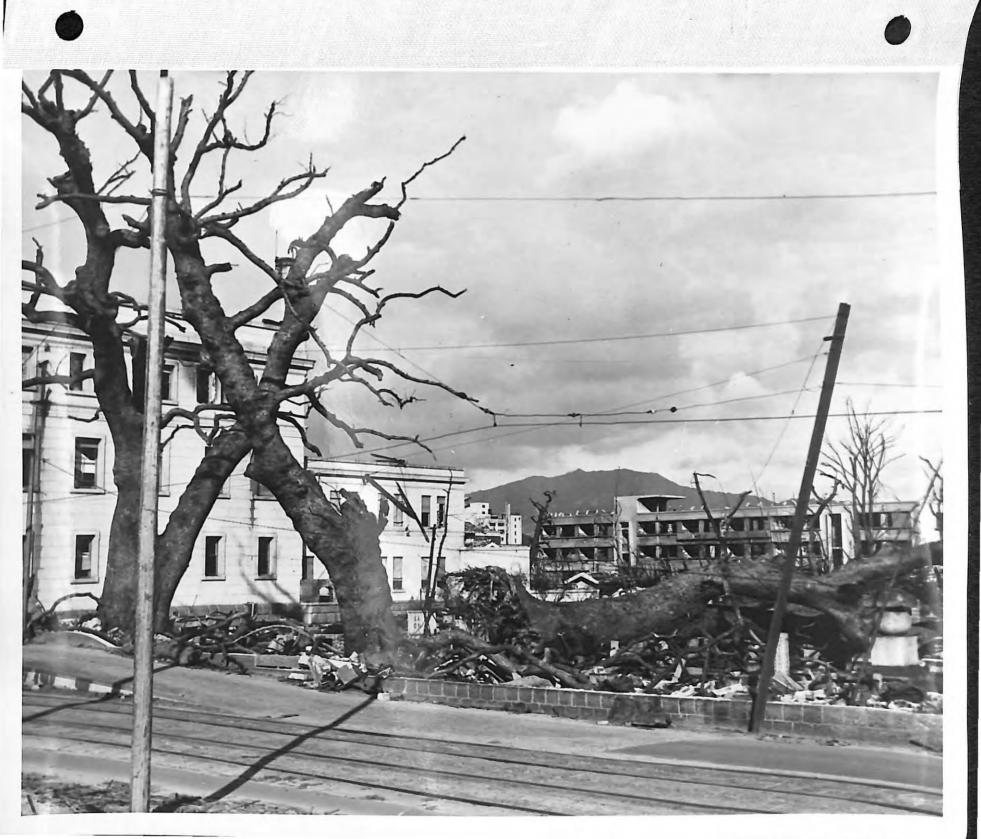
(No. 1 of 5 Views)

One large tree in the cemetery in the foreground was blown down in the direction of the blast.

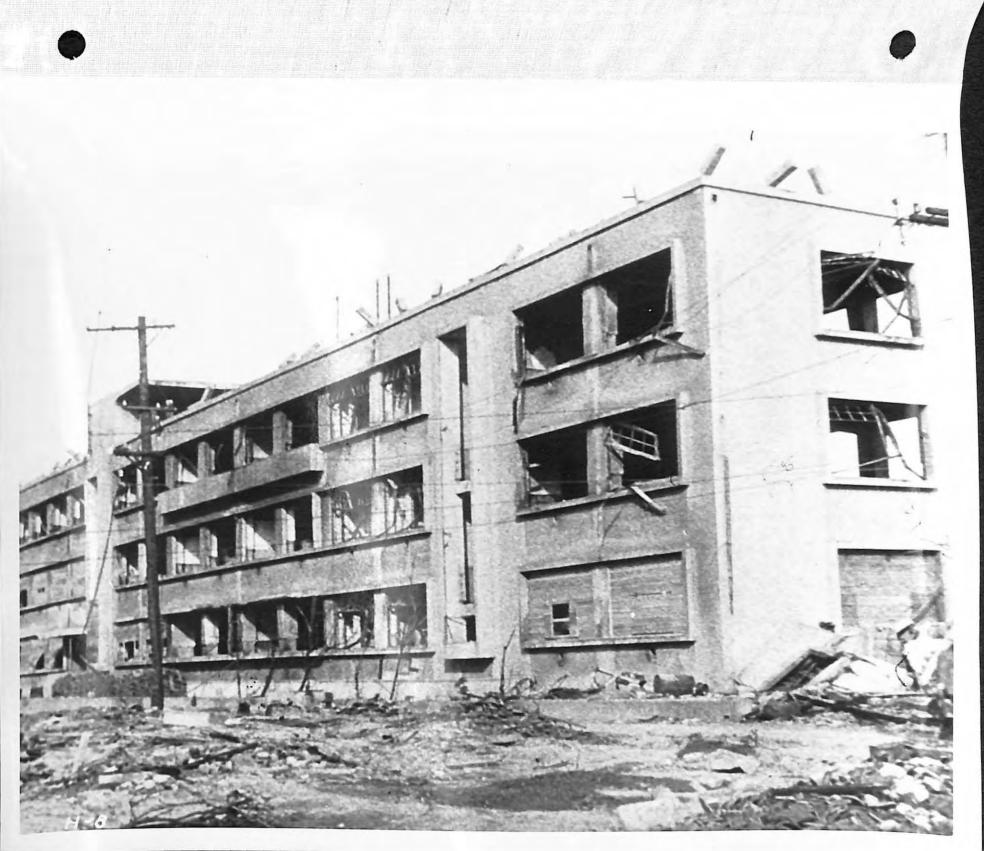
(No. 2 of 5 Veiws)

Windows in the lower right hand corner have been boarded up since the blast.
