NAGASAKI ATOMIC BOMB DAMAGE  
Nagasaki, Japan

9 August 1945 (Japanese Time)

UNITED STATES  
ATOMIC ENERGY COMMISSION  
OAK RIDGE, TENNESSEE

NAGASAKI ATOMIC BOMB DAMAGE

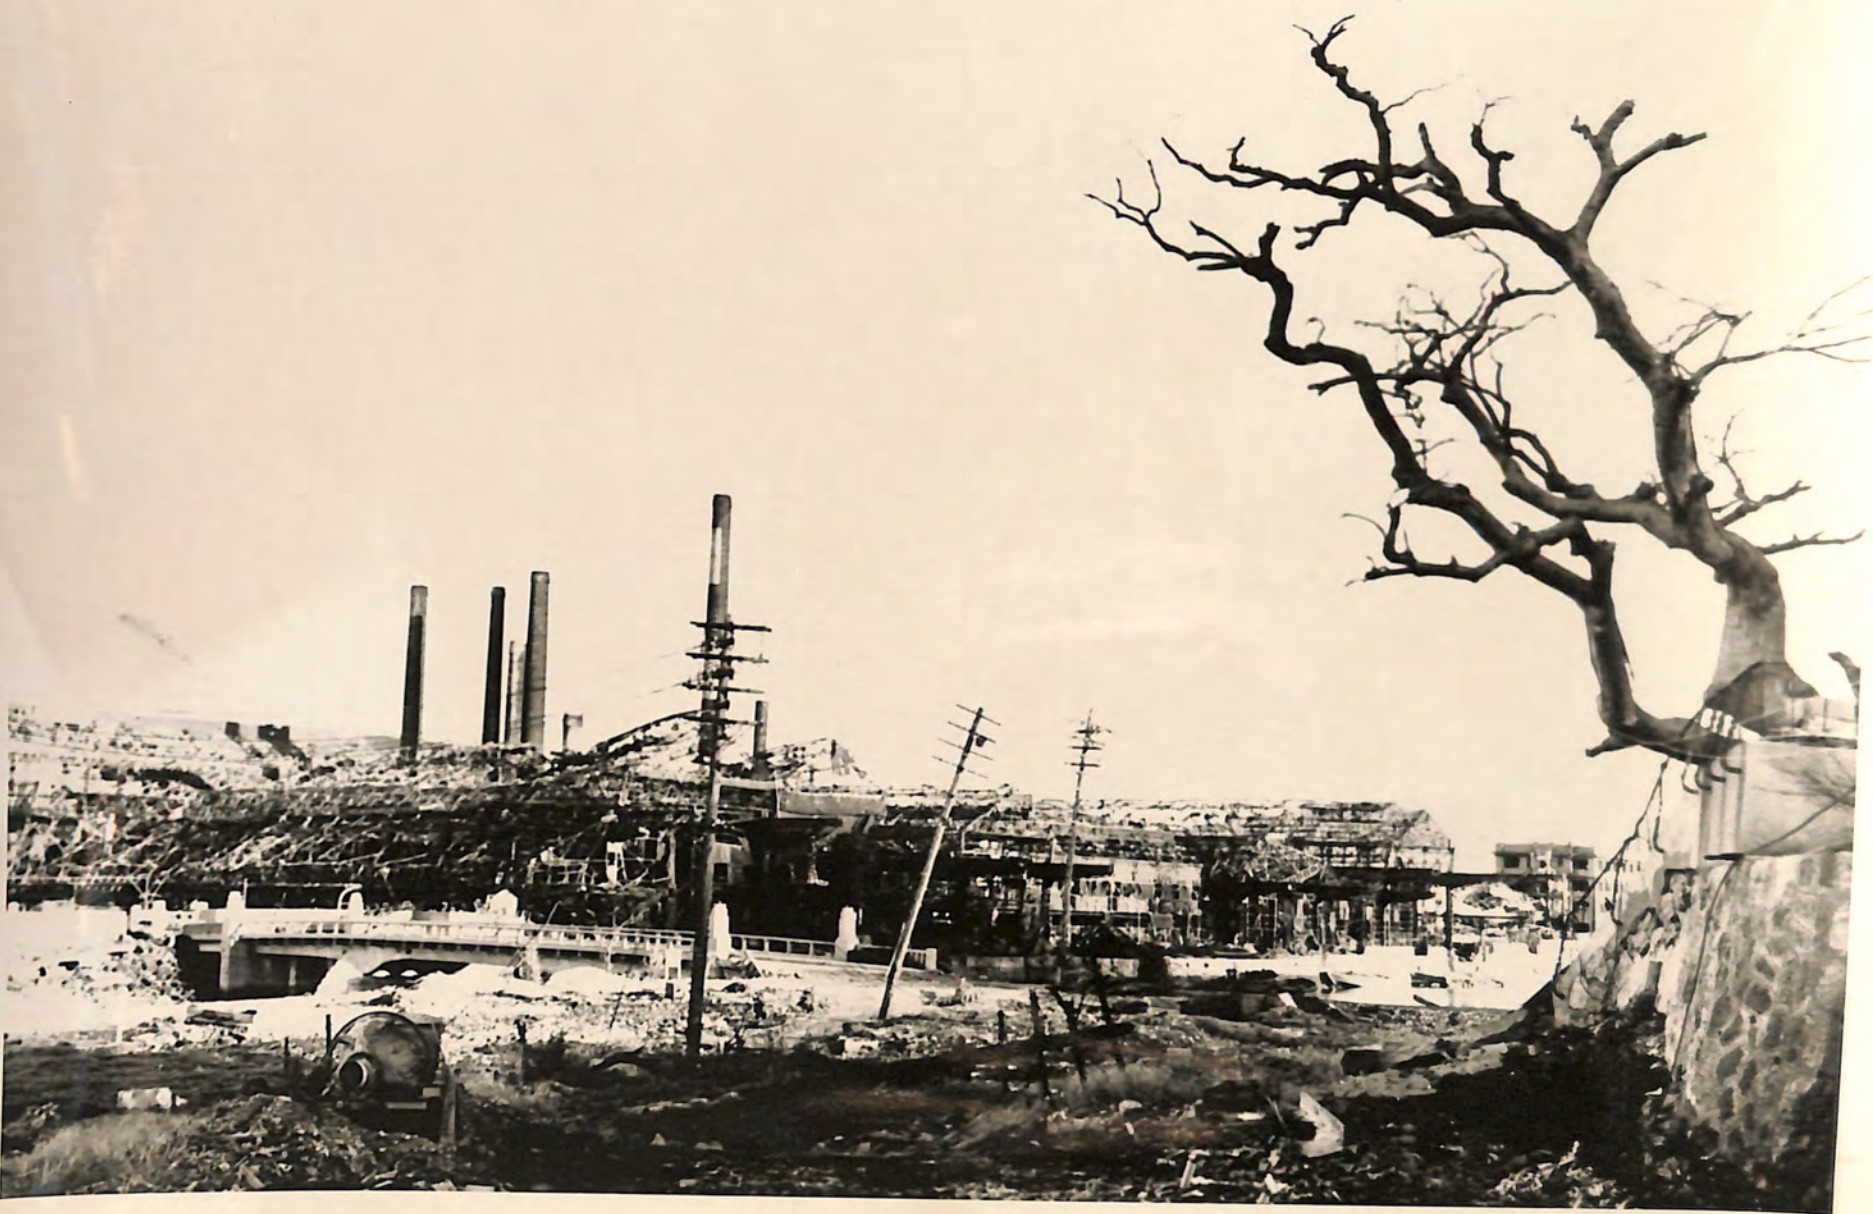
This is a view of the interior of one of the heavy machine shops. Note that although the steel frame sustained minor damage, the corrugated iron roof and siding were stripped by the blast.

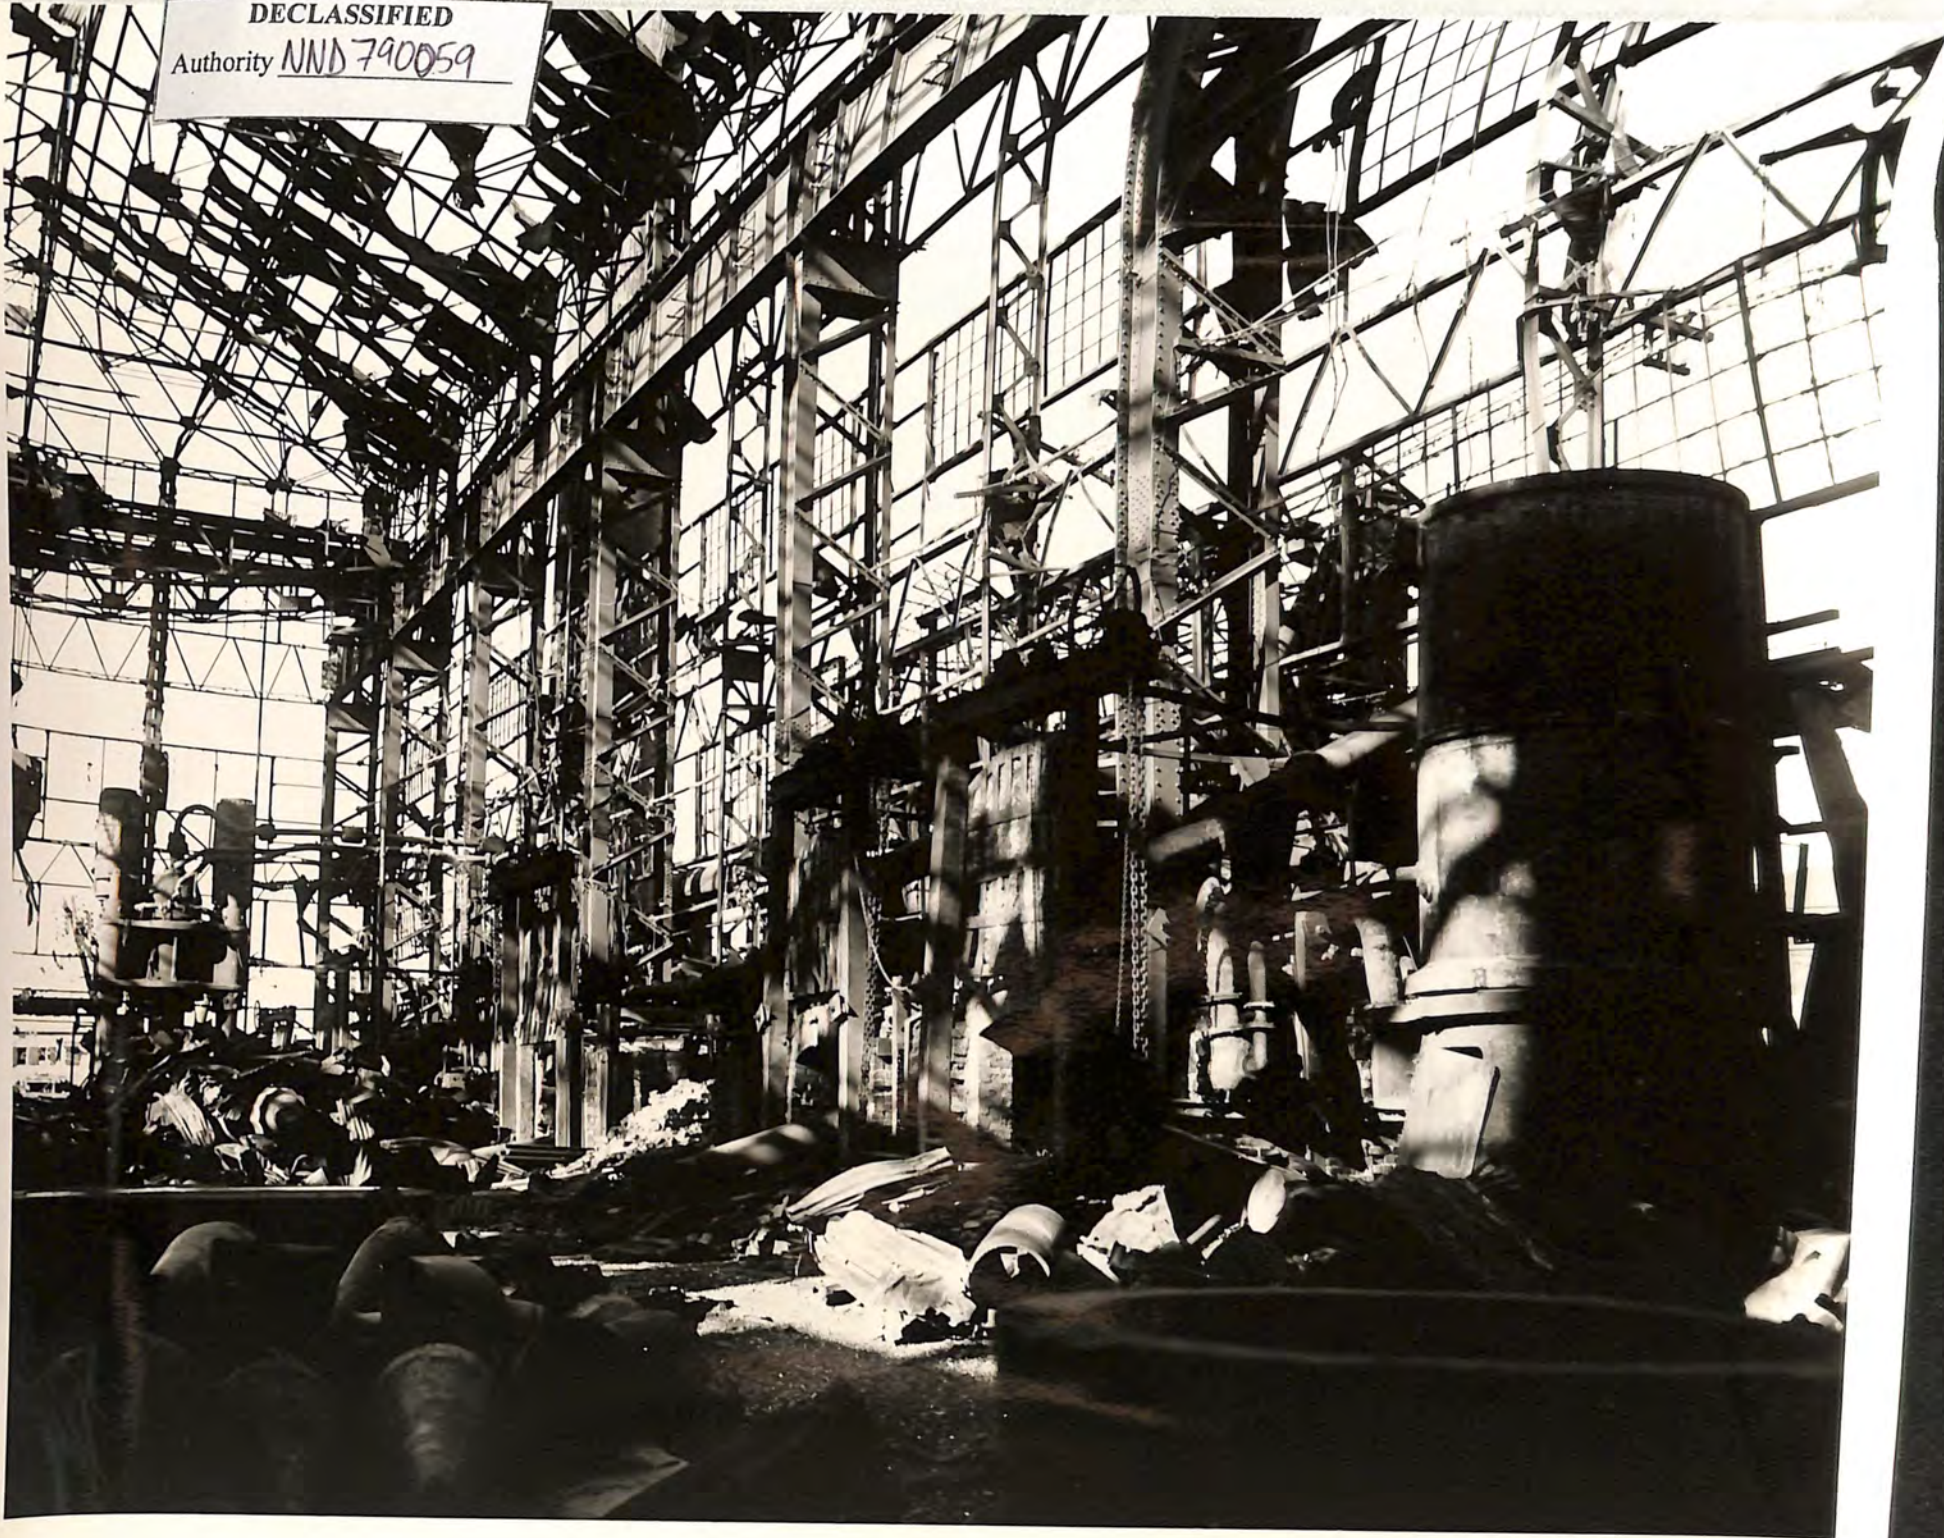
This is a general view of damage caused by the blast to buildings in the South portion of the plant. Note the corrugated metal ripped from the steel frame work and damage to building contents. Reinforced concrete chimneys at this location were apparently uninjured.

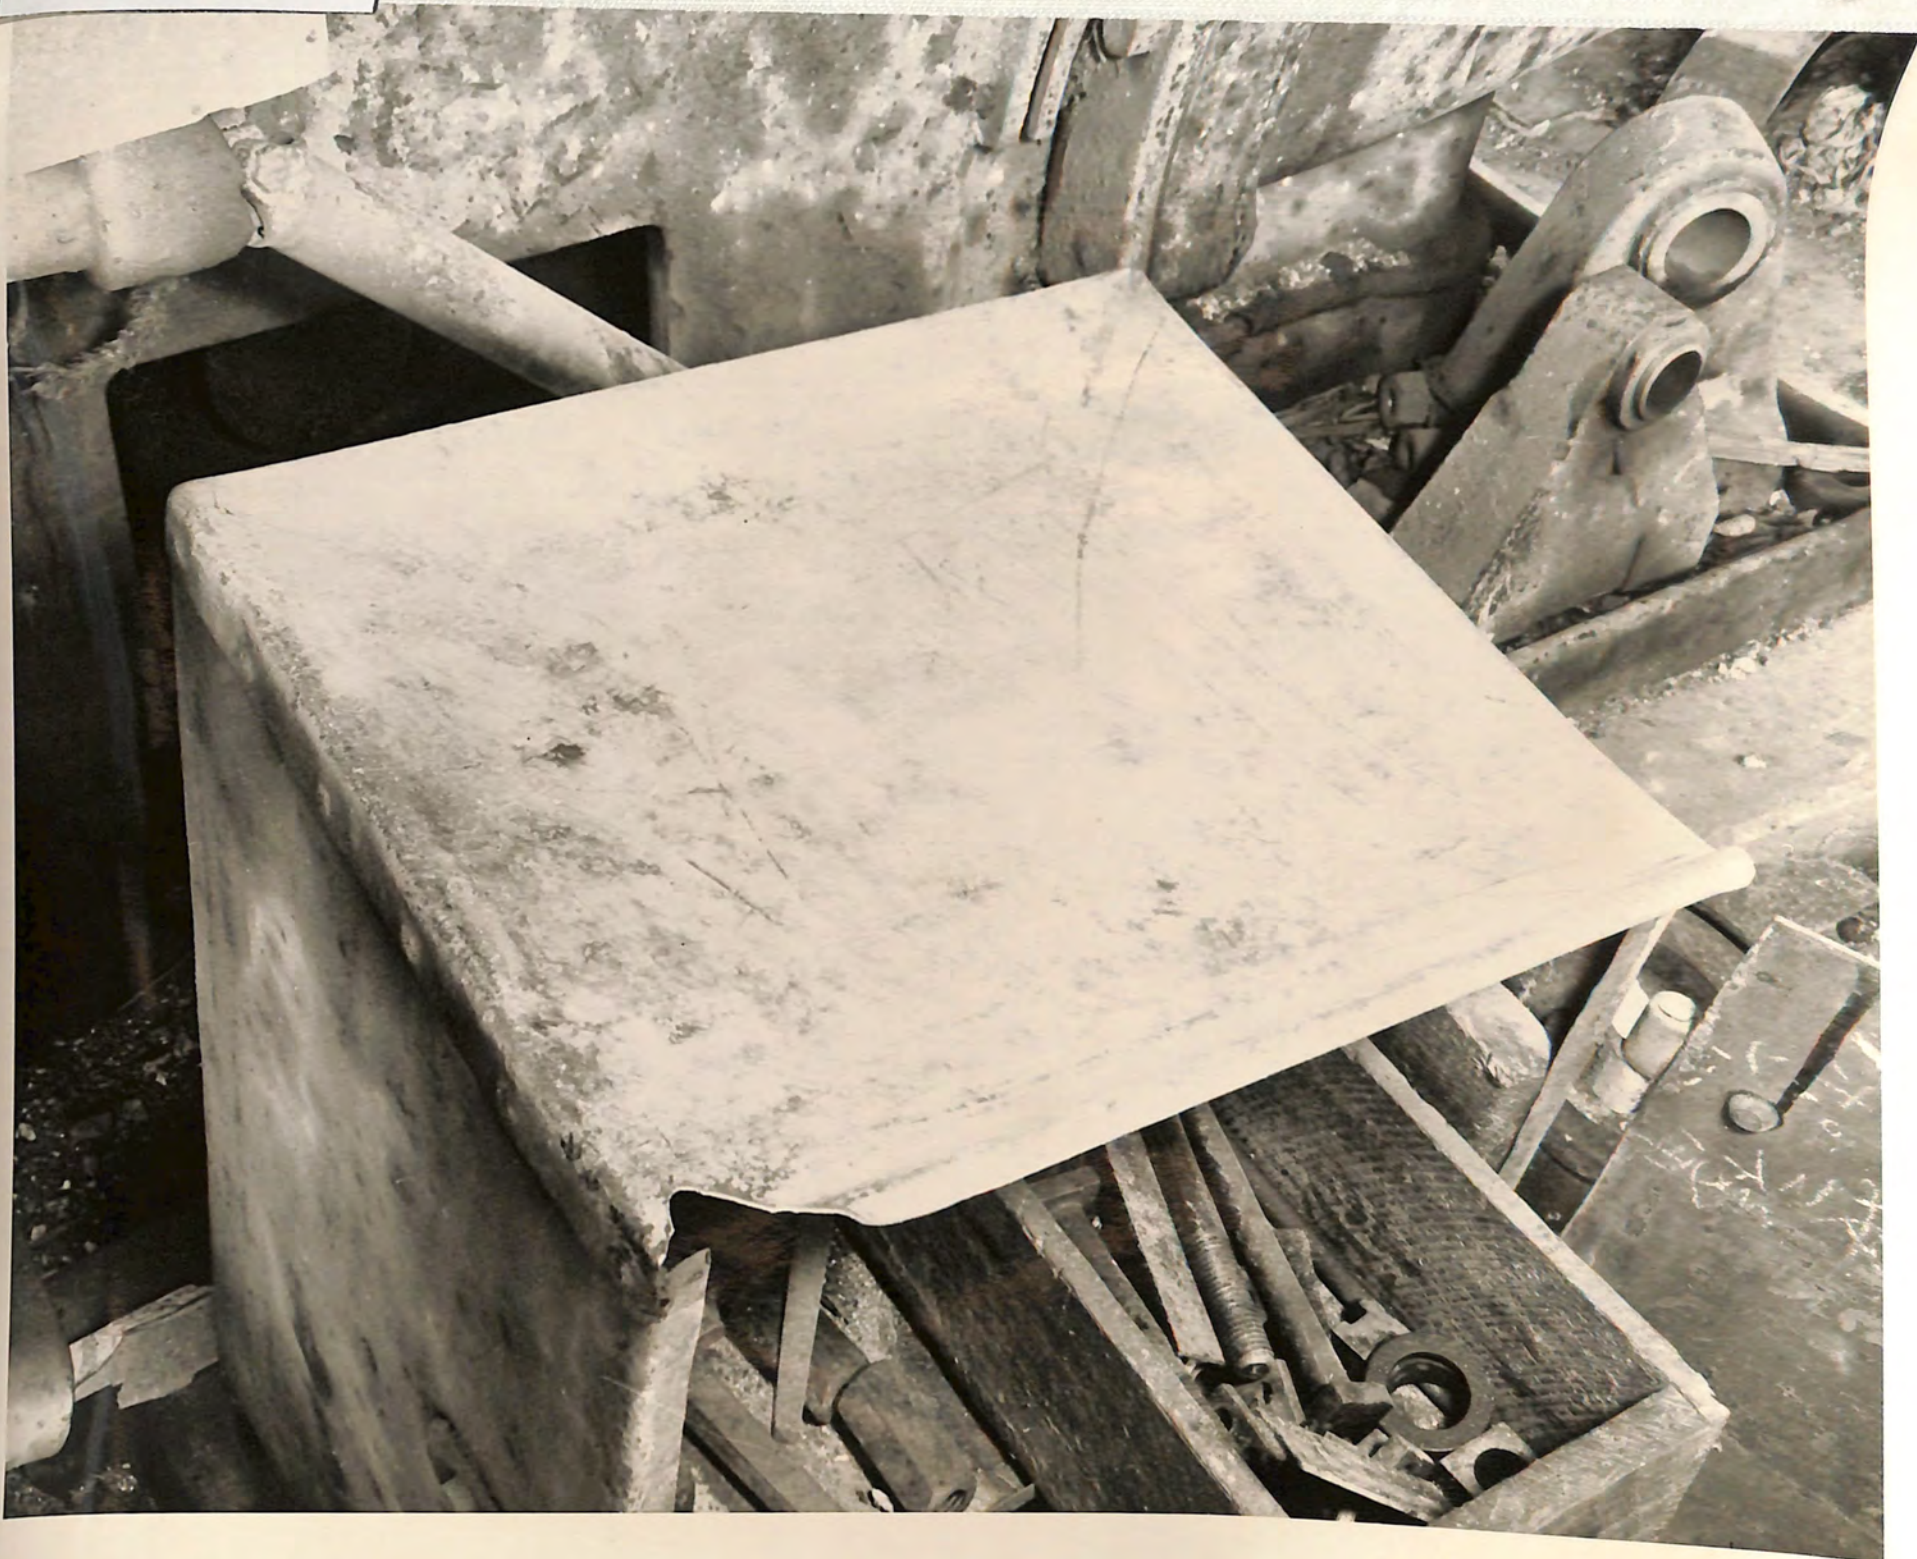
This is another view, showing failure of concrete and structural steel building.

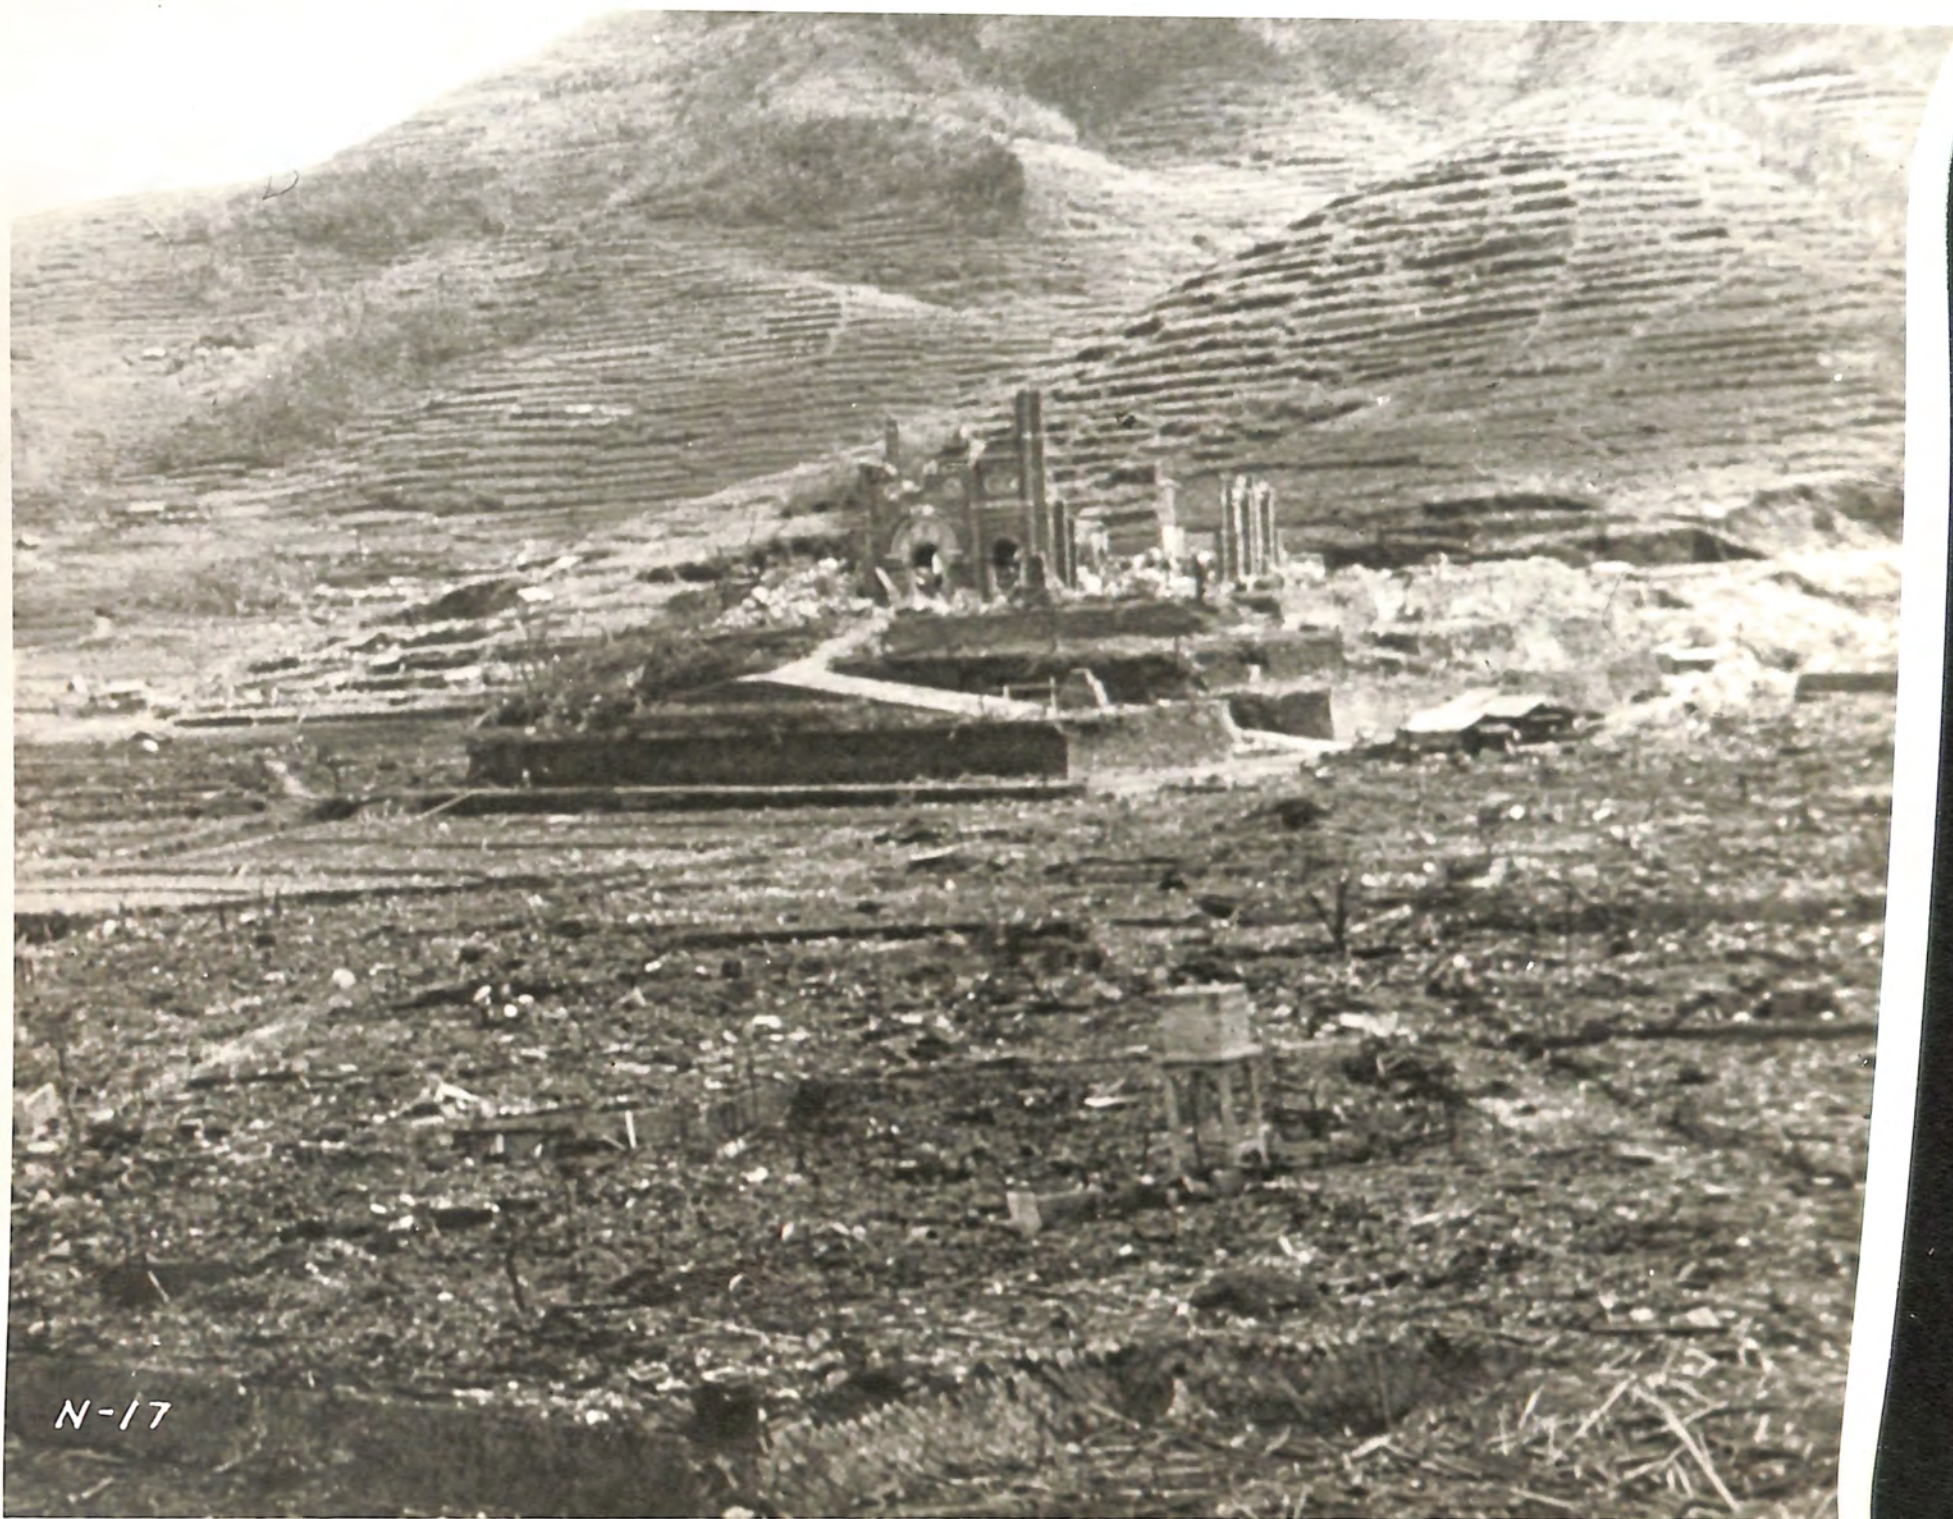
FIGURE 102

This building, wrecked by the blast, was of heavy masonry construction (very thick brick walls). Note steep hills which confined the blast effects largely to the industrial valley.

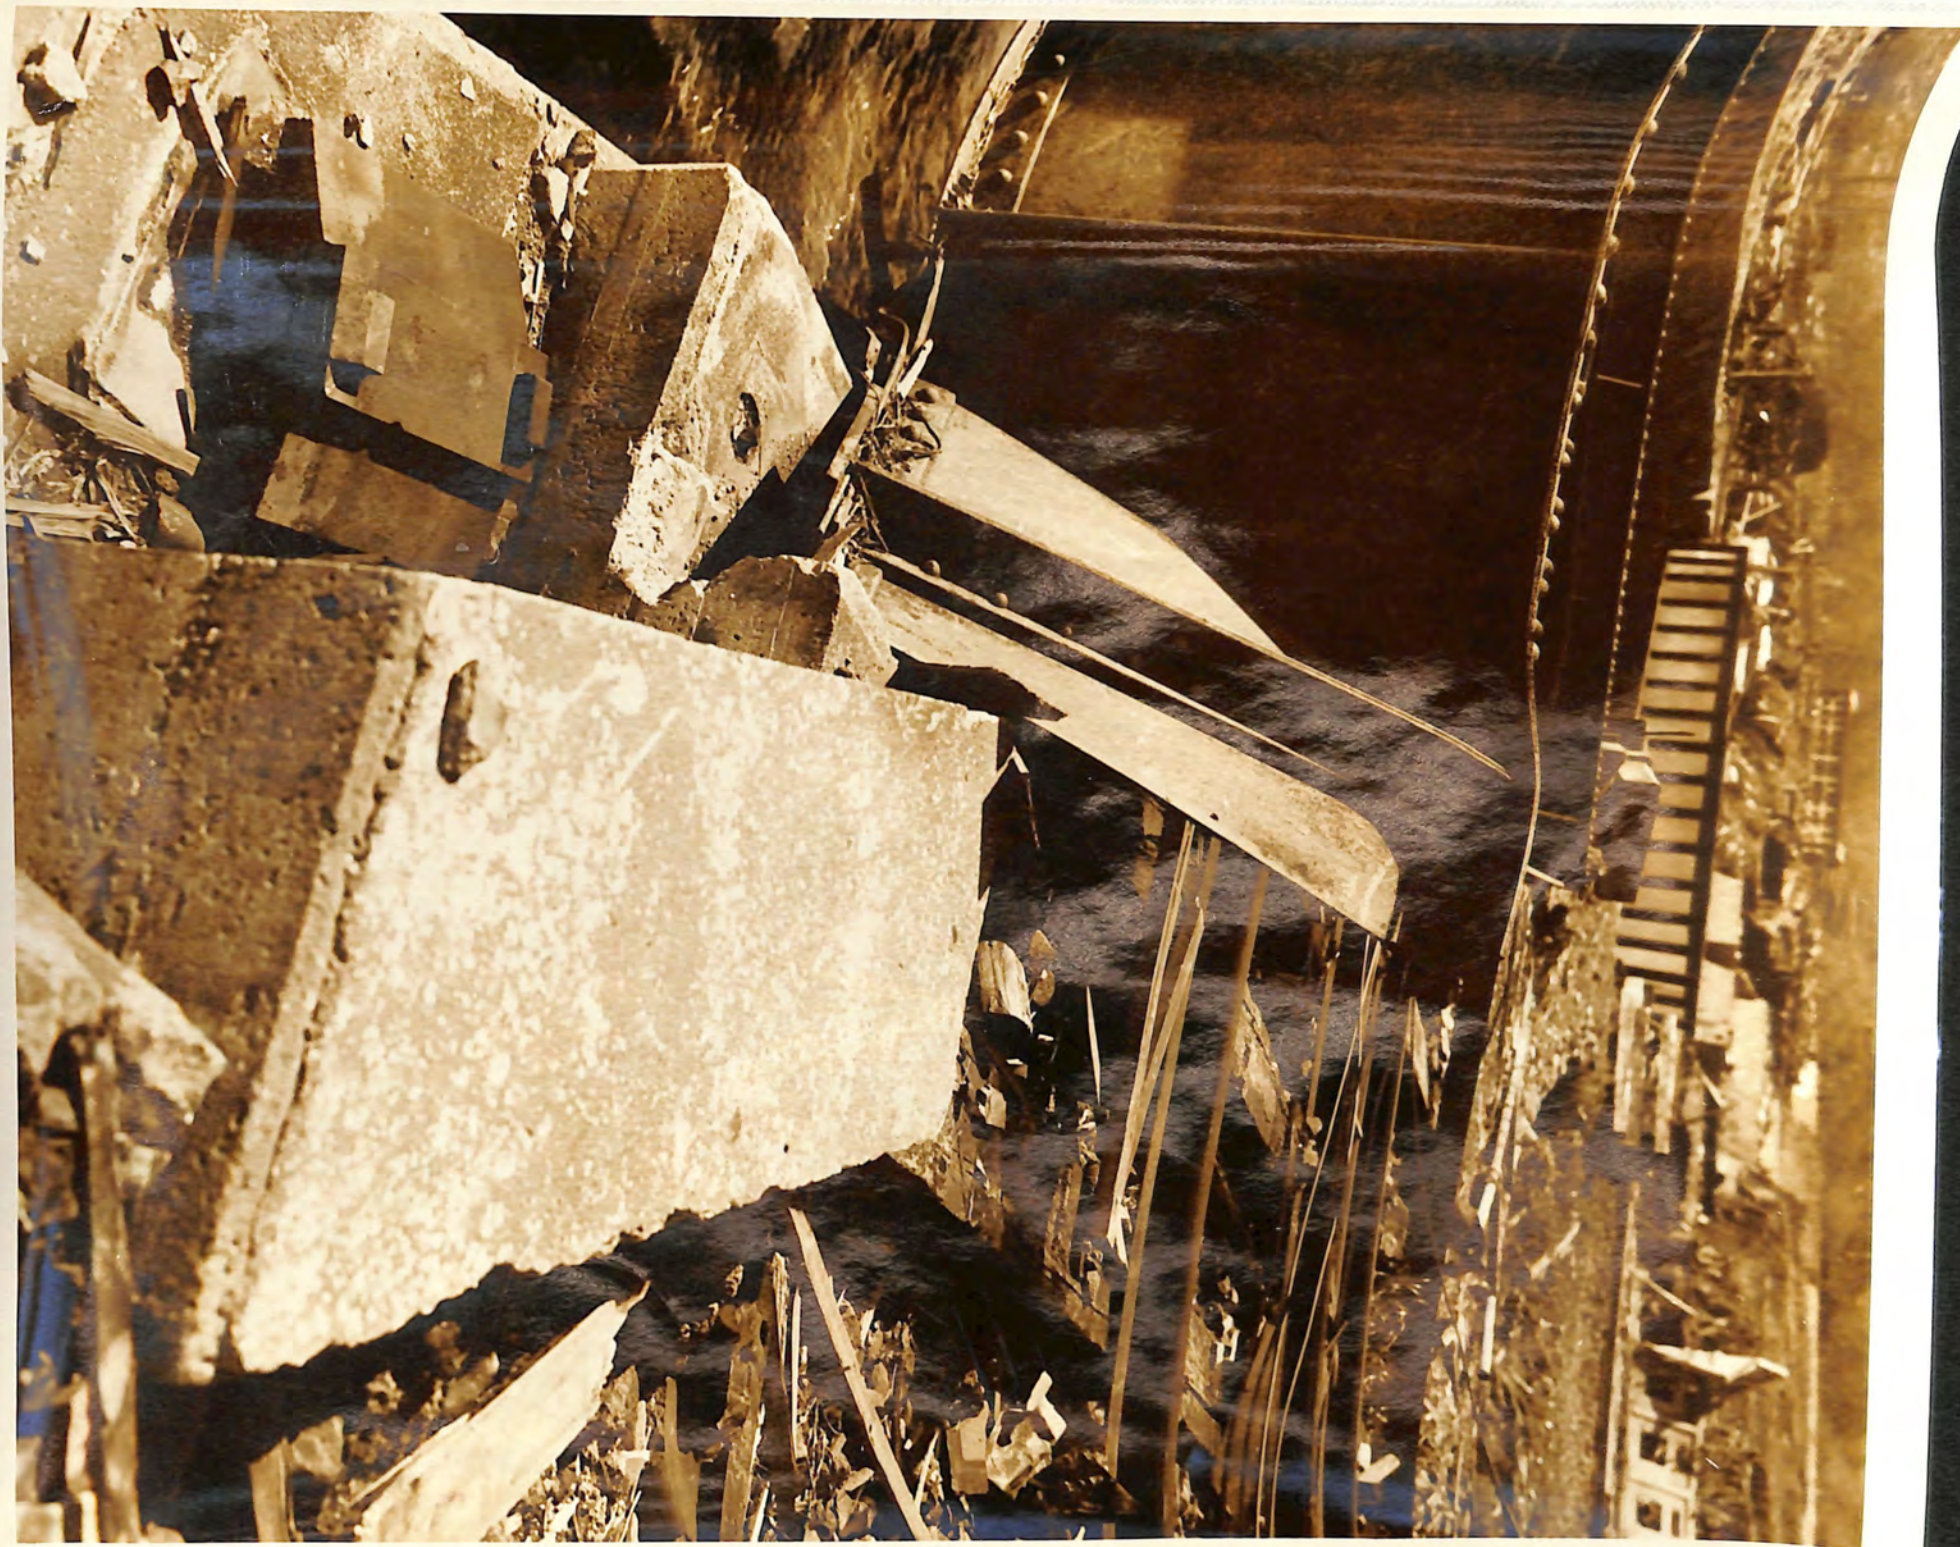
FIGURE 130

This is a close-up of the Northeast corner showing how girder was knocked loose from the metal bridge seat and buckled by the blast. Note the large amount of wood splinters and other combustible material which did not burn.

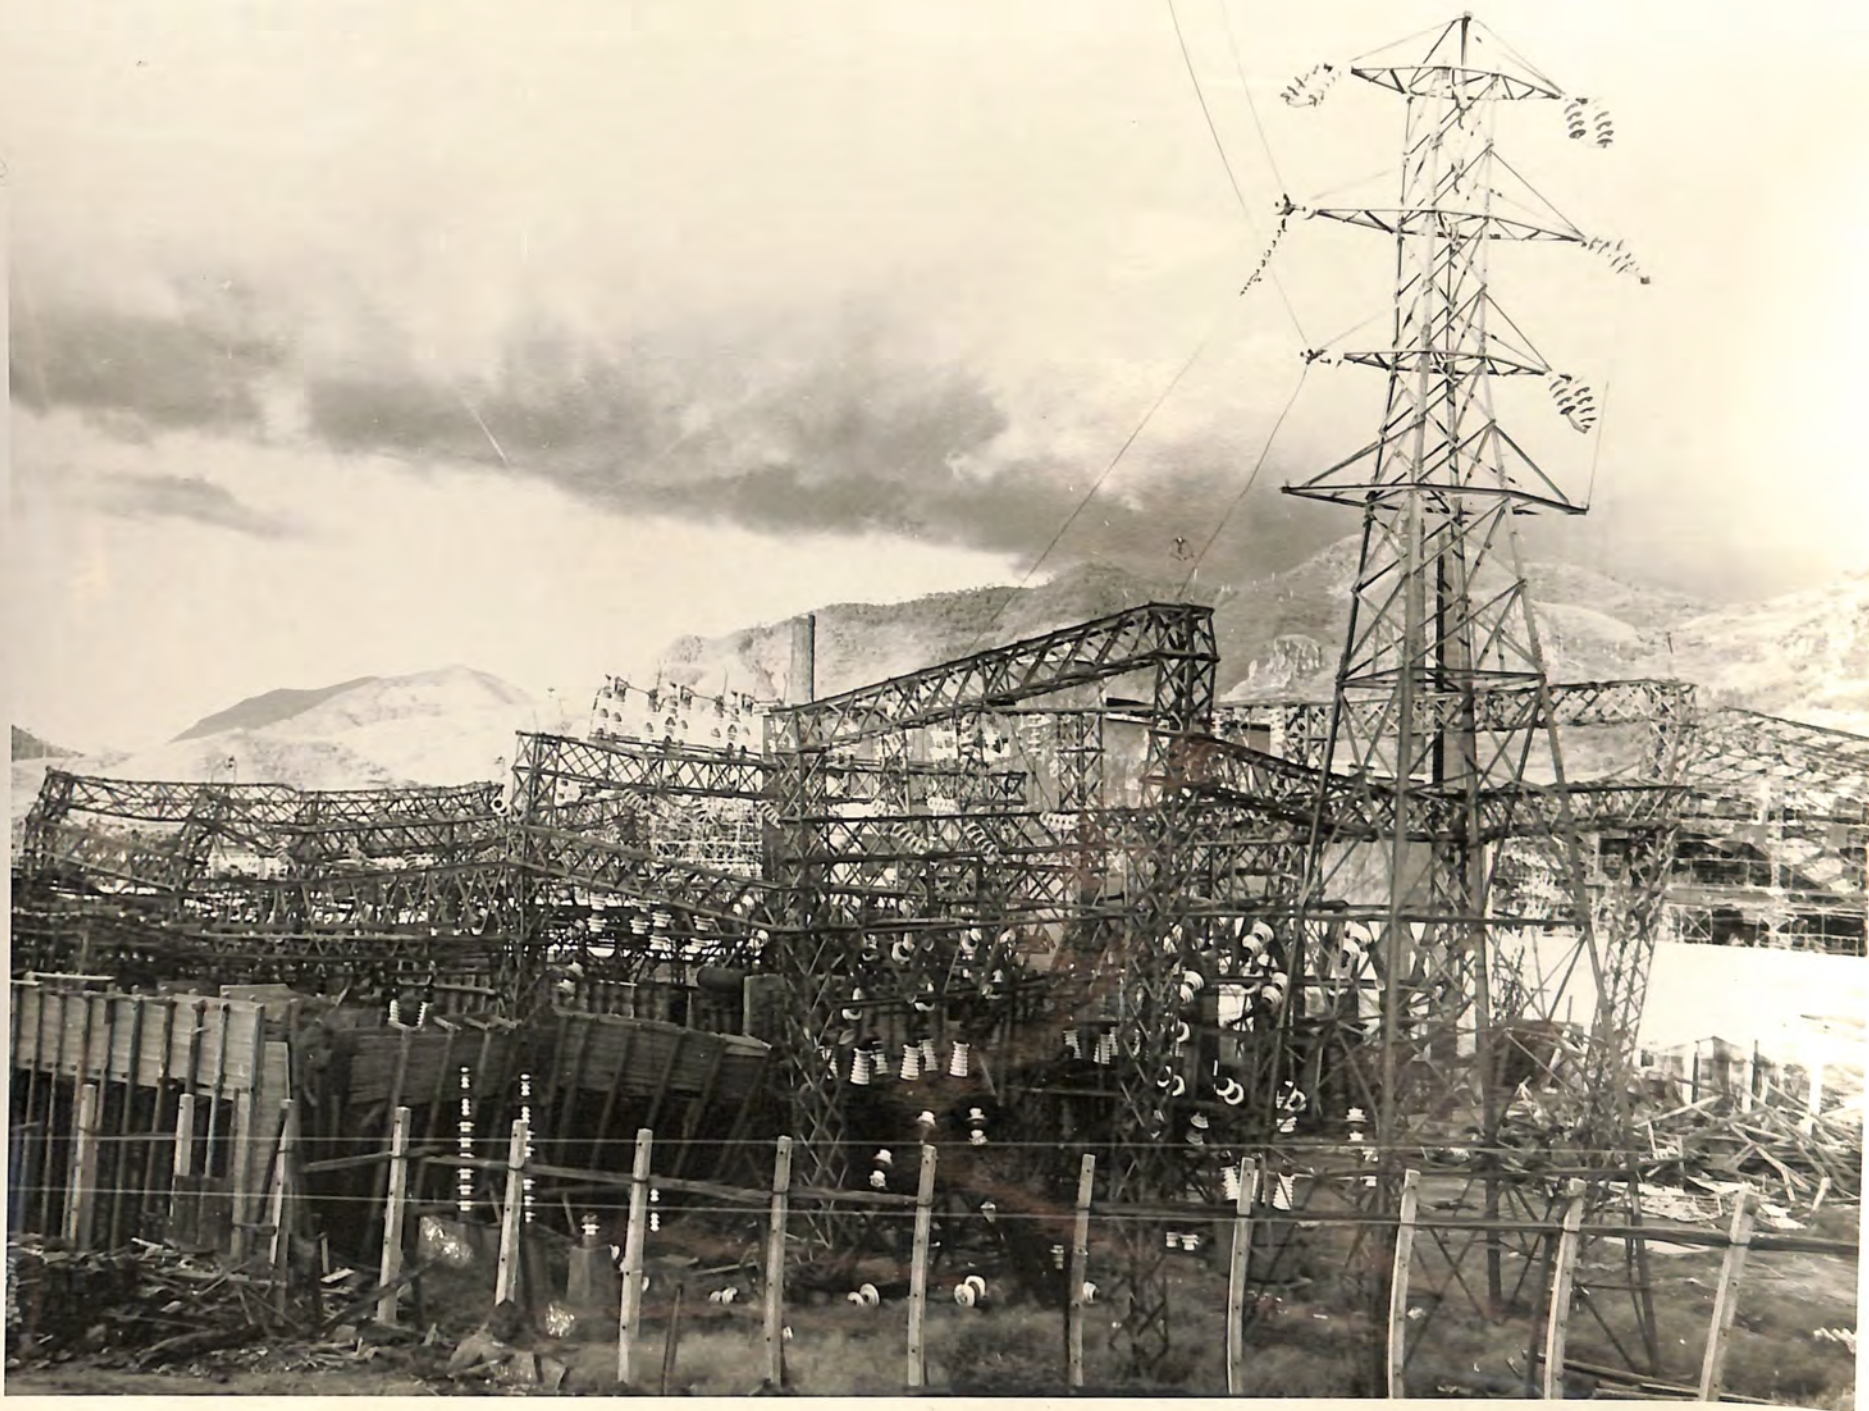
FIGURE 137

While comparatively little electrical power was generated in Nagasaki, a large part of the electric supply was interrupted by the bomb blast, chiefly through damage to electric substations. Figures 137 and 138, show damage to electric substations supplying power to the Mitsubishi Steel and Arms Works and other industries nearby.

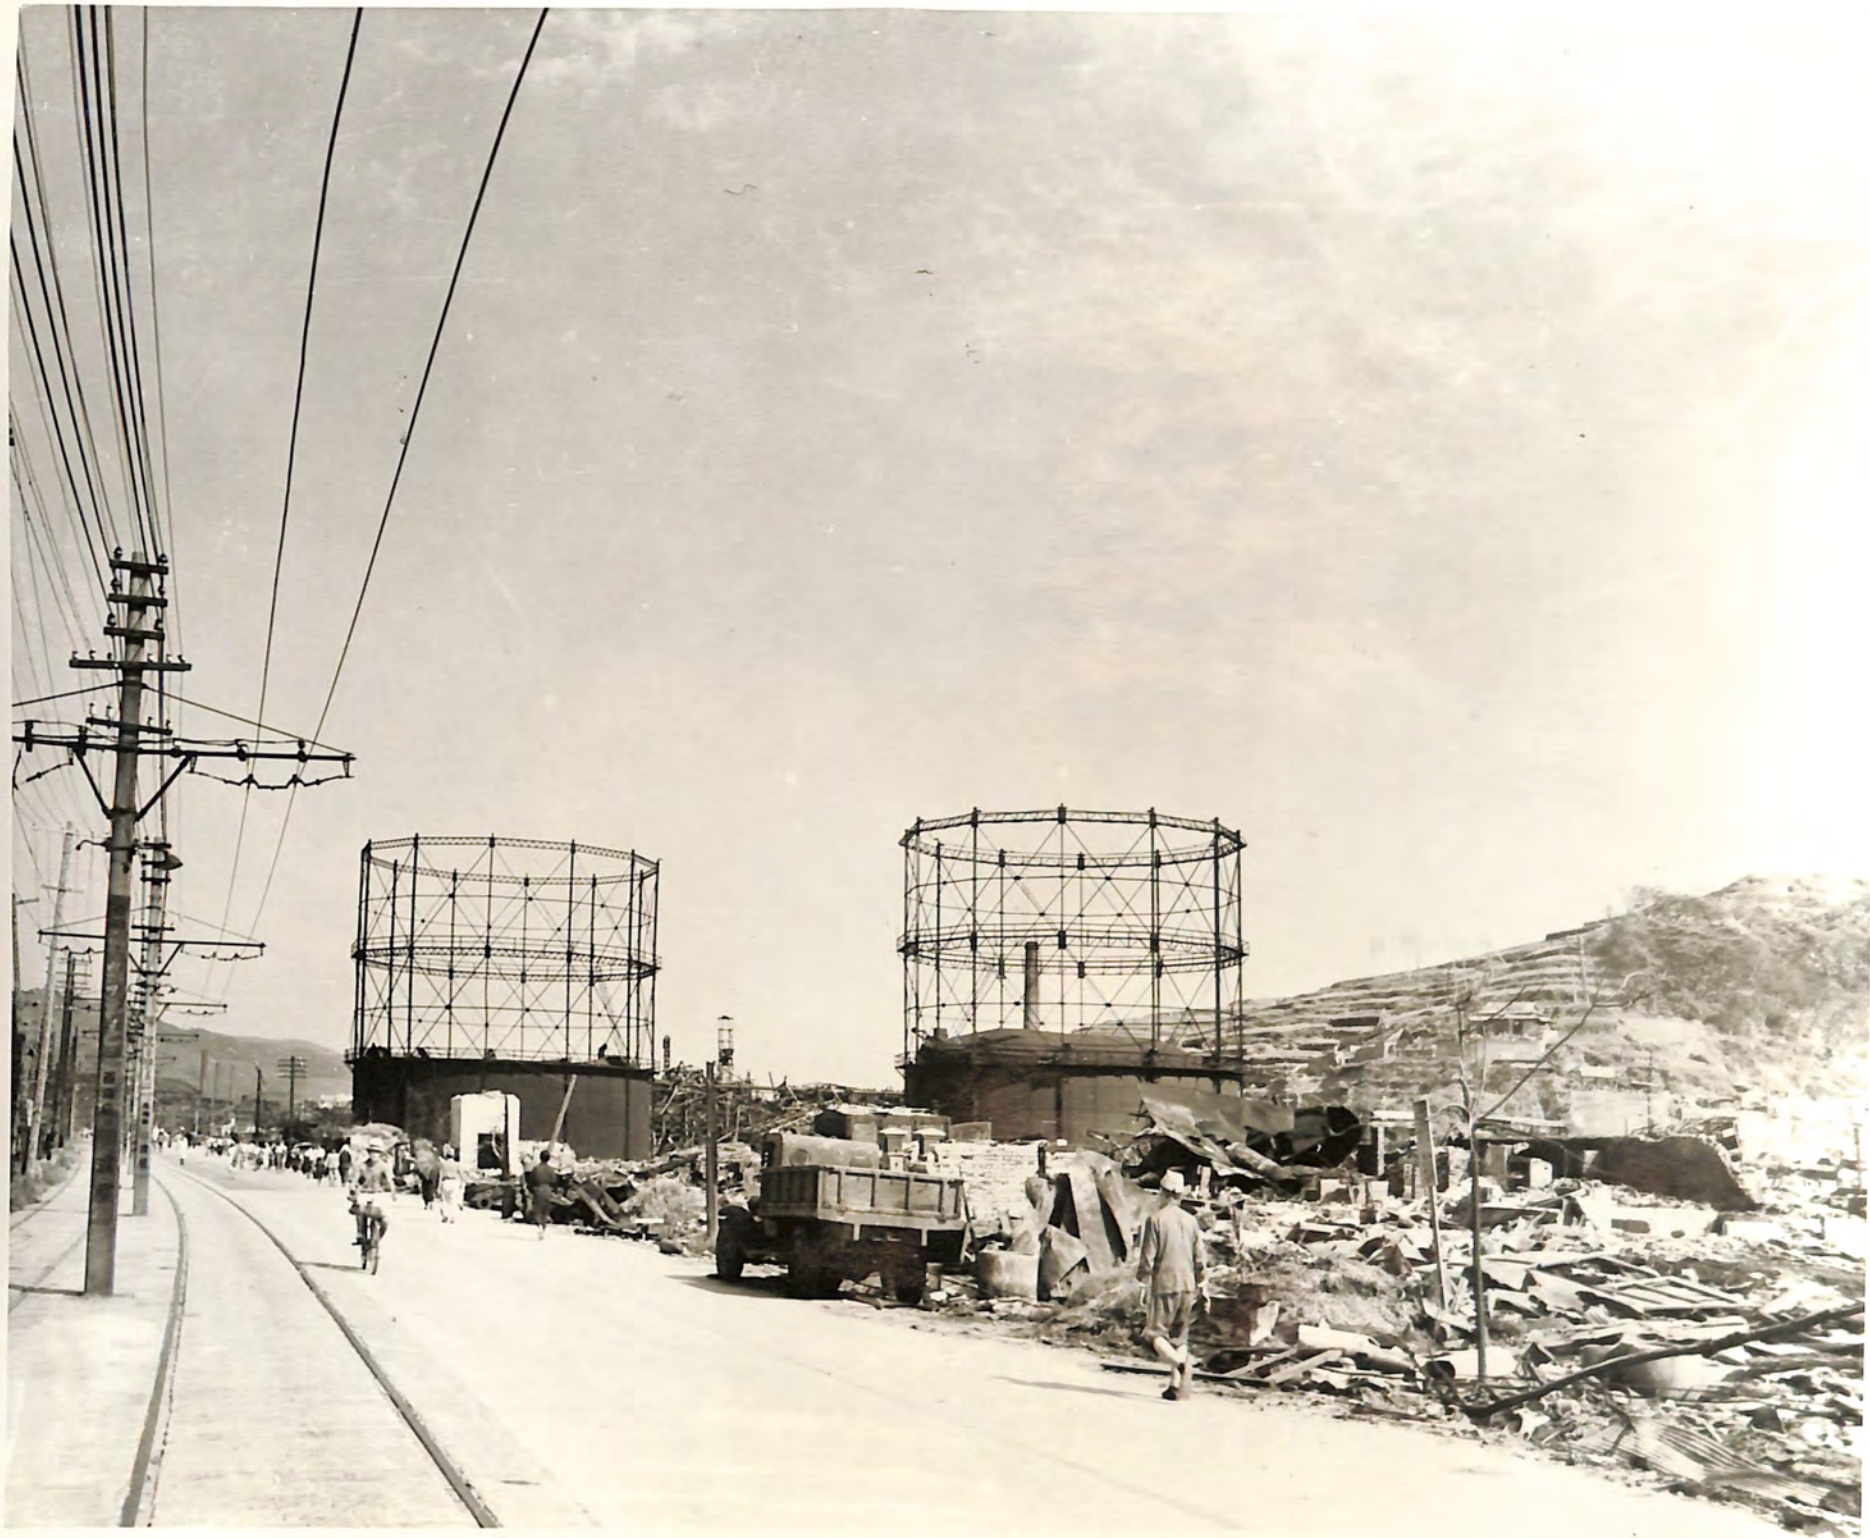
FIGURE 139

Both the Kyushu Gas Works and the Urakami Gas Works were very severely damaged by the bomb blast. They had not been placed in operation as late as six weeks after the Atomic explosion. Figures 139 to 140a, inclusive, depict damage to the Kyushu Gas Company, the Urakami Gas Works, and the Power Plant, respectively.
